# Wirral Borough Council:

## Section 19 Flood Investigation: 22<sup>nd</sup> August and 2<sup>nd</sup> September 2015

May 2016

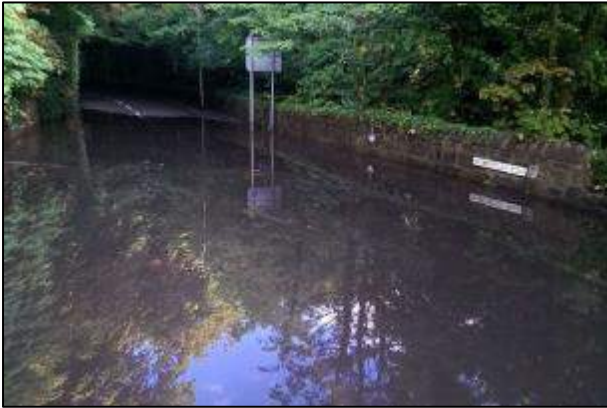
- Spital Dam was subject to flooding up to a depth of 1.2m. This caused significant disruption to vehicular traffic. This occurred during both the 22<sup>nd</sup> August and 2<sup>nd</sup> September flood events, with a motorist being rescued from his car by Merseyside Fire and Rescue during the 2<sup>nd</sup> September incident. Photographs of the flooding can be seen in Photograph 5-1 and Photograph 5-2.
- Bromborough Road was flooded near Unilever and the Port Sunlight Station as was Bebington Road.
- A number of residents at Port Causeway reported external property flooding from the public highway during the 22<sup>nd</sup> August flooding.
- Gorsefield Avenue was flooded on the evening of the 22<sup>nd</sup> August, resulting in internal property flooding.
- Further public highway flooding was reported on The Rake, Woodchurch Road, Prenton Lane and Mount Road.

**Photograph 5-1 Bromborough Road Flooding (2/9/15)**

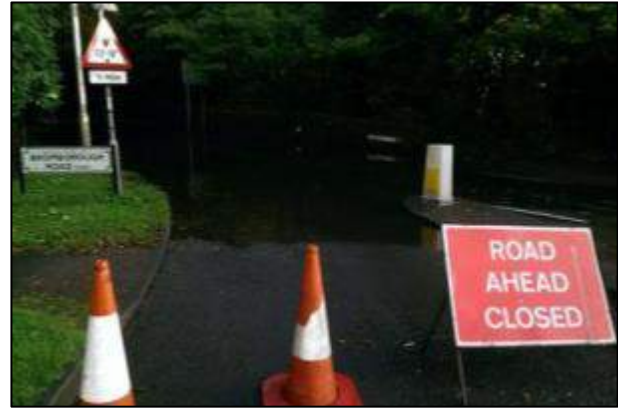
**Photograph 5-2 Bromborough Road Closures (2/9/15)**

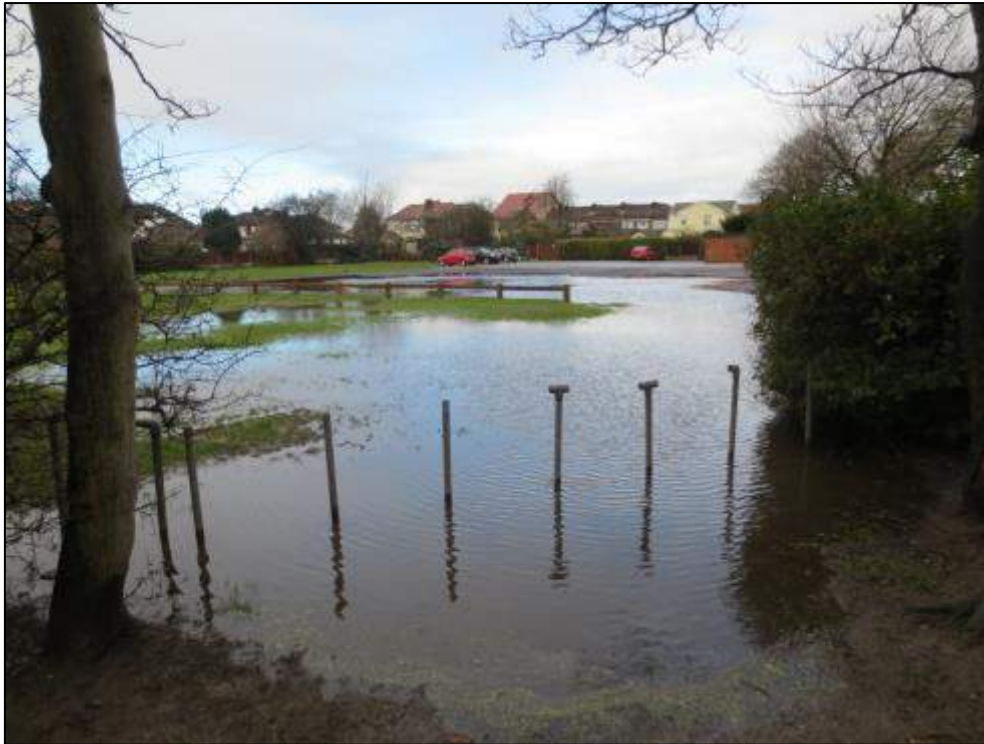
The survey team commenced the site visits in the Coronation Park car park. Extensive pooling of surface water was observed and no formal drainage was apparent at this location (Photograph 5-3). There was no evidence that the surface water ponding in the car park directly impacted on the adjacent residential properties, although this could have potentially impacted them historically.

**Photograph 5-3 Standing Water in the Coronation Park Car Park (1/3/16)**

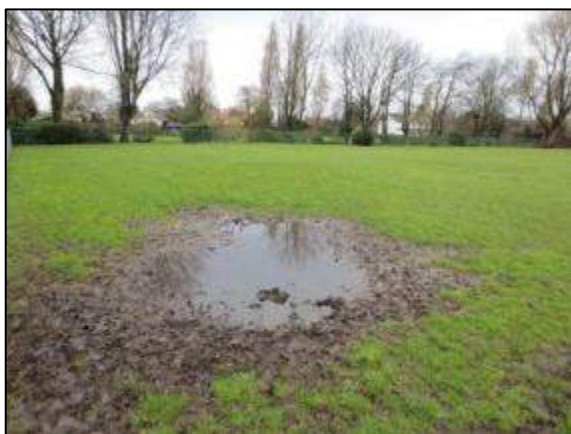
Significant clay deposits and low permeability soils may prevent the infiltration of surface water into the ground and result in the generation of overland flow which residents indicated has happened historically (including on both the 22<sup>nd</sup> August and the 2<sup>nd</sup> September 2015). A drainage ditch is present on the park’s western boundary (adjacent to the allotments) and was observed to be conveying a small volume of water at the time of the visits. This feature may afford a low level of protection to the playing fields and the adjacent residential properties.

**Photograph 5-4 Waterlogged Soils in Coronation Park (1/3/16)**

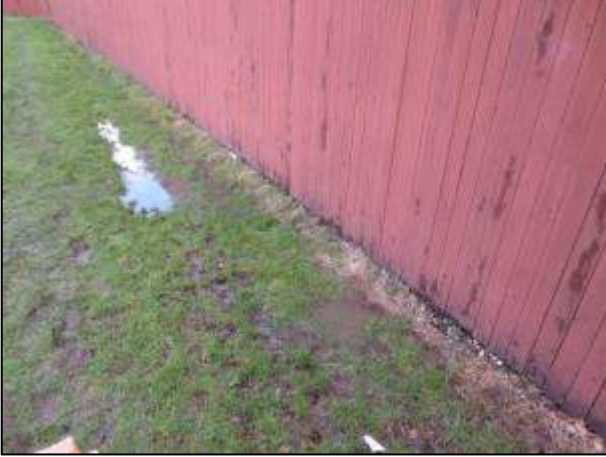
The residents at Brookdale Close confirmed that the majority of the flooding was external, with the exception of 2 individual homes that experienced internal flooding. The residents also confirmed that the properties which experienced historic flooding have now had new doors fitted by Magenta Living.

Photograph 5-6 Surface Water behind Brookdale Close (1/3/16)

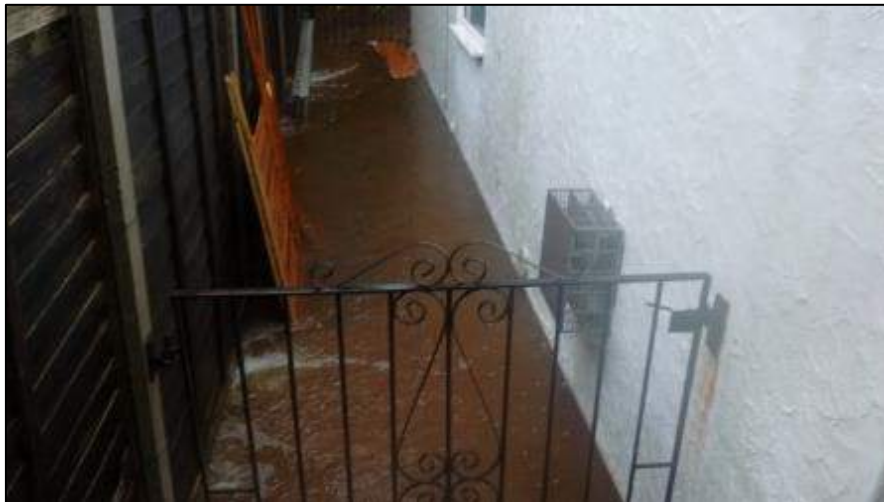
The survey team undertook a walkover at Joan Avenue at the request of residents who had experienced severe flooding during the 2<sup>nd</sup> September 2015 event. This visit also entailed the provision of bespoke flood risk resilience advice to the residents. The residents at Joan Avenue indicated that the flood flow route originated from the Coronation Park and was influenced by the topography of the adjacent bowling green. The overland flow was subsequently routed through and around a number of properties on Joan Avenue (Photograph 5-8) and onto Greasby Road.

Photograph 5-8 Flooding at the back of Joan Avenue (2/9/15)

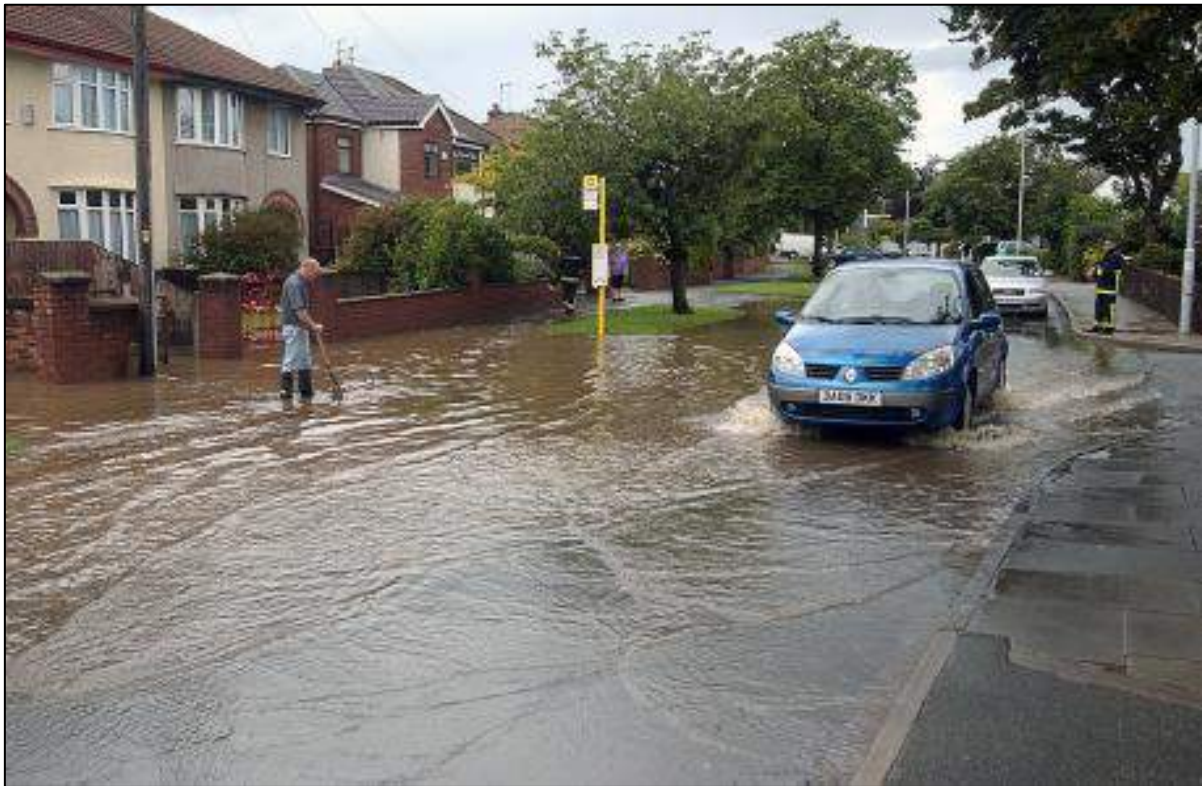
A review of internet sources that there have been a number of flooding incidents at this location. On 17<sup>th</sup> July 2007 Wirral Globe<sup>11</sup> reported that “torrential downpours brought chaos to parts of Greasby this afternoon as roads were flooded after just 30 minutes of rain.” The report notes that Arrowe Road was closed, and that internal and external flooding affected properties on Arrowe Road and Rigby Drive. A picture accompanying the report (Photograph 5-9) shows significant flooding in Arrowe Road adjacent to the public footpath leading from Lloyd Drive.

**Photograph 5-9 Arrowe Road Flooding (17/7/07)**

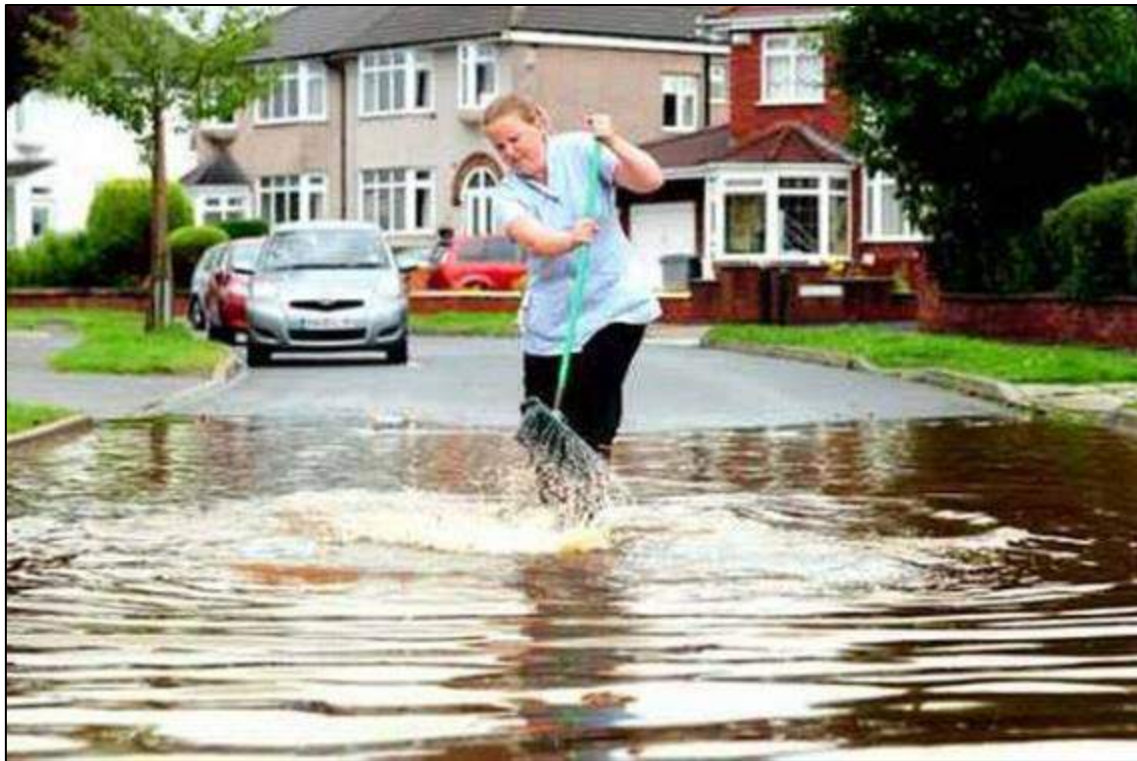
**Photograph 5-10 Rigby Drive Flooding (16/8/12)**

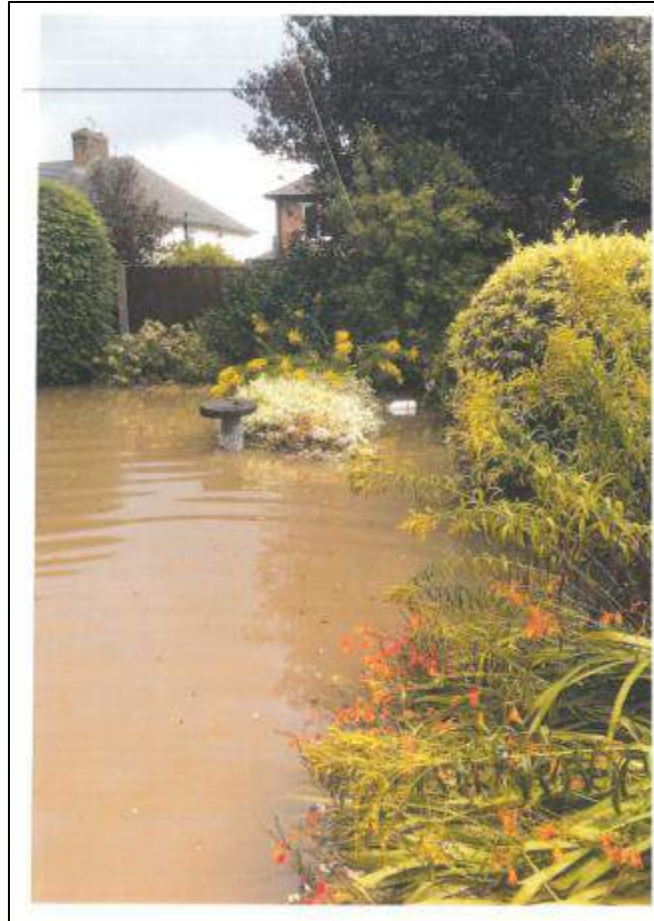
Flooding and surface flows from this area may potentially compound the issues around Arrowe Road (which is immediately downslope), though the sewer connectivity has not been confirmed at this stage.

**Photograph 5-11 Rigby Drive Flooding (Unknown Date)**

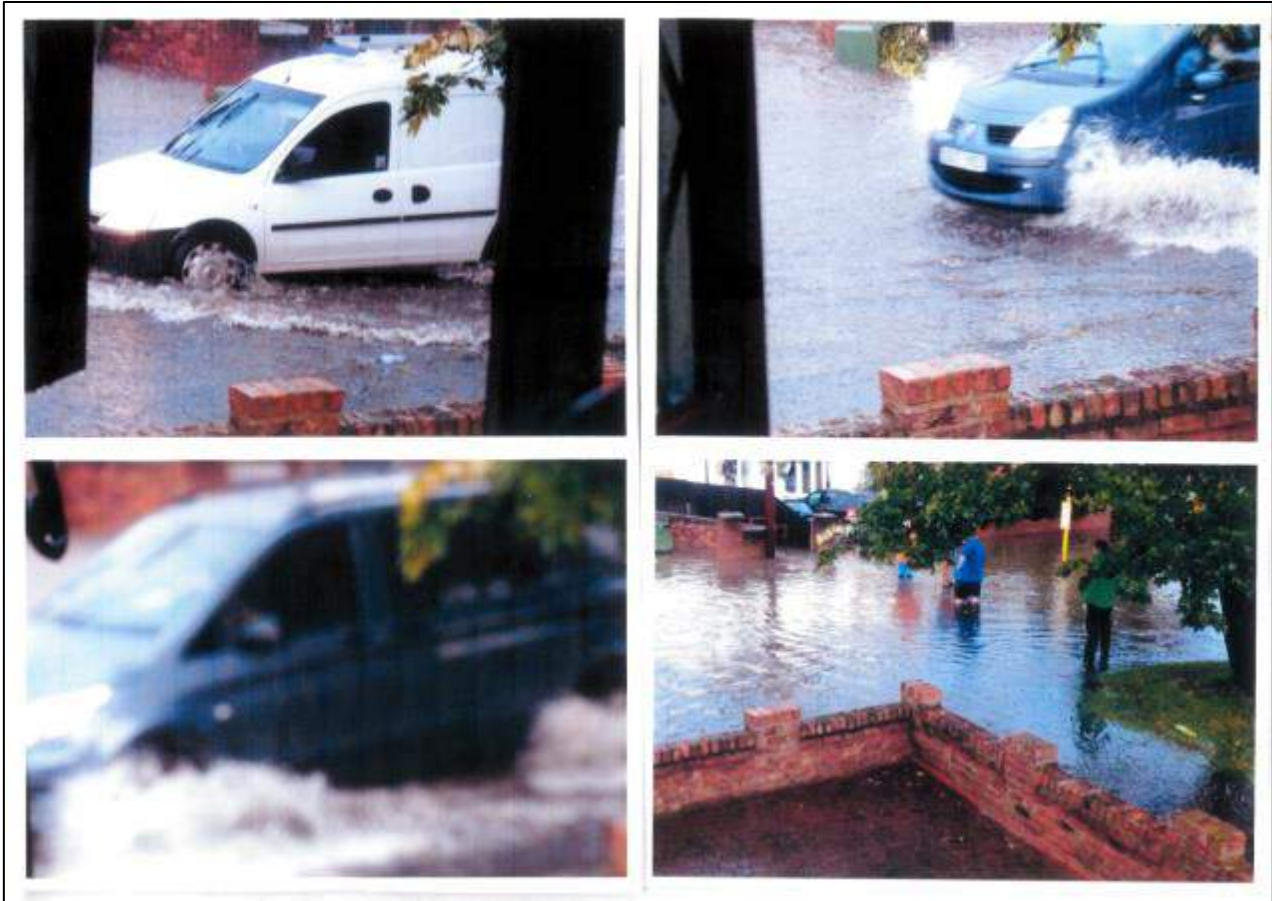
A neighbouring resident provided a number of photographs of the historic flooding to the survey team (Photograph 5-12). UU has confirmed that it has not received any reports of flooding from residents in this area for the 2<sup>nd</sup> September 2015 flooding.

**Photograph 5-12 Arrowe Road Flooding (2/9/15)**

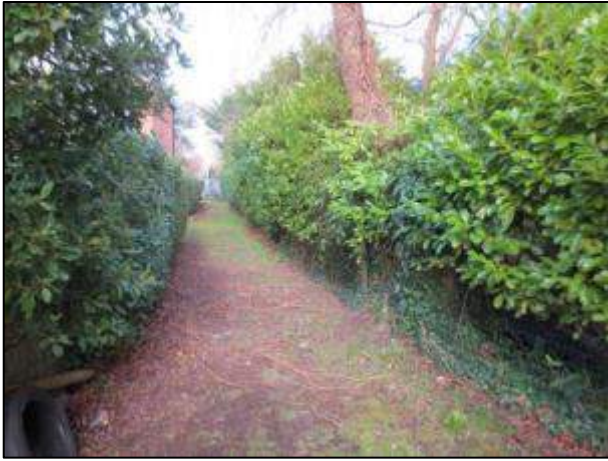
The local residents also provided photographic and video evidence of the flood flow route through the properties on the 2<sup>nd</sup> September 2015. This information was used to indicate an approximate flood flowpath for this at this location.

**Photograph 5-13 Surface Water Flowpath at Rylands Hey  
(1/3/16)**

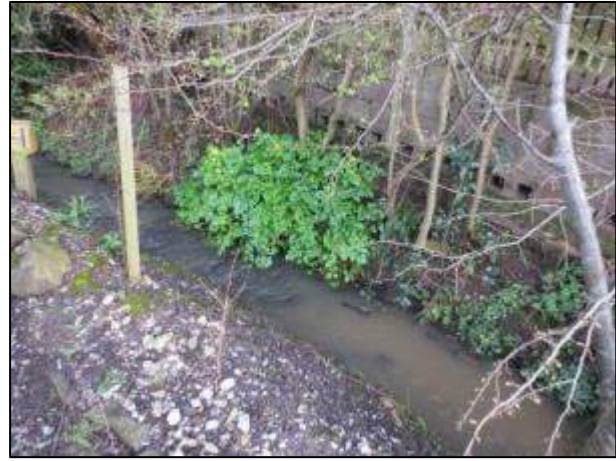
**Photograph 5-14 Ordinary Watercourse at Rylands Hey  
(1/3/16)**

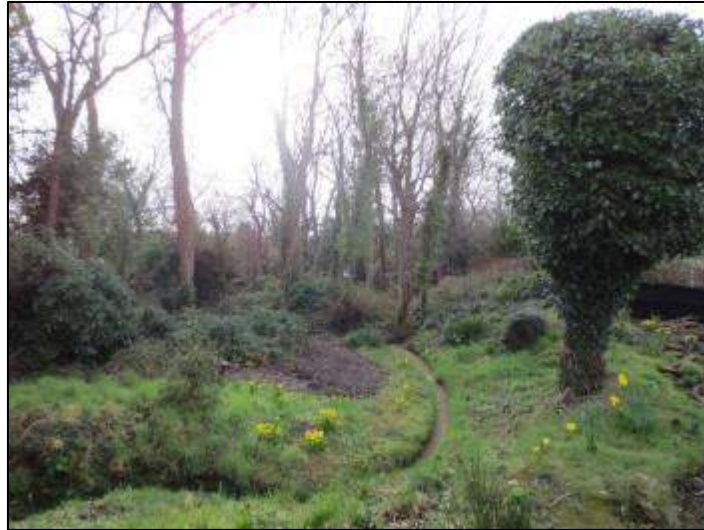
On the opposite side of the close a resident concerned with flooding from an ordinary watercourse which is a tributary of the Greasby Brook. This issue was reported as being a result of a tree growing within the unmaintained ordinary watercourse which then traps debris during times of flood. This consequently results in a localised constriction to flow and a backwater effect.

**Photograph 5-15 Vegetation Growth within an Unnamed Ordinary Watercourse (1/3/16)**

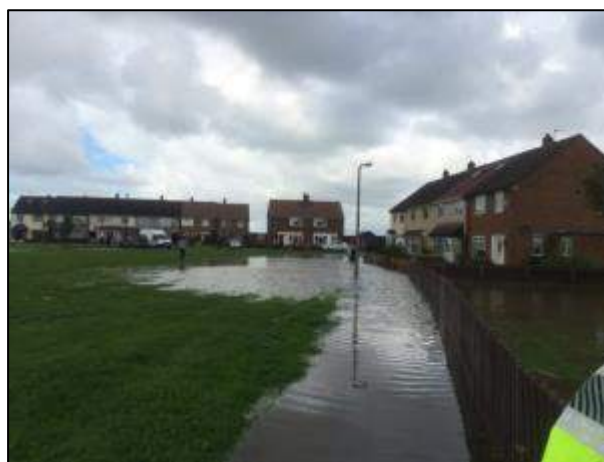
Photograph 5-17 Flooding at Tern Way (2/9/15)

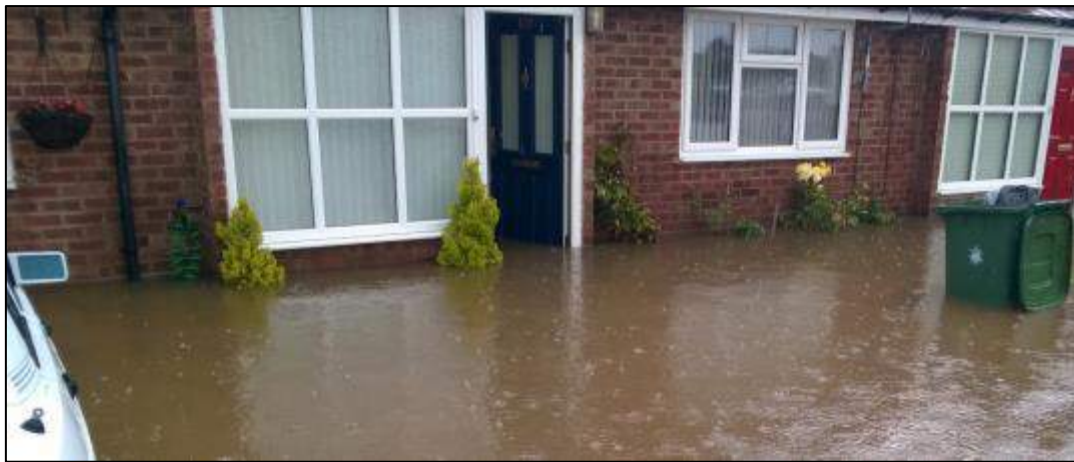
**Photograph 5-20 Flooding at Tern Way (2/9/15)**

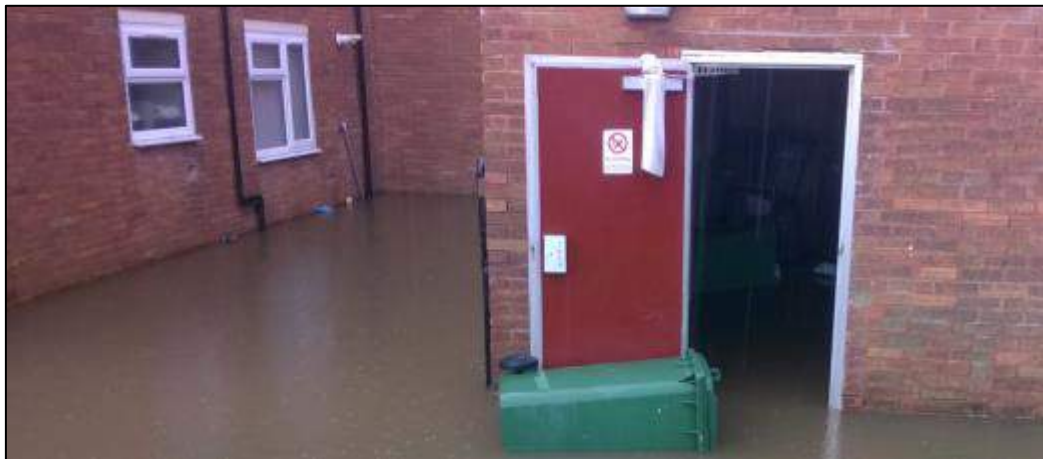
**Photograph 5-21 Flooding at Tern Way (2/9/15)**

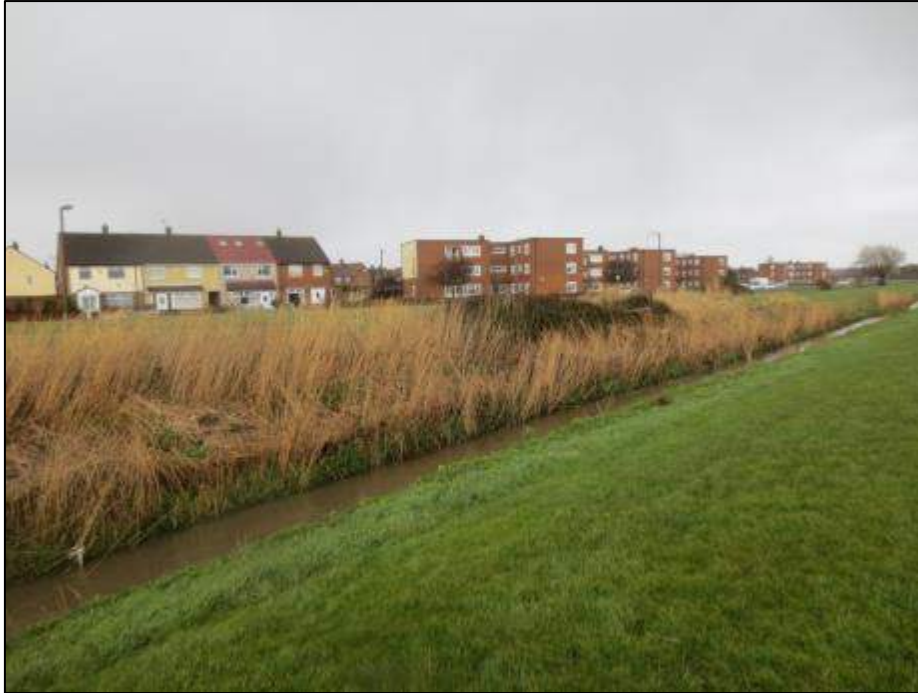
The AECOM site walkover on the 2<sup>nd</sup> of March 2016 prioritised residents and the areas identified within the estimated flood outline produced by the Environment Agency local area team following the event. The Arrowe Brook was observed as being in relatively good condition, with little debris and freely flowing. The watercourse is relatively straight with clearly defined uniform banks on each side of the river. The topography of the adjacent floodplains is flat, with a limited change in level between the bank crests and the neighbouring properties (Photograph 5-22).

**Photograph 5-22 The Arrowe Brook in Morton (Looking Upstream) (2/3/2016)**

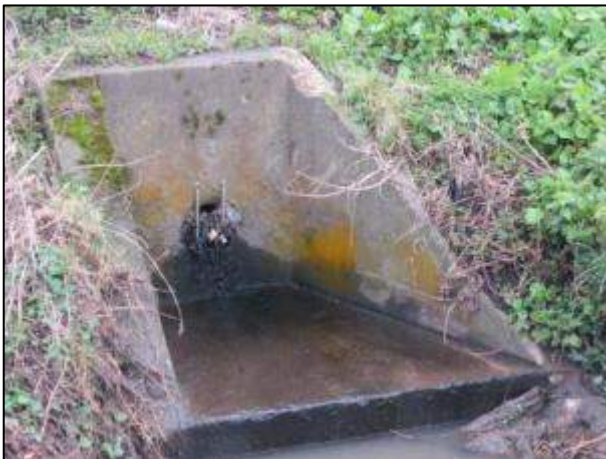
A number of large surface water outfalls (of varying diameter) were also observed along this reach of the Arrowe Brook. Several of these outfalls were visibly blocked at the trash screen and potentially retaining water within the drainage system.

**Photograph 5-23 Blocked Surface Water Outfall (2/3/16)**

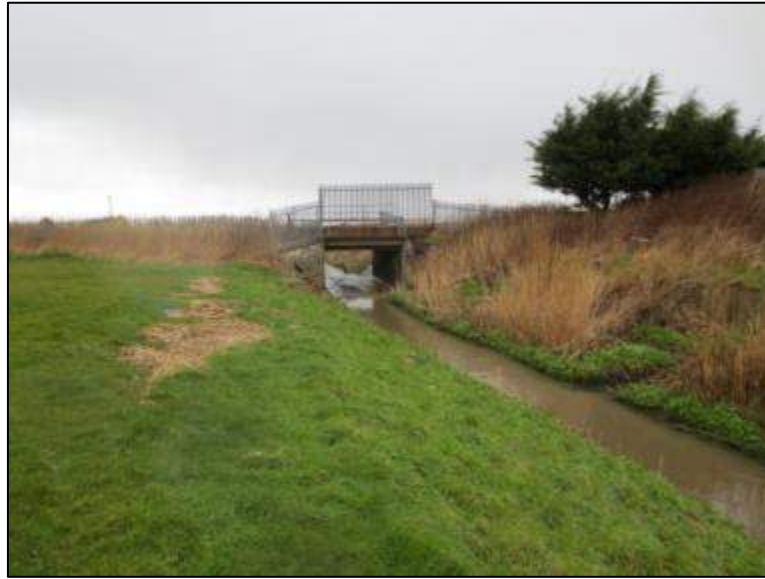
The site walkover identified recent evidence of increased water levels immediately upstream of the Rail Bridge as evidenced by a series of wrack marks just below the crest levels of the river banks (Photograph 5-25). This indicates that the capacity of the Rail Bridge may potentially throttle flows during times of flood which could result in a backwater effect and lateral spilling into the adjacent floodplain.

**Photograph 5-25 Arrowe Brook Railway Bridge (2/3/16)**

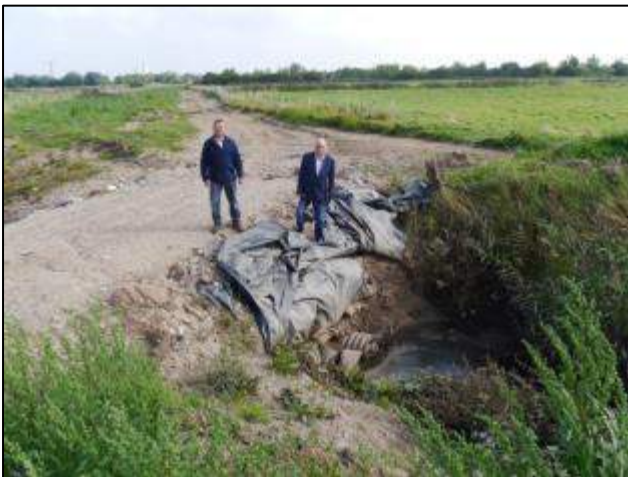
These temporary crossings are intended to be constructed such that at high flows they overtop. Photographs of the structure are shown in Photograph 5-26 and Photograph 5-27.

**Photograph 5-26 Arrowe Brook, UU structure (post-event photograph)**

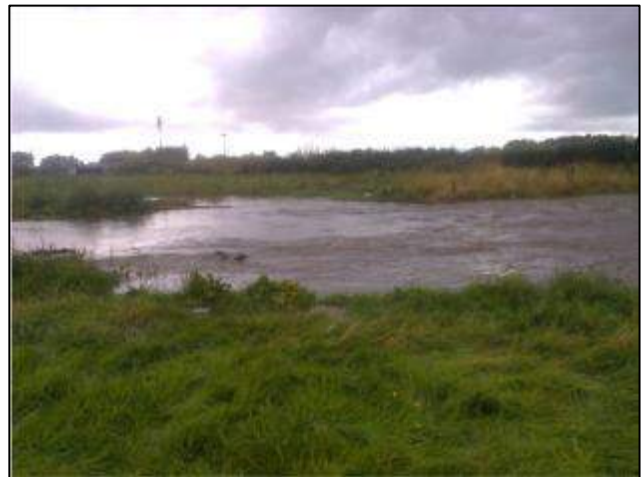
**Photograph 5-27 Arrowe Brook, Looking North Across the UU structure, 09:38, 2/9/15**

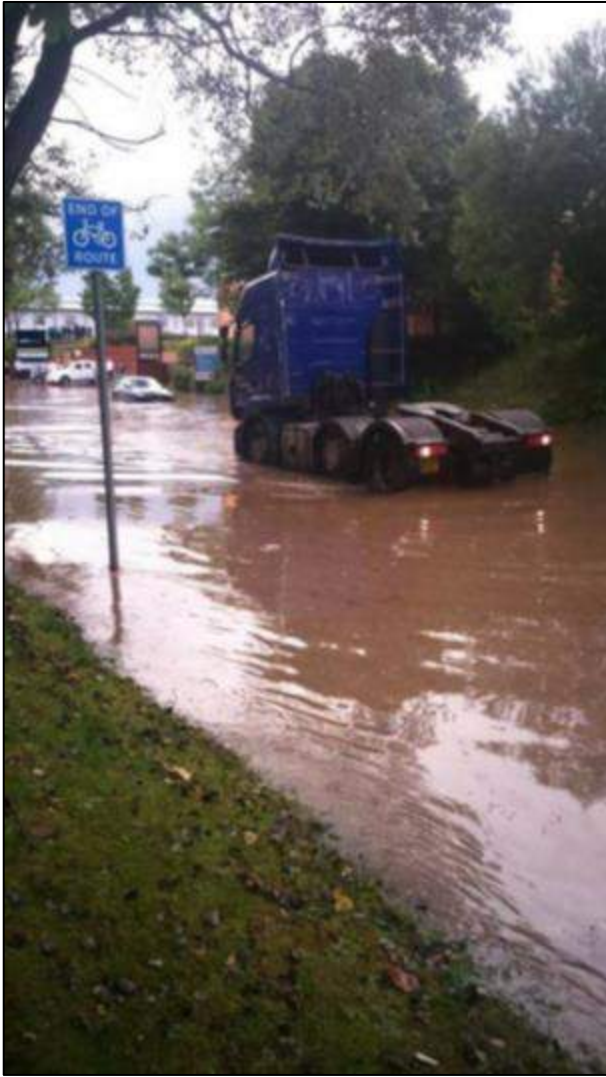
SP Energy Networks have also provided photographs of the access road flooding at the North Cheshire Trading Estate as shown in Photograph 5-28 and Photograph 5-29.

**Photograph 5-28 Flooding on Prenton Way (2/9/15)**

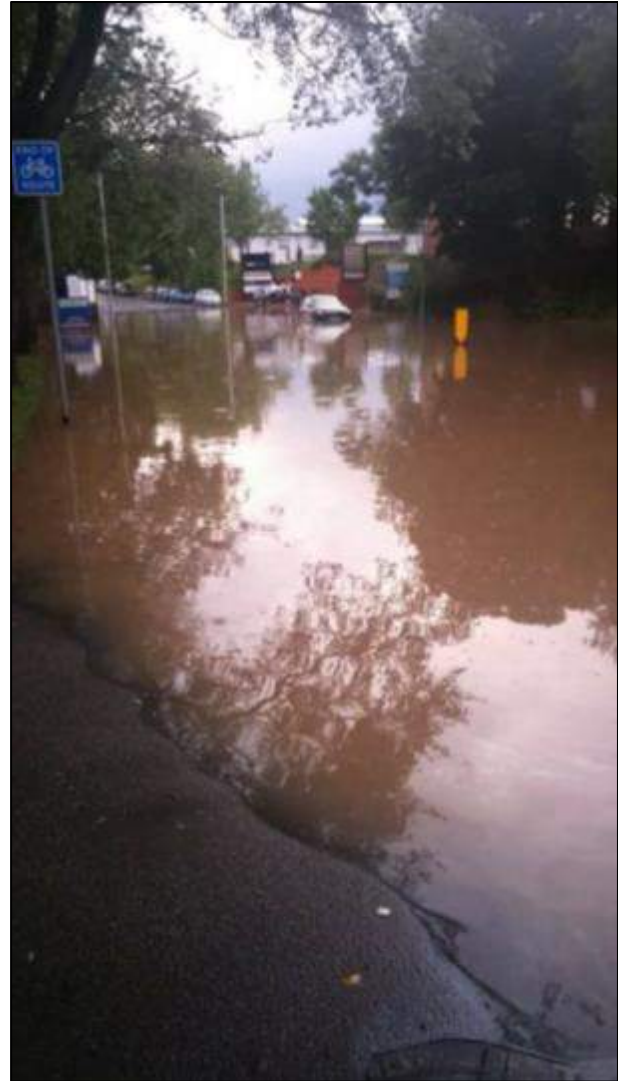
**Photograph 5-29 Flooding on Prenton Way (2/9/15)**

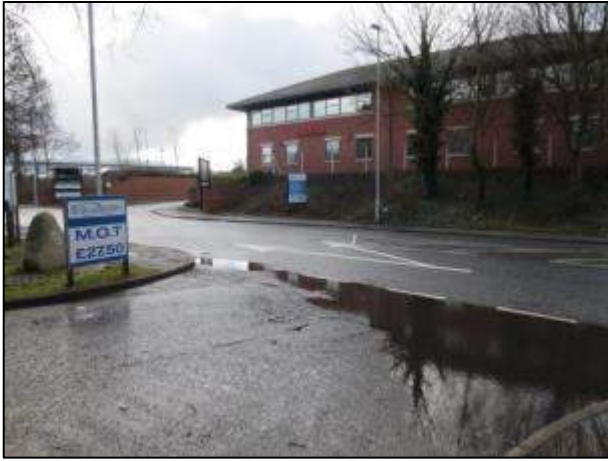
**Photograph 5-30 Low spot on the Prenton Way (3/5/15)**

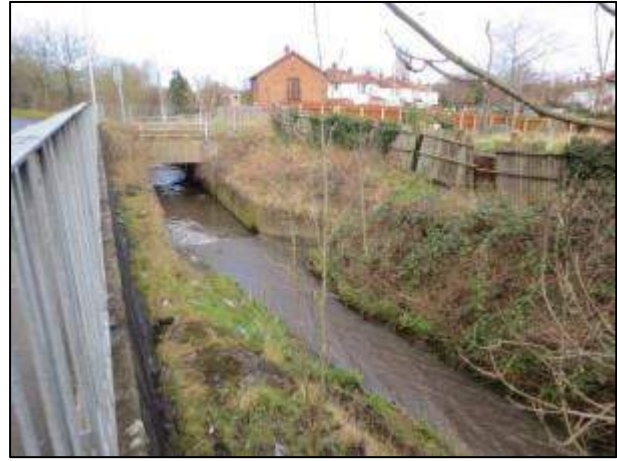
The survey team also observed an access bridge to Durley Drive over the Prenton Brook. The soffit level of this structure is relatively low compared to the deck level of the access road. Based upon these observations it was considered that this structure could potentially impact on the conveyance of flow during high water levels. This could potentially lead to a backwater effect which could result in lateral spilling over the low bank levels. Blockage of this structure could exacerbate flood risk, though the active Environment Agency operations teams found no evidence of a blockage occurring during the 2<sup>nd</sup> September 2015 flooding.

**Photograph 5-31 Access Bridge to Durley Drive**

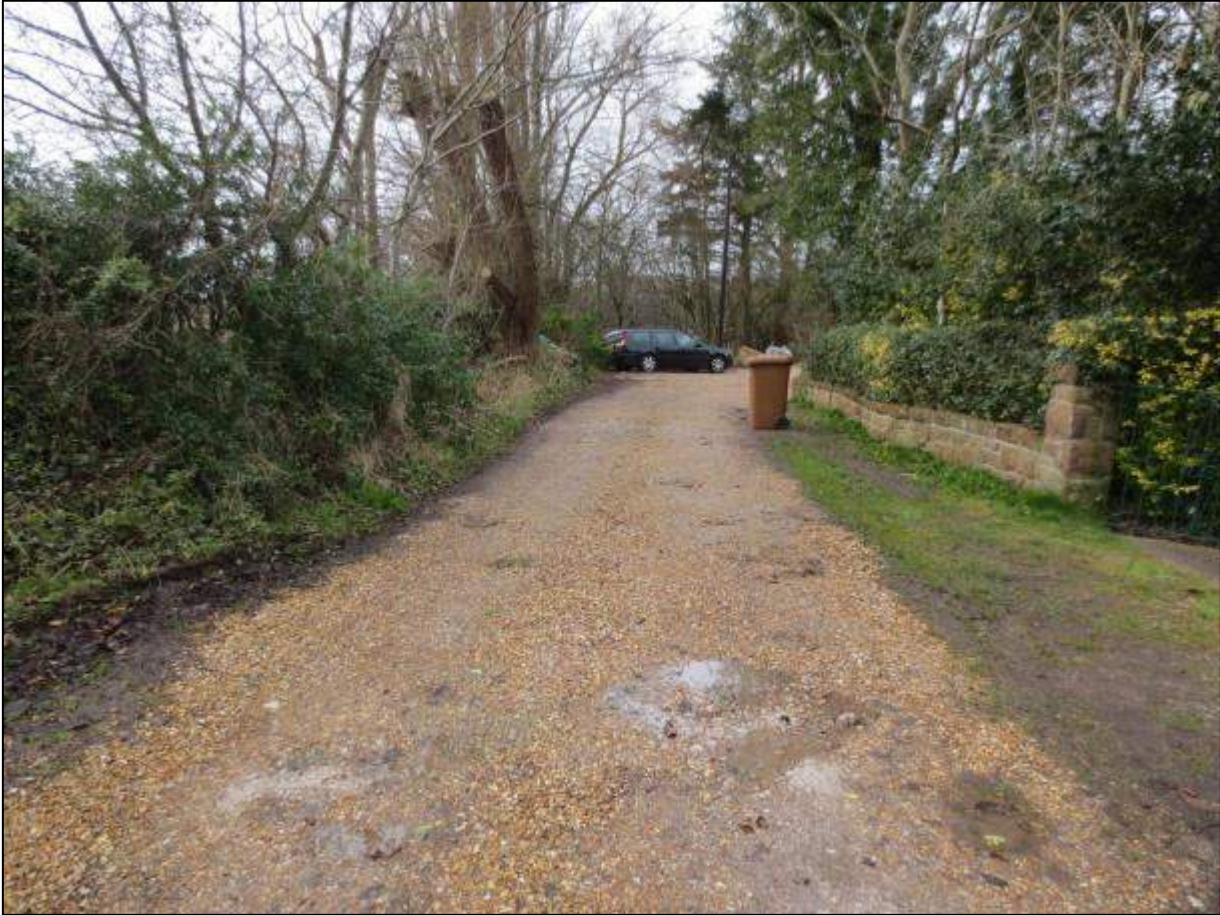
Photograph 5-34 Unadopted Highway on Mayew Road (2/3/16)

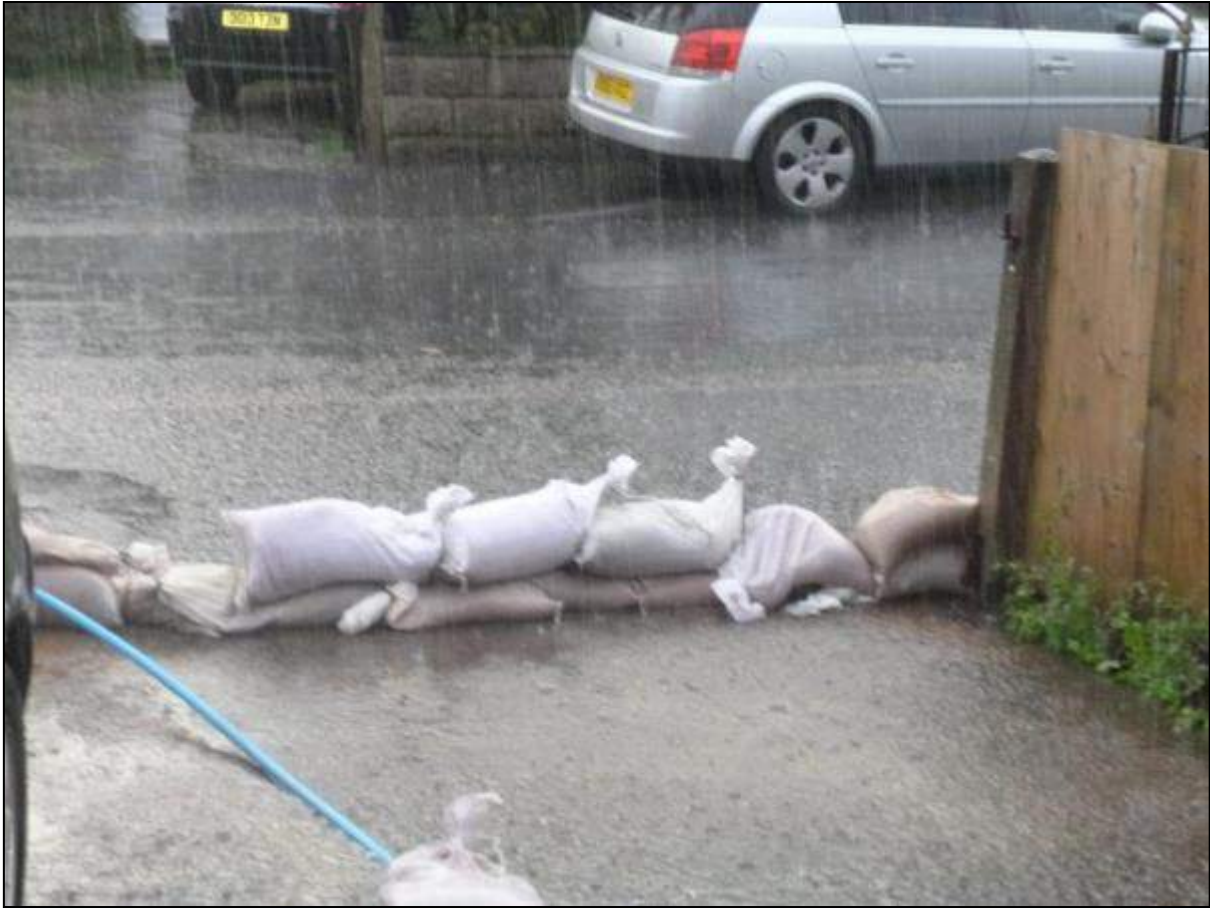
**Photograph 5-35 Surface Water Flooding at Thingwall Drive (Unknown Date)**

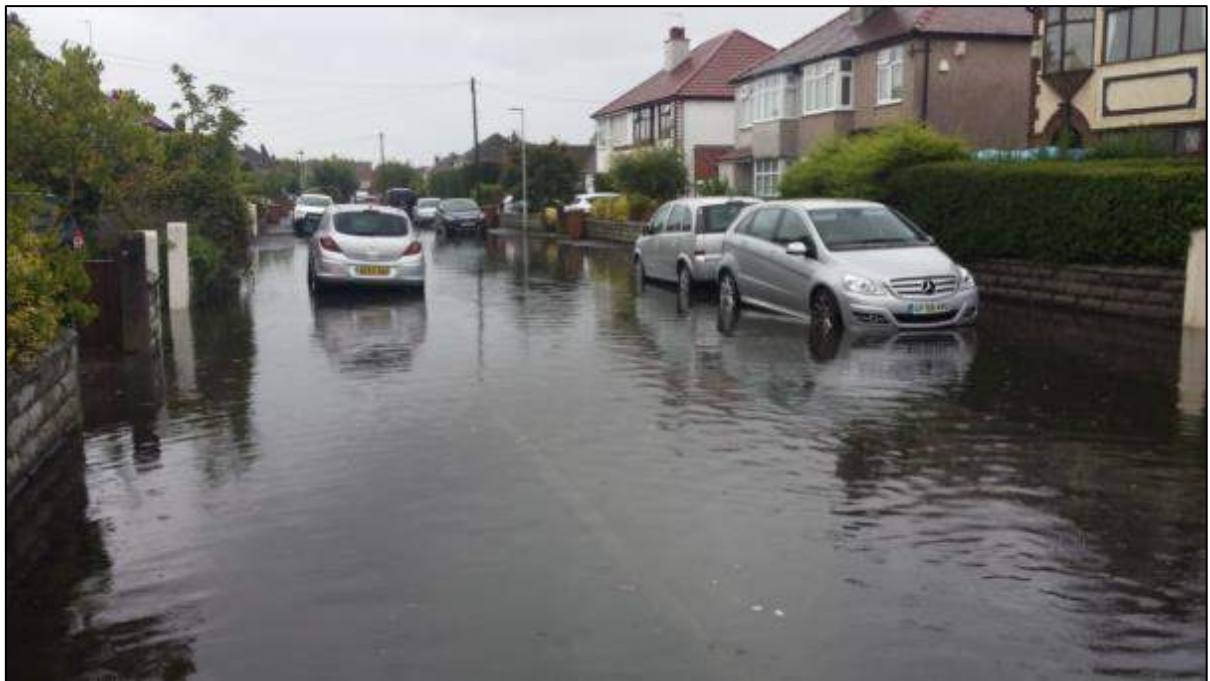
**Photograph 5-36 Surface Water Flooding at Thingwall Drive (2/9/15)**

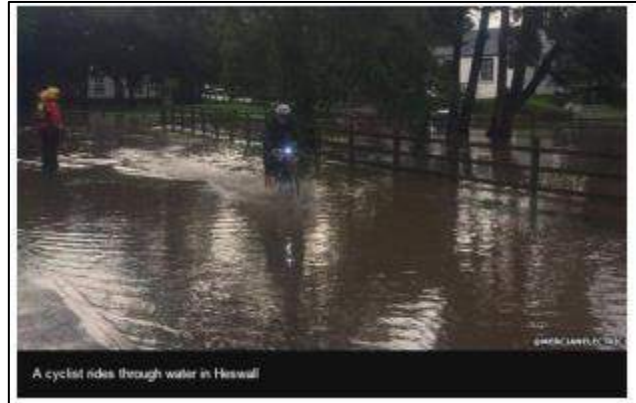
Photograph 5-40 Highway Flooding in Heswall (2/9/15)

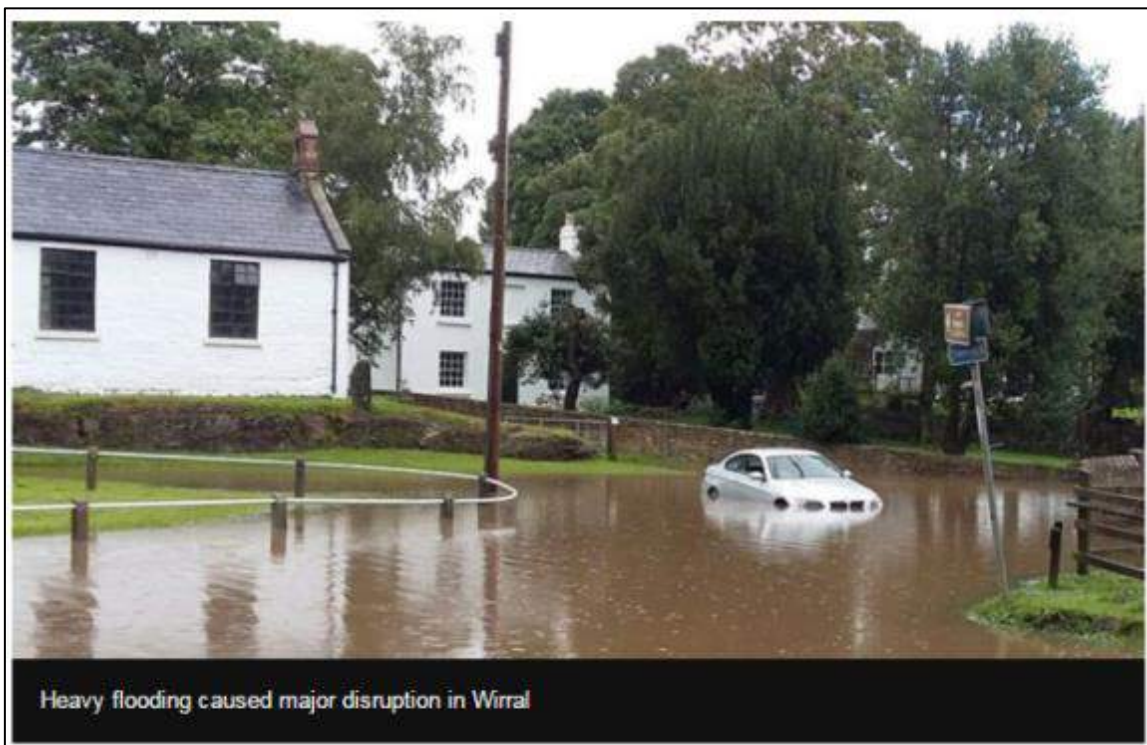
Photograph 5-41 Brimstage Flooding (2/9/15)
