Flood & Water Management Act 2010
Section 19
Flood Investigation Report

Date of Incident: 23rd July 2017
Location: Oxton, Claughton, Bidston,
Prenton, Birkenhead & Bromborough

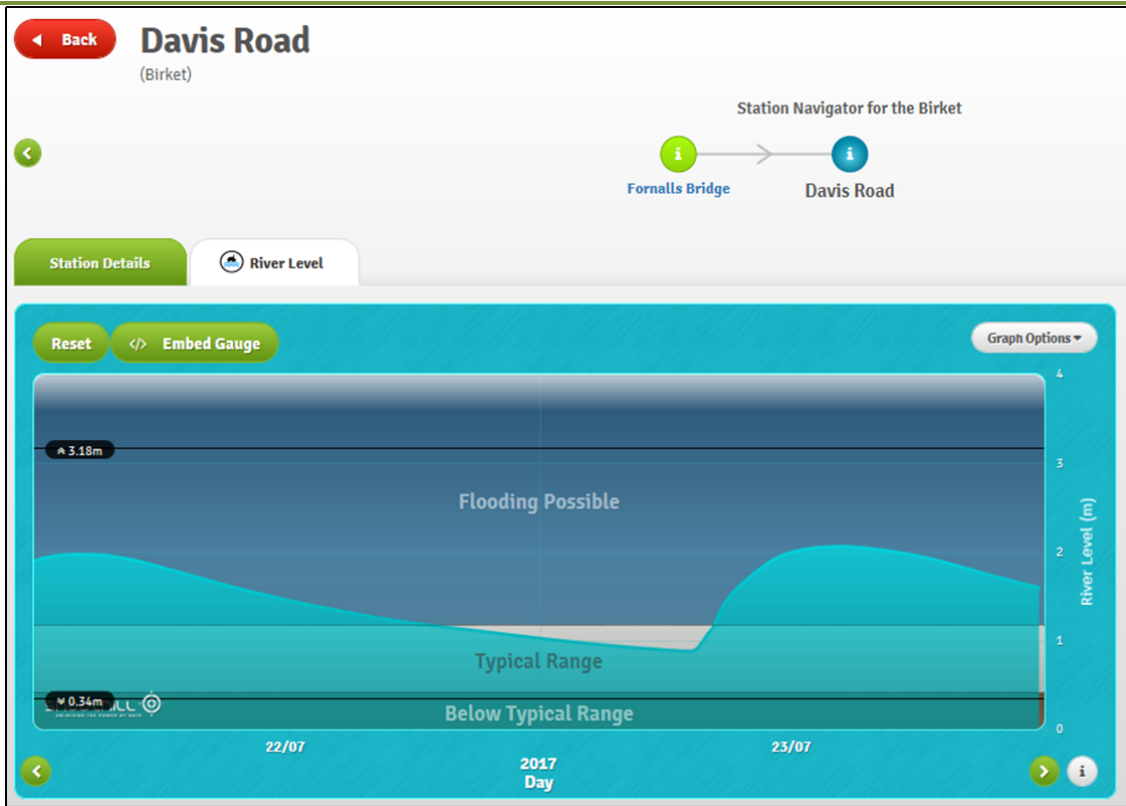
Figure 1 : Davis Road River Level Gauge

It can be seen that the river catchment responded to the localised flooding in Birkenhead area some 3 to 4 hours after the rainfall ceased, with peak river level recorded at approximately 12:00 GMT.

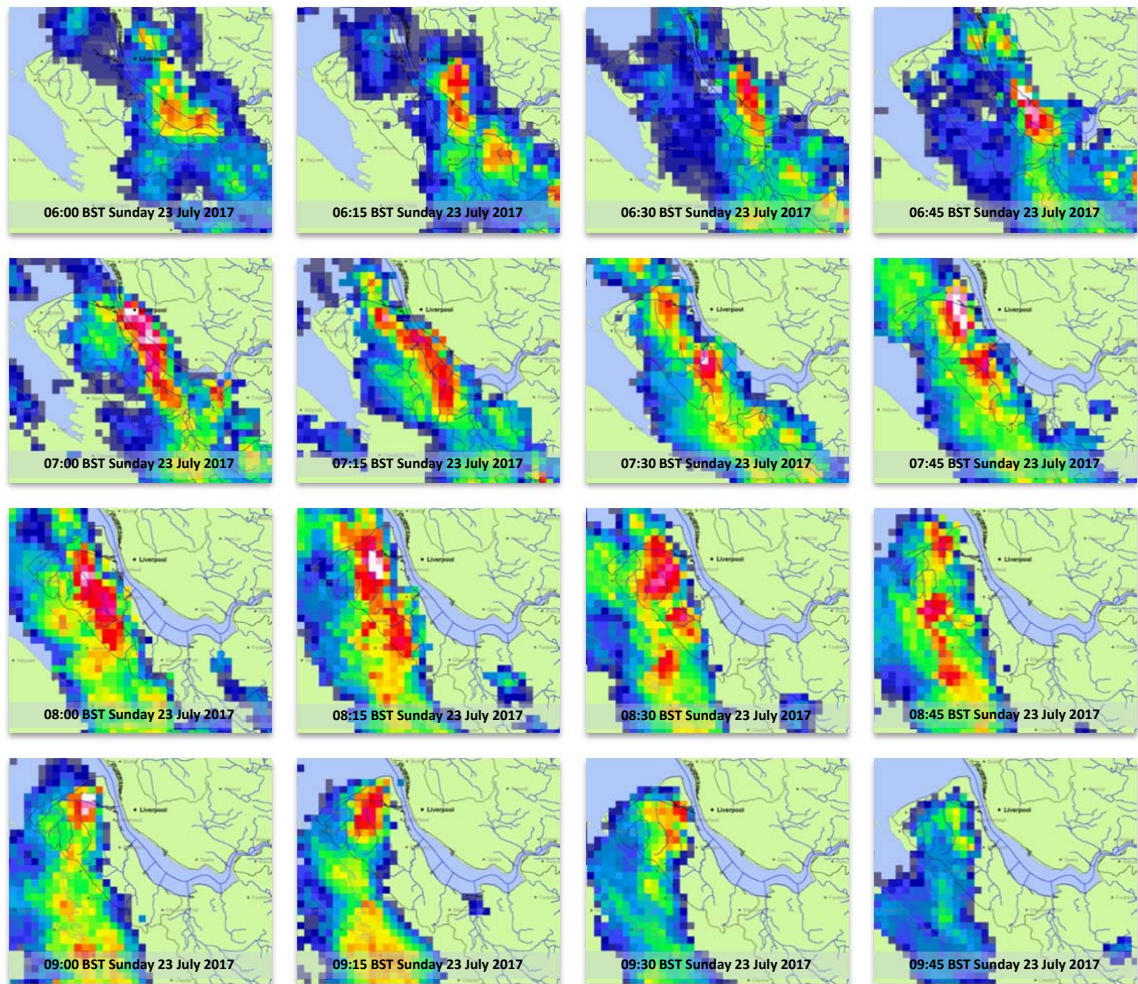
Figure 3 : Radar Rainfall Intensity Sunday 23rd July 2017 06:00 to 09:45 BST
(Imagery courtesy of Environment Agency)

Approximate analysis of the radar data for the Birkenhead and Oxtan areas identifies that more than 27mm rain fell within the period 06:00 to 09:45 BST, with 20mm of this rainfall occurring between 07:45 and 08:15 BST.

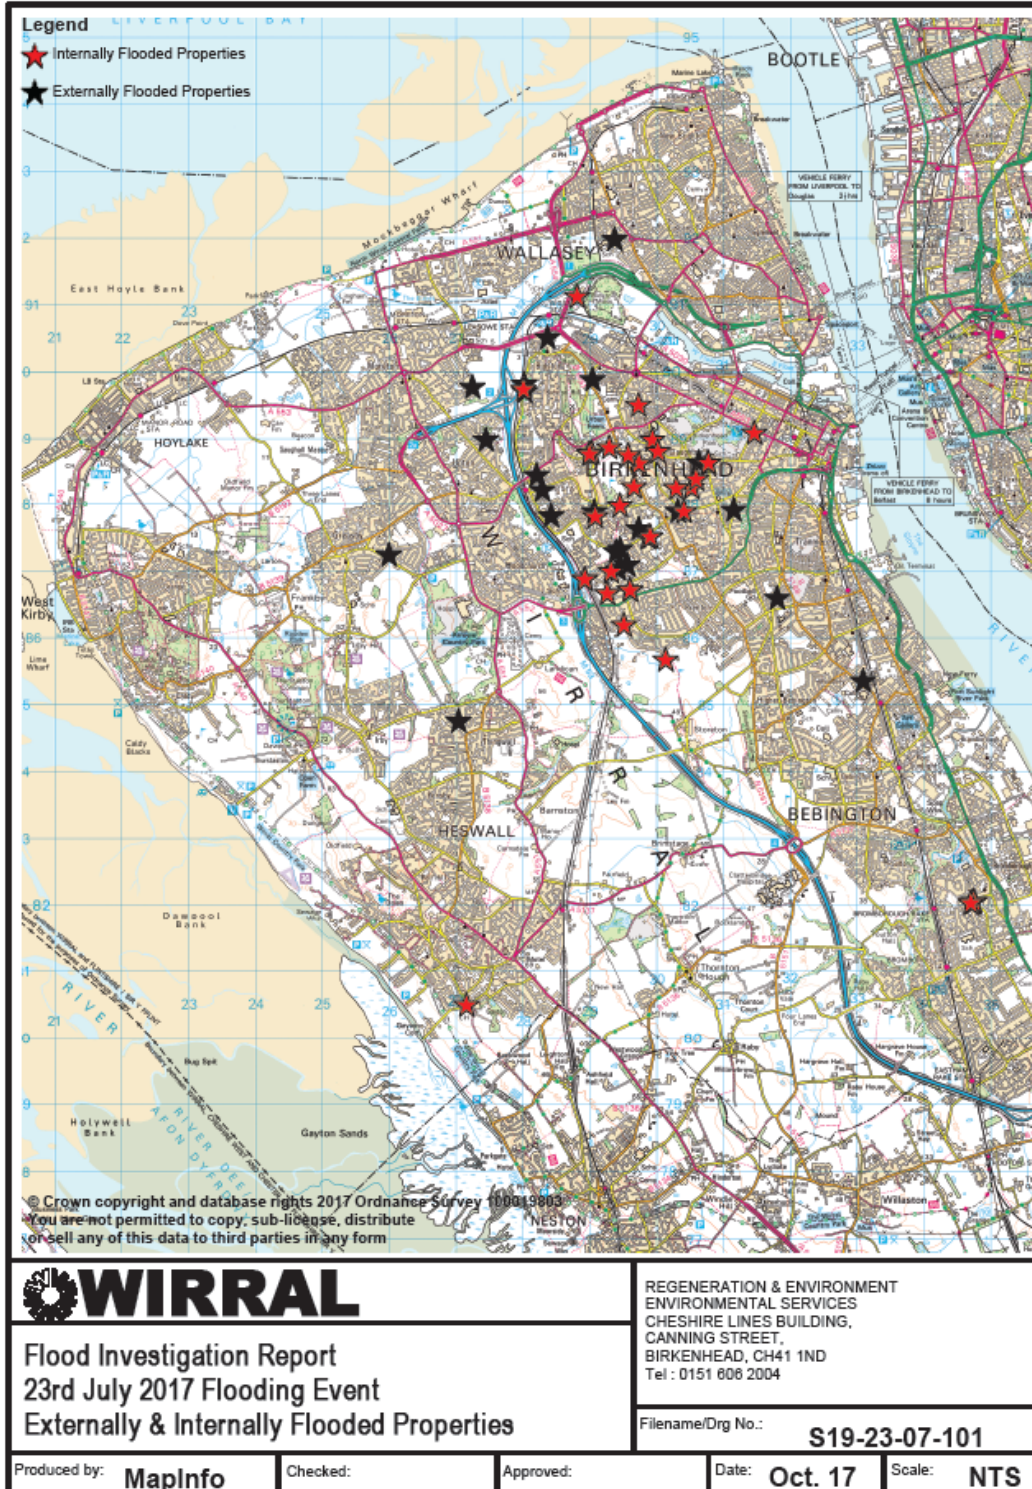
Figure 4: Location of Flooded Properties

Flooding incidents have been mapped using Mapinfo Geographic Information System (GIS) to help understand the spatial variation of the event. The output from this mapping can be seen in Figure 4 below. Internally flooded property is denoted by a red star whereas a black star identifies external flooding.

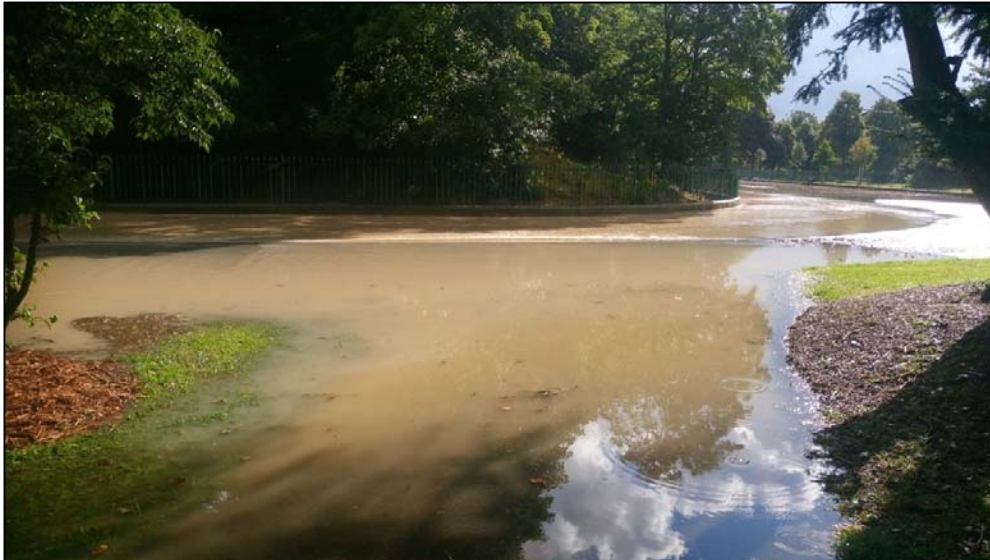
Significant overland flow was also reported through Birkenhead Park which led to flooding of properties and businesses on adjacent roads at Park Road North and Conway Street.

Figure 5: Overland Surface Water flow in Birkenhead Park, 23rd July 2017

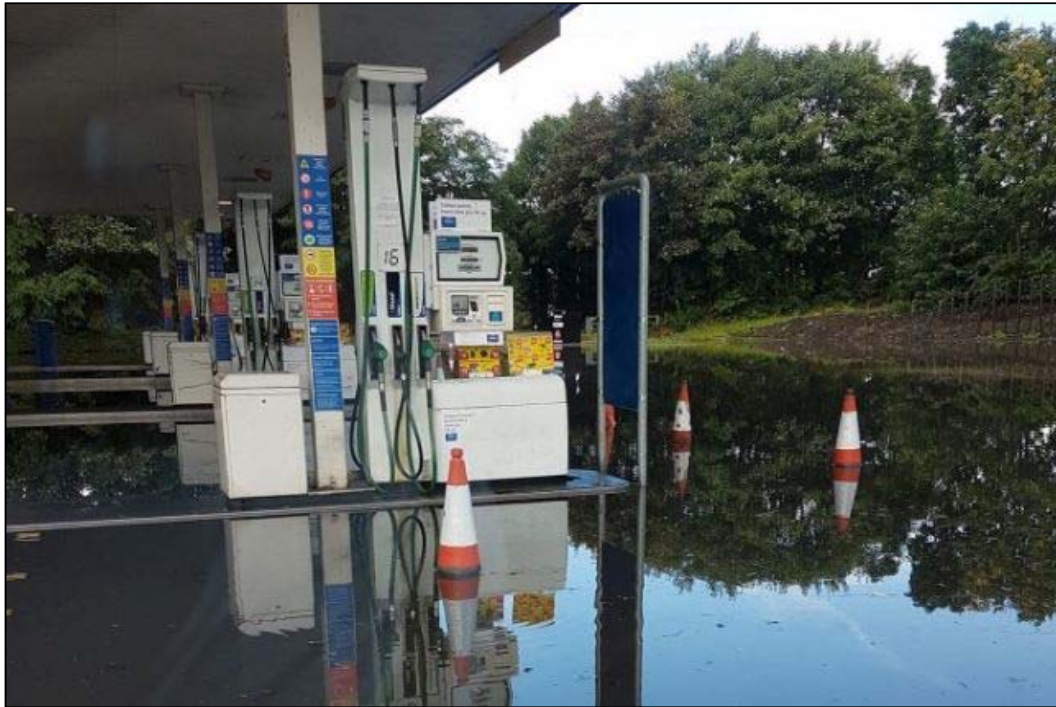
At the Tesco Retail site in Bidston flooding occurred at the petrol station.

Figure 6: Surface Water flooding at Tesco Petrol Station, 23rd July 2017

United Utilities report that this flooding was caused by a blockage on the surface water sewer, the nature of the blockage being formed from oil and other hydrocarbon pollutants. United Utilities suspect that clearing the blockage to remove the flooding would have led to a pollution incident at the River Birket. The blockage was removed in a controlled manner once the flooding had abated.

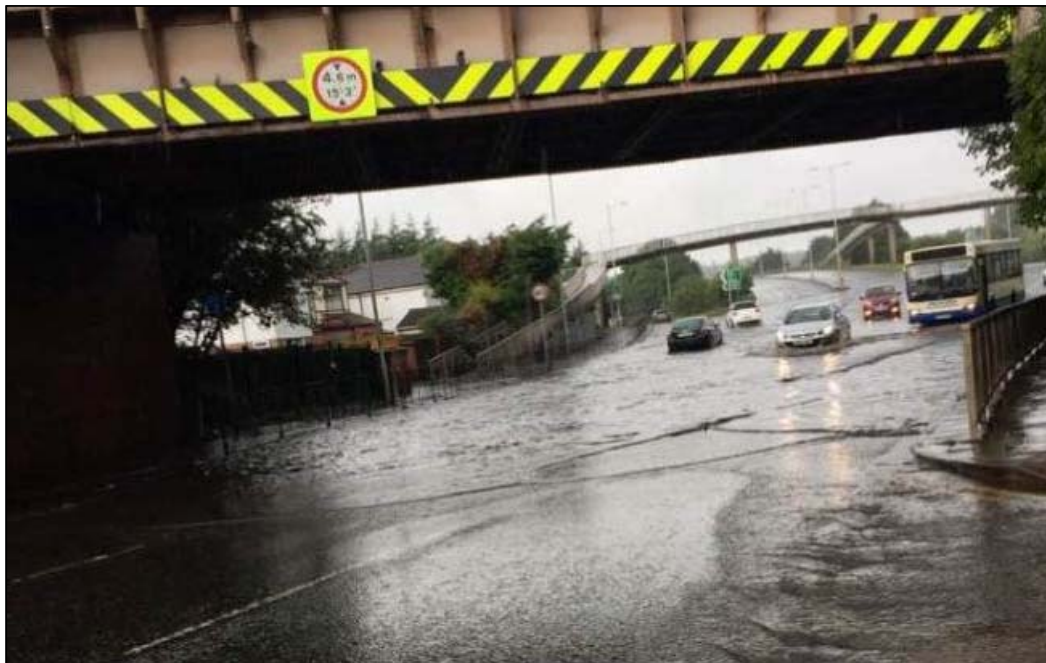
The problem at the low point of Woodchurch Road has been ongoing for several years. Historic investigations have identified an obstruction in the highway drain that is not easily rectified and further investigation is required to confirm the exact nature of the obstruction and develop a solution to reduce the highway flood risk at this location.

Figure 7: Flooding at Woodchurch Road, Prenton, 23rd July 2017
