# Wirral Borough Council:

## Section 19 Flood Investigation: 22<sup>nd</sup> August and 2<sup>nd</sup> September 2015

May 2016

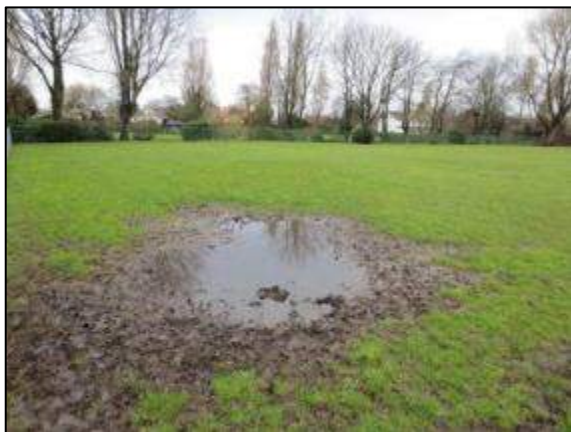
Significant clay deposits and low permeability soils may prevent the infiltration of surface water into the ground and result in the generation of overland flow which residents indicated has happened historically (including on both the 22<sup>nd</sup> August and the 2<sup>nd</sup> September 2015). A drainage ditch is present on the park’s western boundary (adjacent to the allotments) and was observed to be conveying a small volume of water at the time of the visits. This feature may afford a low level of protection to the playing fields and the adjacent residential properties.

**Photograph 5-4 Waterlogged Soils in Coronation Park (1/3/16)**

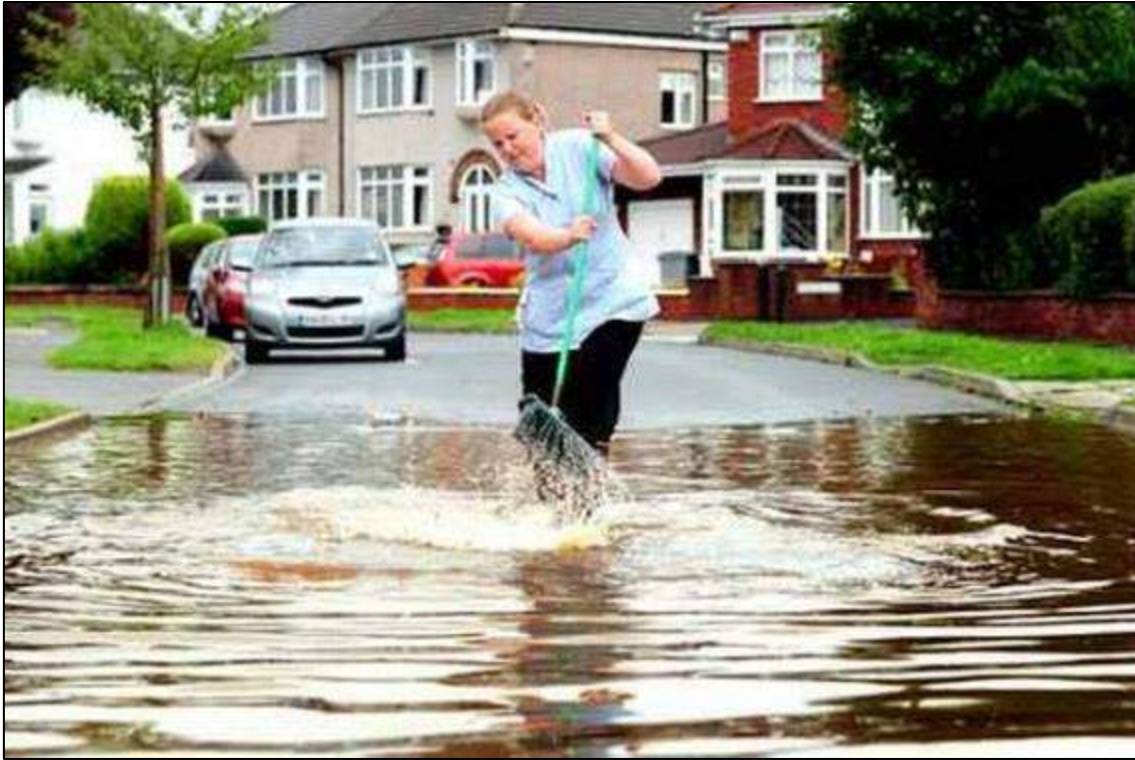
**Photograph 5-10 Rigby Drive Flooding (16/8/12)**

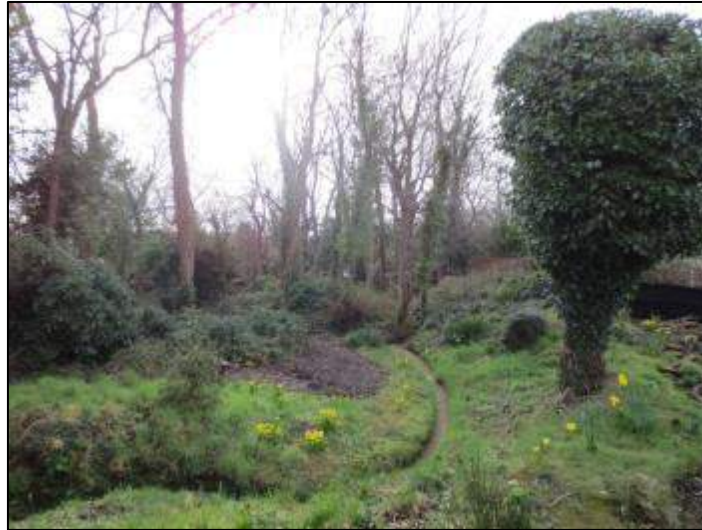
On the opposite side of the close a resident concerned with flooding from an ordinary watercourse which is a tributary of the Greasby Brook. This issue was reported as being a result of a tree growing within the unmaintained ordinary watercourse which then traps debris during times of flood. This consequently results in a localised constriction to flow and a backwater effect.

**Photograph 5-15 Vegetation Growth within an Unnamed Ordinary Watercourse (1/3/16)**

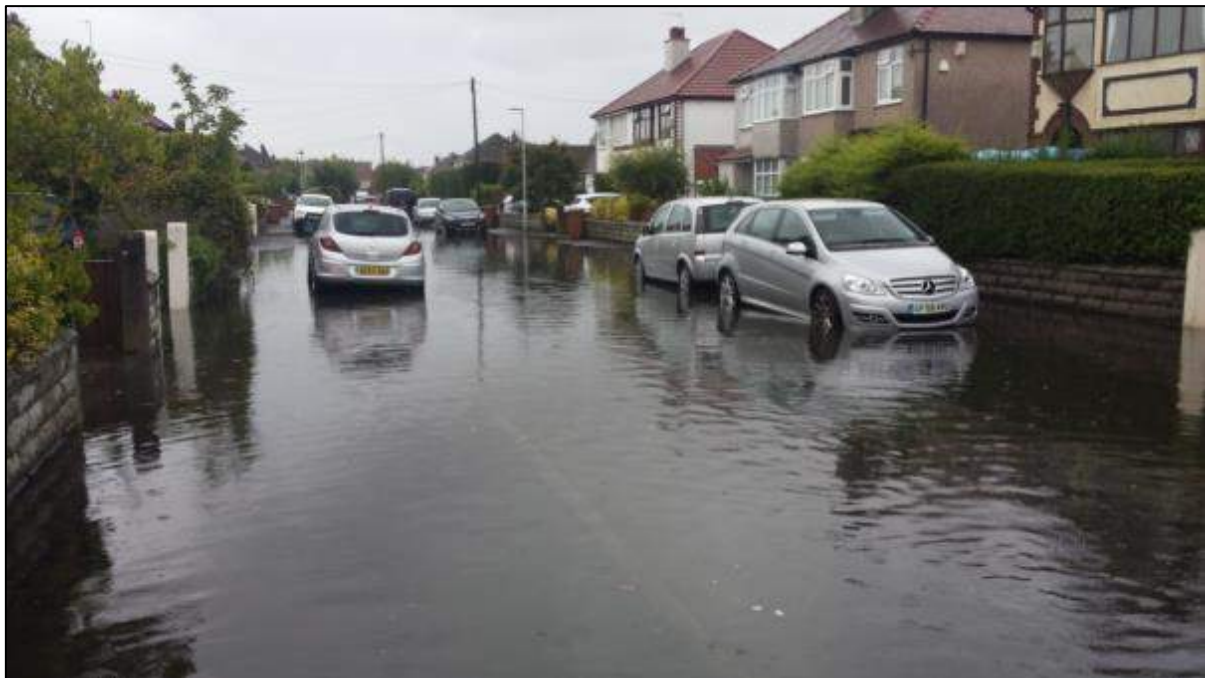
**Photograph 5-36 Surface Water Flooding at Thingwall Drive (2/9/15)**
