Flood & Water Management Act 2010
Section 19
Flood Investigation Report

Date of Incident: 23rd July 2017
Location: Oxton, Claughton, Bidston,
Prenton, Birkenhead & Bromborough

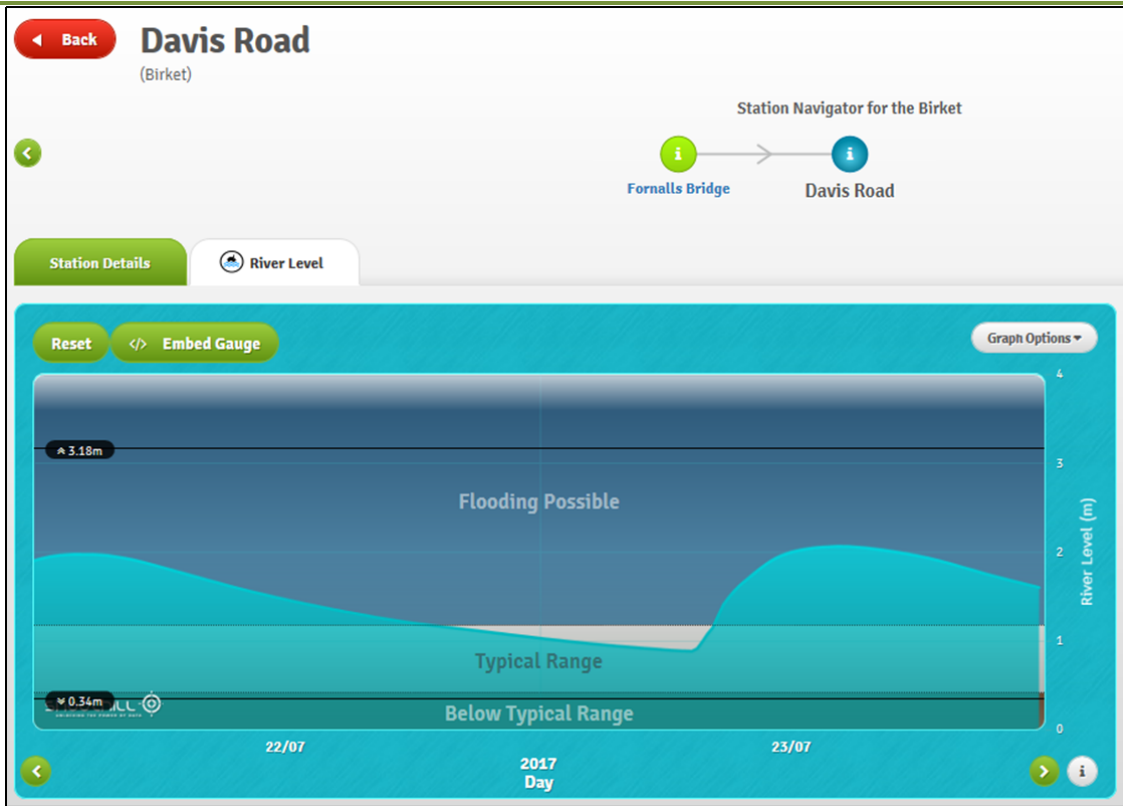
It can be seen that the river catchment responded to the localised flooding in Birkenhead area some 3 to 4 hours after the rainfall ceased, with peak river level recorded at approximately 12:00 GMT.

Figure 1 : Davis Road River Level Gauge

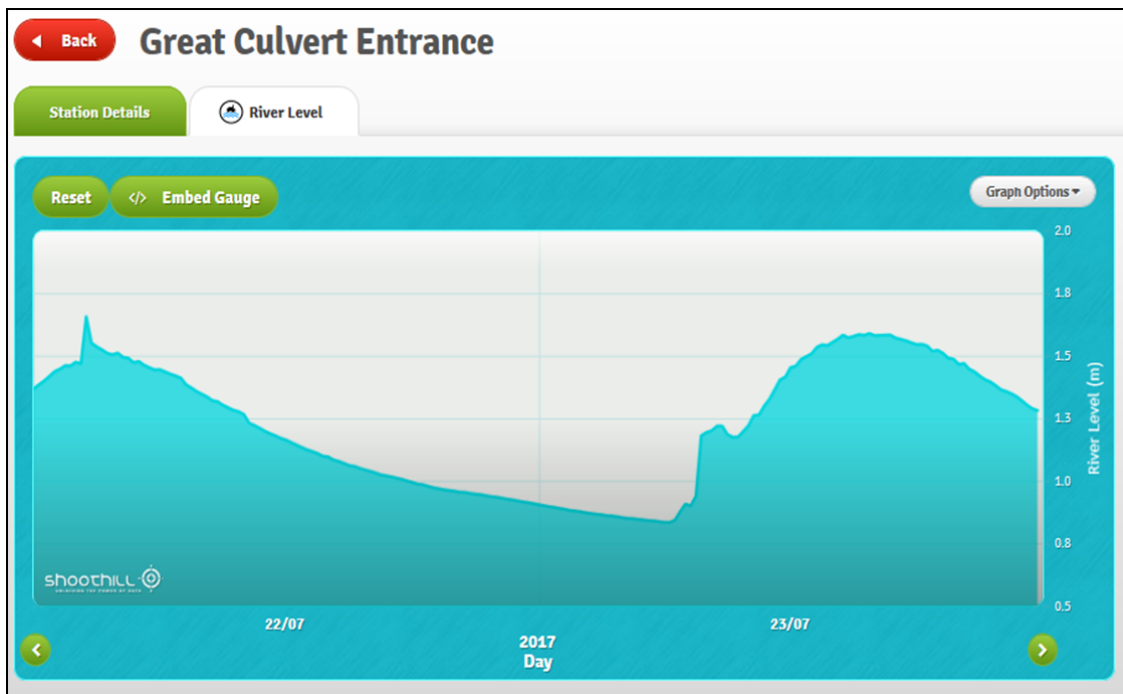
Figure 2 : Great Culvert Entrance River Level Gauge

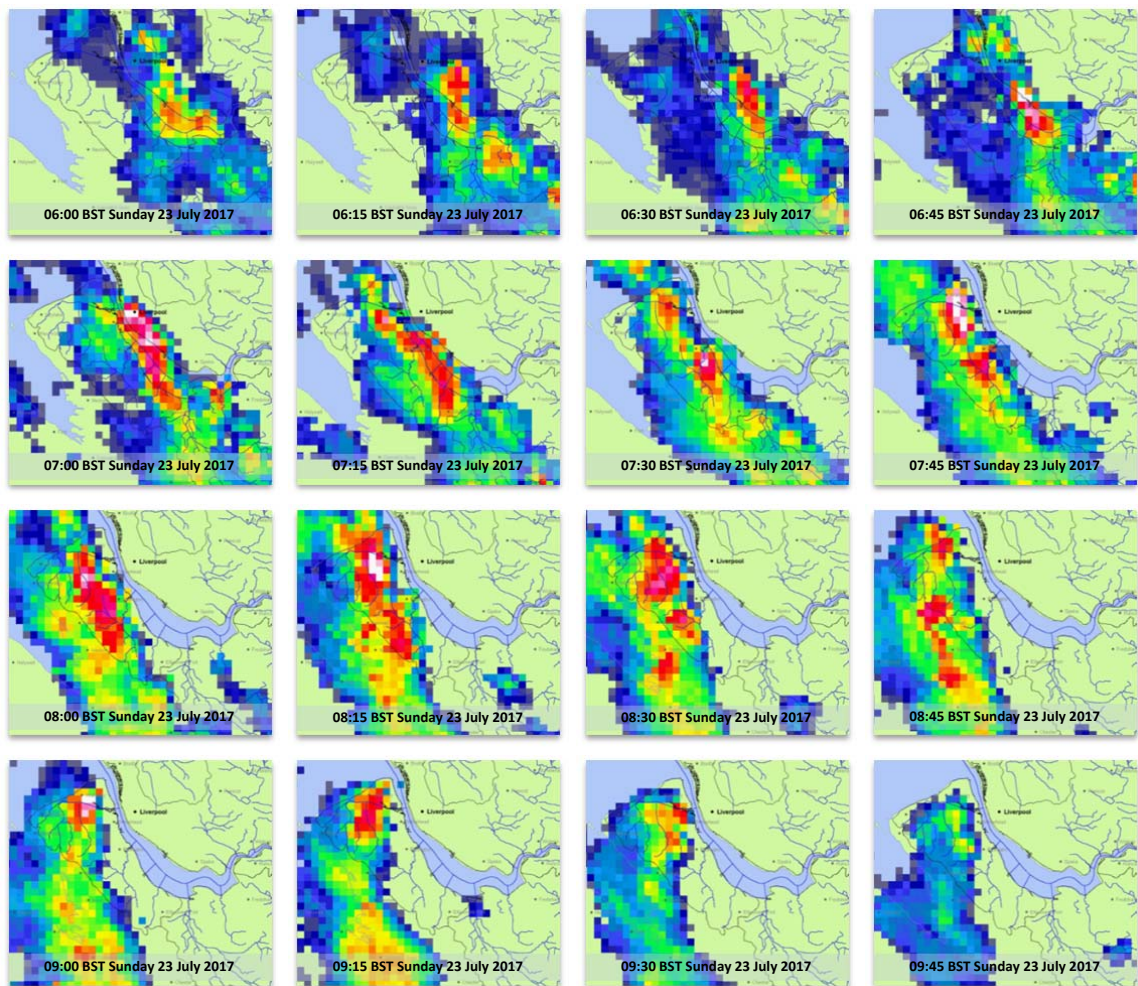
Figure 3 : Radar Rainfall Intensity Sunday 23rd July 2017 06:00 to 09:45 BST
(Imagery courtesy of Environment Agency)

Approximate analysis of the radar data for the Birkenhead and Oxtton areas identifies that more than 27mm rain fell within the period 06:00 to 09:45 BST, with 20mm of this rainfall occurring between 07:45 and 08:15 BST.

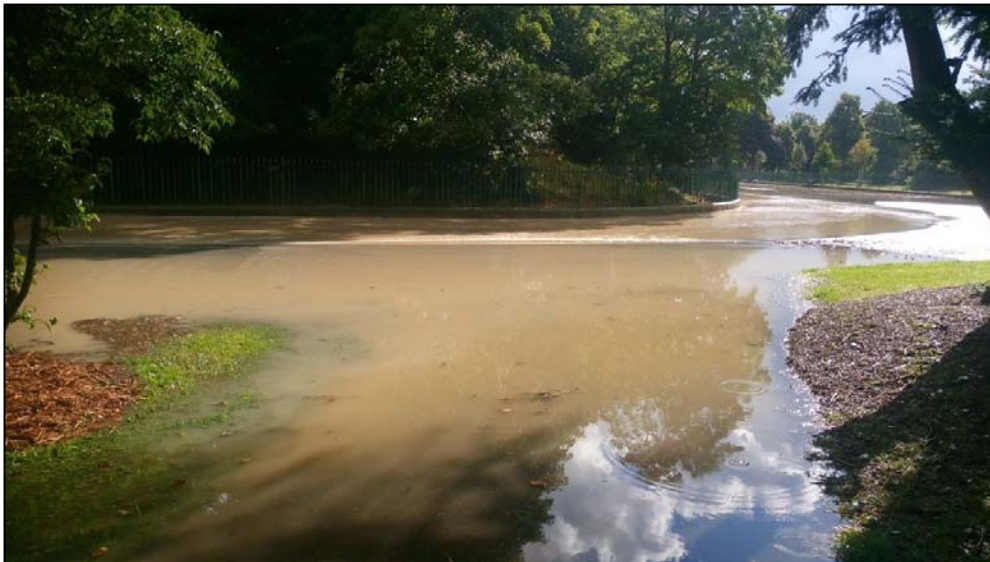
Significant overland flow was also reported through Birkenhead Park which led to flooding of properties and businesses on adjacent roads at Park Road North and Conway Street.

Figure 5: Overland Surface Water flow in Birkenhead Park, 23rd July 2017

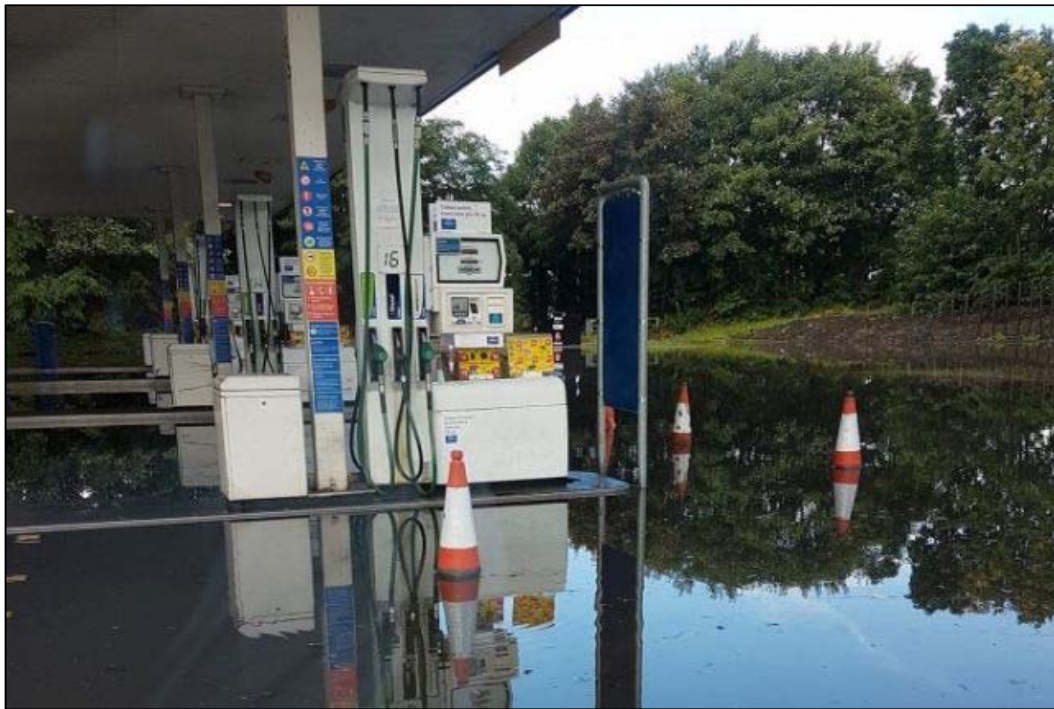
At the Tesco Retail site in Bidston flooding occurred at the petrol station.

Figure 6: Surface Water flooding at Tesco Petrol Station, 23rd July 2017

United Utilities report that this flooding was caused by a blockage on the surface water sewer, the nature of the blockage being formed from oil and other hydrocarbon pollutants. United Utilities suspect that clearing the blockage to remove the flooding would have led to a pollution incident at the River Birket. The blockage was removed in a controlled manner once the flooding had abated.

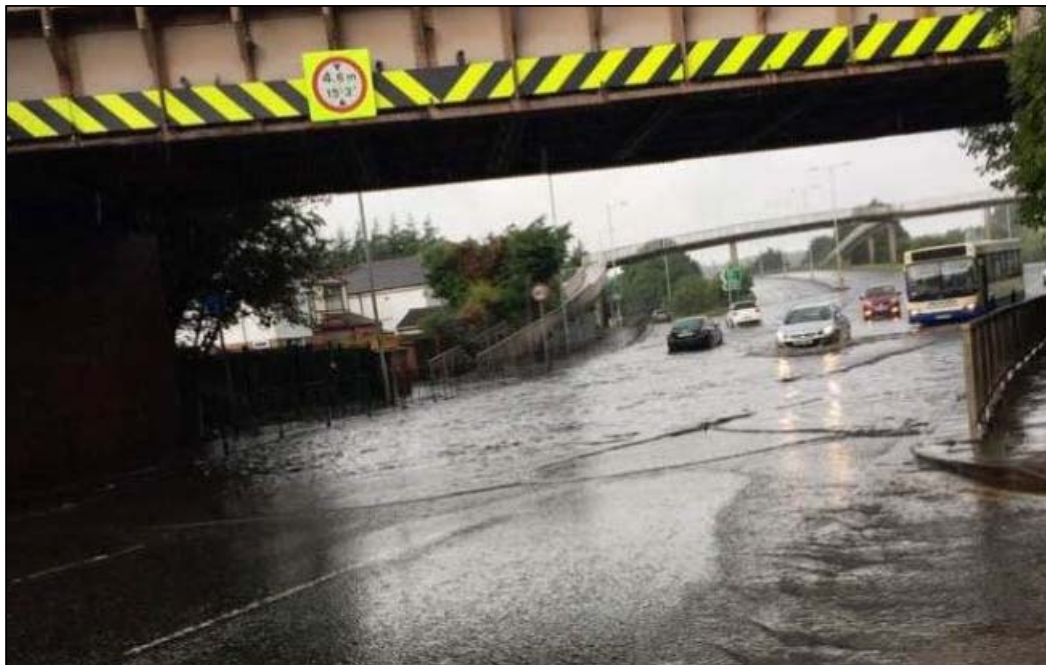
The problem at the low point of Woodchurch Road has been ongoing for several years. Historic investigations have identified an obstruction in the highway drain that is not easily rectified and further investigation is required to confirm the exact nature of the obstruction and develop a solution to reduce the highway flood risk at this location.

Figure 7: Flooding at Woodchurch Road, Prenton, 23rd July 2017
