Wirral MBC
Flood Investigation
Report
Reeds Lane/Reedville
Grove, Leasowe

1 Introduction

1.1 LLFA Investigation

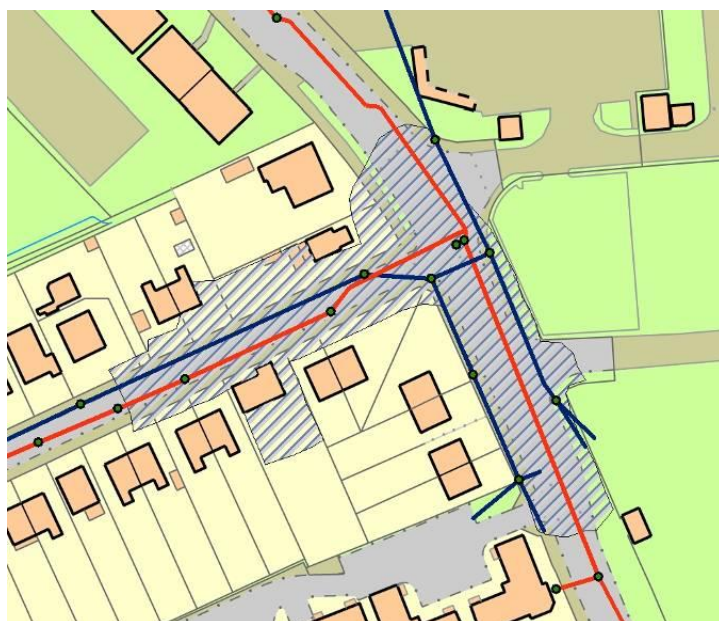
Fig.2. Approximate extent of the flood, Reedville Grove/Reeds Lane.

Rain started to fall around 6.00pm on Sunday the 23rd September, it continued overnight and through the following day, stopping at around 5.00pm on the 24th. At approximately 12.00pm on the 24th Reeds Lane and Reedville Grove started to flood and by 2.00pm Reeds Lane became difficult to drive through to the extent that Bristol-Myers Squibb started to clear their site of cars, fearing that they may not be able to remove them later. At 4.00pm the Council received requests to provide sandbags to defend domestic properties and a decision was made by the Emergency Control Operators to issue sandbags although this was contrary to the Council's sandbag policy; and by 6.00pm Reeds Lane was closed. United Utilities were on site by 5.00pm on the 24th and started removing the flood water into tankers. Flood water was surcharging from manholes on the public combined sewer system. The public surface water sewer system also surcharged and was unable to drain the floodwater through the gullies in the road. High river levels on the Birket are believed to have prevented efficient discharge from the public surface water system at the flapped outfall. One property suffered some flooding to its garage/workshop and porch; and nine properties suffered flooding to their gardens and driveways, while access to Bristol-Myers Squibb Pharmaceuticals was also restricted. UU continued to pump until late in the evening but were requested to stop due to noise. The Environment Agency attended the site at 9.30pm, following reports of flooding in Reedville Grove and high river levels on the Birket. UU continued to draw off the flood water throughout Tuesday the 25th and into Wednesday 26th. Rain started again on Tuesday afternoon and continued, albeit with a lesser intensity until Wednesday morning. Bristol-Myers Squibb Pharmaceuticals remained closed on Tuesday 25th. On Wednesday 26th both United Utilities and the Council's Emergency Planning Team responded to the access problems that the flooding was causing by utilising vehicles, which included a 4x4, to assist residents to move through the flood water. The Emergency Planning Team also arranged for a Social Services Team to be on site to assist vulnerable people to access medical assistance and undertake some shopping for essential groceries. The Fire Brigade were also in attendance and assisted residents and care workers through the floodwater until the 4x4 vehicle arrived on site. On Wednesday the combined sewer manhole was still surcharging but floodwater started to slowly drain into the surface water system and into the Birket. Bristol-Myers Squibb re-opened on Wednesday and workers were helped into the factory, borrowing wellington boots to get through the flood water, their cars were parked on Reeds Lane. By Thursday morning, the 27th, the majority of the flood water had subsided, although water was still surcharging from the public combined sewer in Reedville Grove and running away down the nearby road gullies. Following a hose down of the area and gully cleaning by United Utilities the Road was inspected and re-opened. Damage to Reedville Grove footway and kerbing was identified and emergency works ordered. It is not known at this stage, if any long term damage has occurred to the Public Highway

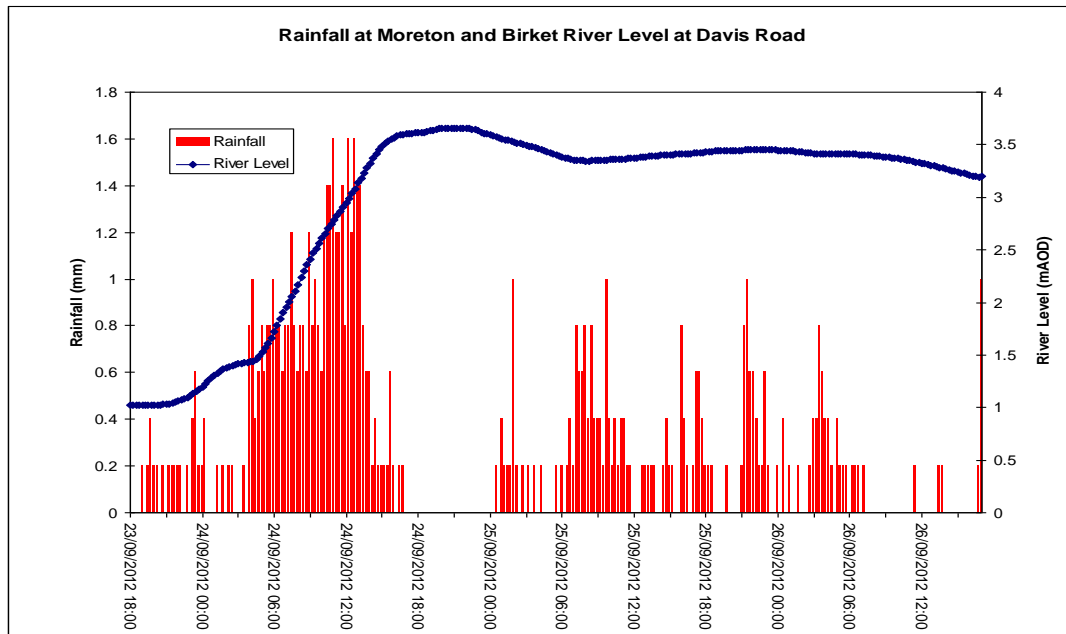
Fig.3. Rainfall and river levels.

The rainfall during the 23rd to 26th of September fell on saturated ground and rapidly ran-off into the river system forcing the levels to rise quickly, rain fell over three days, off and on, and maintained the rivers at a high level for several days. The river height came up to within about 1m of the bank top in the area close to the Debris Screen at the Great Culvert Entrance and level monitoring gauge at Davis Road but still had a great deal of capacity in the channel. There are three major elements of infrastructure affecting the Birket, a recently upgraded debris screen at the entrance to the Great Culvert, a pumping station operated by United Utilities that intercepts the River Birket flows and pumps them into the West Float Docks, the pass forward flows, particularly during storm conditions then combine with discharges from the surrounding public sewers and pass to a further pumping station which lifts the flows to the United Utilities Shore Road treatment works on the River Mersey. During the period of the flooding, the debris screen was in operation and both the pumping stations were reported to be running at their maximum capacity. Although none of the flooding in Reeds Lane area was due to the Birket overtopping its banks, the continued high levels prevented the discharge of the flooding for an extended period.

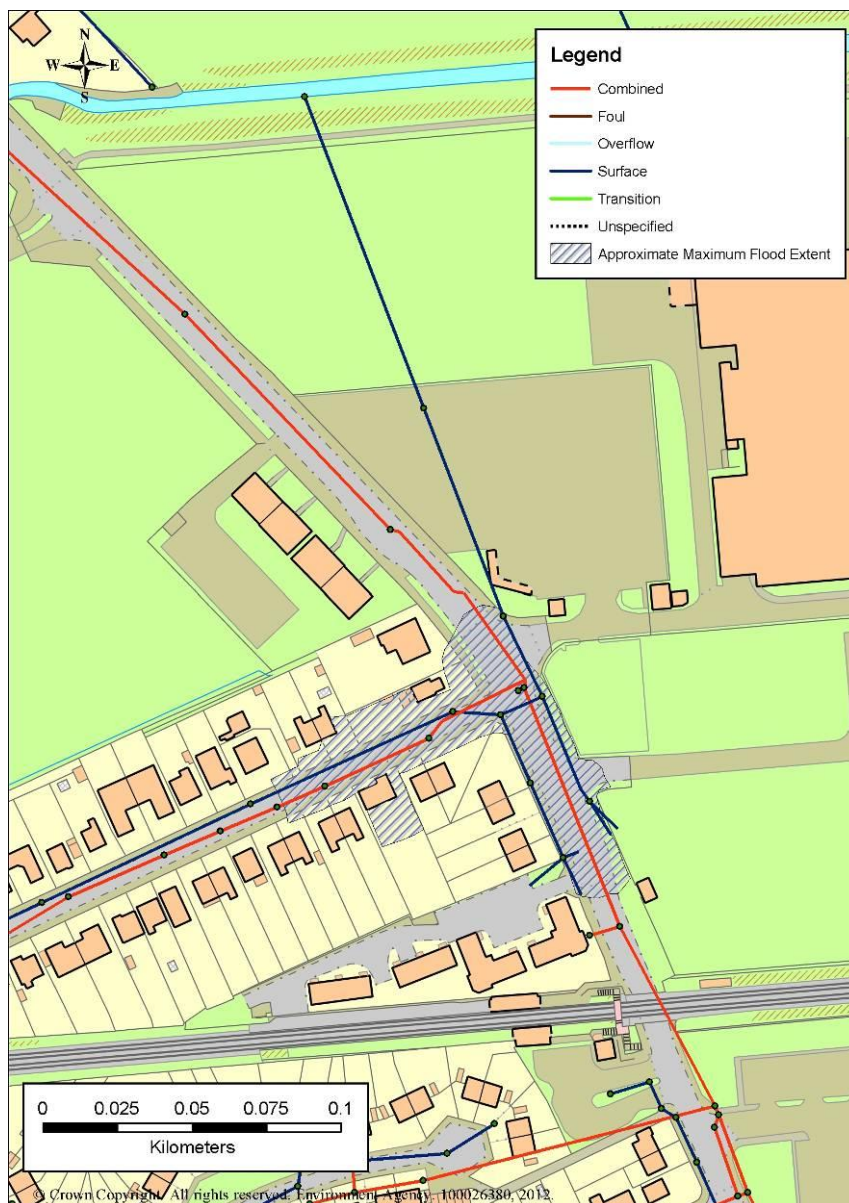
Fig.6 United Utilities sewer network and approximate flood outline.

The flooding on Reeds Lane and Reedville Grove was caused by a combination of flows from the surcharged combined sewer in Reedville Grove and surface water which was unable to discharge to the separate surface water sewer through the road gullies due to high river levels that prevented free discharge at the surface water sewer outfall into the Birket. The flood water level at the low point in the road was at a similar level to the peak water level of the Birket at the outfall and over the period of flooding the river level remained fairly constant. The road started to drain when the river level had dropped sufficiently to allow the flap valve at the outfall to open.

Flooding was caused by a combination of under capacity in the combined sewer network and the Moreton Pumping Station which led to the sewers surcharging, resulting in flooding in Reedville Grove; and the locked surface water drainage system, which prevented discharge from the highway. The rainfall on the preceding days fell on to saturated ground and rapidly ran-off into the river system forcing the levels in the Birket to rise quickly, locking the surface water sewers preventing any discharge.

- United Utilities should review the performance of their assets/infrastructure during the event and consider any viable options to reduce the surcharging of the system at this low point.

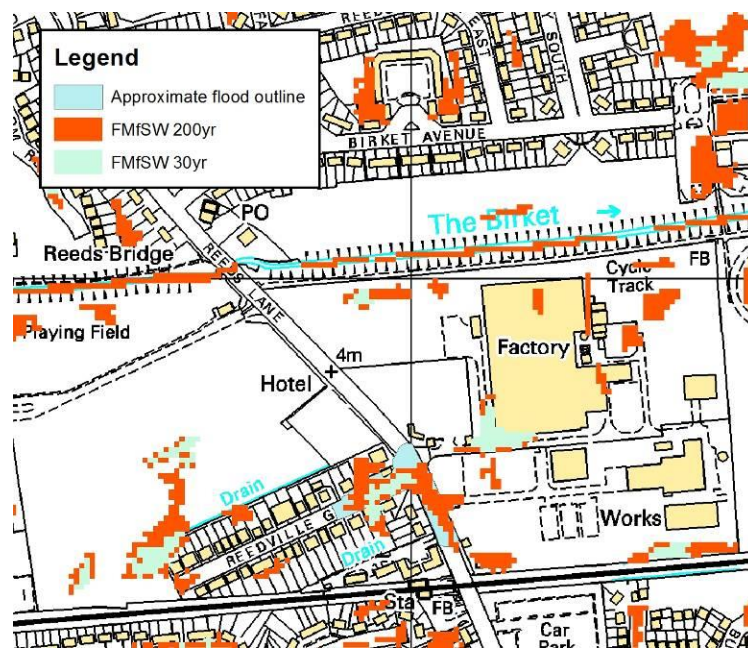
Fig.7. Environment Agency flood outline maps

The water being unable to drain from either system inundated the road and gardens and eventually caused some internal flooding in one property. The area that flooded is in a low point and has been identified as an area susceptible to surface water flooding on the Environment Agency's Flood Map for Surface Water. (Fig 7)
