BIRKENHEAD PARK CONSERVATION AREA APPRAISAL & MANAGEMENT PLAN

BIRKENHEAD PARK CONSERVATION AREA APPRAISAL AND MANAGEMENT PLAN

**APPENDIX G – GAZETTEER OF BOUNDARY TREATMENTS**

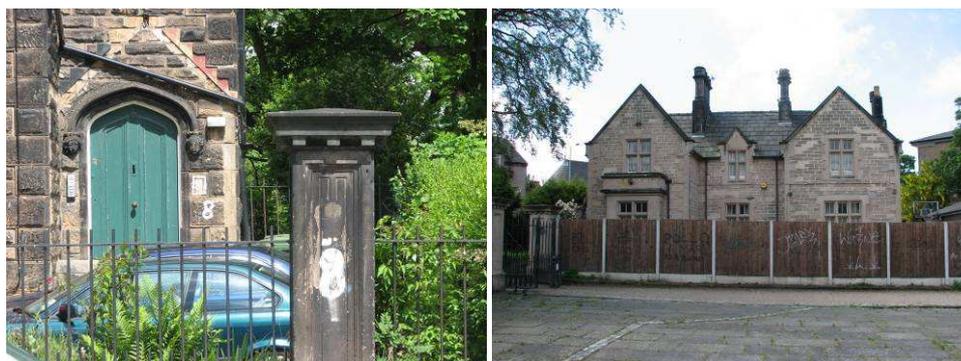
**Issue:** Buildings are not generally named as they were in the 19<sup>th</sup> century and most are now referred to by house numbers. As a consequence many of the carved names on gateposts are incorrect and residents have used various other means of identifying the number. Some of these are particularly detrimental to the character of the area or potentially damaging to the gatepost. In a number of instances the number has been simply sprayed onto an original gatepost. This has occurred even to gateposts that are supposedly protected by being part of the curtilage of their associated listed building.

*Spray-painted early / original gatepost and poor quality boundary treatment*

**Response:** Use a partnership scheme to offer building owners an opportunity to have the building number carved into the existing gatepost or a high quality number made at reduced cost. In future use advisory leaflet to inform best practice.

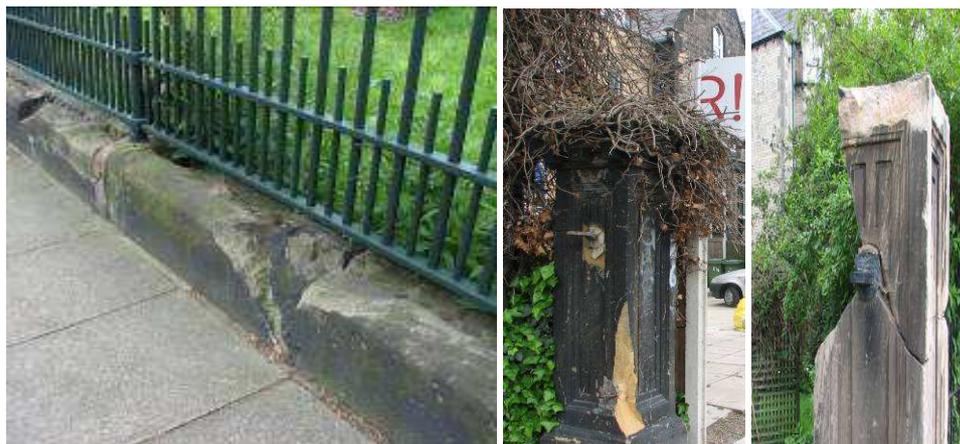
**Issue:** A great number of original gateposts have been lost. It appears likely that many original gateposts have been replaced in recent years in reconstituted stone. The use of reconstituted stone is a heavy compromise (made on grounds of costs) as the material will not weather in the same way. Any loss of original fabric is permanent erosion of the parks history.

*(Left) Damage to original stone plinth; (Middle) dirty / damaged original gatepost that could be carefully repaired; (Right) although a large section of this gatepost has been lost, the remainder is in a fair condition and should be repaired by carefully drilling out any rusting ferrous fixings and piecing in a new section. This may be cheaper than replacing the whole post in reconstituted stone.*

**Issue:** Many of the existing stone plinths to the boundaries are in a poor condition. This is a result of general wear and tear but also due to the effects of the iron railings rusting and subsequently expanding, causing cracking to the stone. The visual effect of this has been worsened by poor quality cementitious repairs, not matching the colour or texture of the stone and sometimes exacerbating the rate of deterioration. The resultant phenomenon is a tendency to remove and replace the plinths. Due to the cost of replacing in matching natural sandstone, cast reconstituted equivalents have been used. The use of reconstituted stone is a heavy compromise (made on grounds of costs) as the material will weather in the same way. Any loss of original fabric is permanent erosion of the park's history.

**Response:** Protect all existing original gateposts with article 4 directions, wherever possible. There should be a policy insisting that as much of the original gateposts are retained as possible during any repair and reinstatement works. There should be a presumption towards introducing new sections where damage / loss has occurred instead of an entire new post being erected. Some limited lime mortar repairs may be appropriate. There must be an aspiration to reinstate any lost elements in natural, matching sandstone. It should be recognised that the use of reconstituted stone compromises the quality and appearance of the park. Its use should therefore be considered on a case by case basis and it should not be used where funding could be made available for natural sandstone.

**Response:** **Protect all existing original plinth walls with article 4 directions, wherever possible. There should be a policy insisting that as much of the original plinths are retained as possible during any repair and reinstatement works. There should be a presumption towards introducing limited new sections where damage / loss has occurred instead of an entire new length being replaced. Some soft lime mortar repairs are likely to be appropriate. A suitable mix should be agreed and recorded on file. There must be an aspiration to reinstate any lost elements in natural, matching sandstone. It should be recognised that the use of reconstituted stone compromises the quality and appearance of the park. Its use should therefore be considered on a case by case basis and it should not be used where funding could be made available for natural sandstone.**
