## HESWALL LOWER VILLAGE CONSERVATION AREA APPRAISAL AND MANAGEMENT PLAN

### PART 1 – CONSERVATION AREA APPRAISAL

Prepared for Wirral Council by Donald Insall Associates Ltd, 2007 – Wirral Council 2009

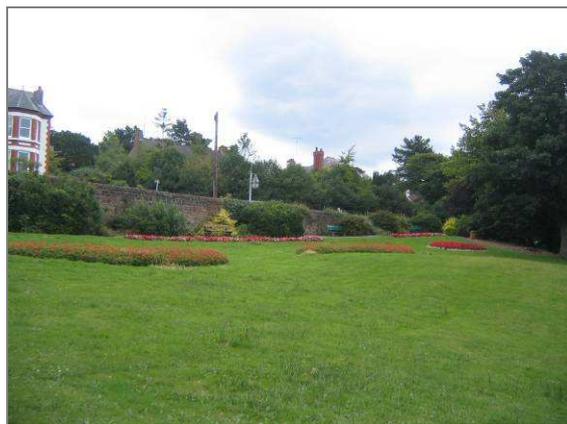
3.4.3 **Dawstone Park** was laid out by the local authority in 1931 on a triangle of vacant land at the head of School Lane. It slopes down steeply towards the west. On the north east side it is bounded by a retaining wall off Dawstone Road which is at a higher level. On the north west side there is a further retaining wall at the abutment of School Lane, but in this area the land of the park is the higher. On the south side the park abuts Brow Lane where the trees and vegetation of the park more or less blend into the vegetation along the lane.

3.4.4 In the top section of the park there are a number of formal beds with ‘parks department’ formal bedding schemes. The middle section is largely open grass criss- crossed by paths and with specimen trees. At the lower end is a small quantity of children’s play equipment.

3.4.5 The park would benefit from a scheme of improvement as there is evidence of vandalism and graffiti and maintenance standards are not particularly high.

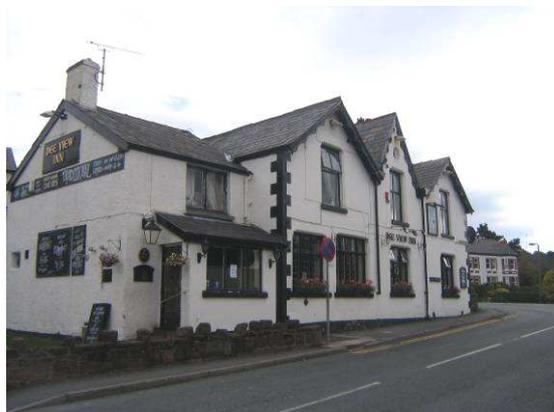
- 4.2.1 **Dee View Inn** - This is a late Victorian building set in the acute angle of the road down from the upper part of Heswall to the Lower Village. It is set between Mount Road and Dee View Road, overlooking Dawstone Road, the park and the war memorial. The building is white painted render with black painted quoins under a slated roof. Some of the slating is of fish-tail pattern – this feature should not be lost in any re-roofing. The main roof is of three ridges running east-west with gables onto The Mount and Dee View Road.

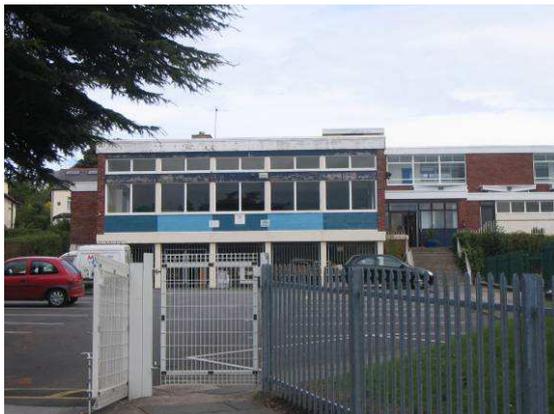
**4.2.2 Primary school** - The school is an extensive flat-roofed building from 1961 with large areas of west facing glazing. The principal façade has blue tiled inset panels. Roofs are edged with deep white fascias. As usual with this type of building which has grown and changed there are a number of additional adjoining similar classroom buildings some with shallow pitched roofs.

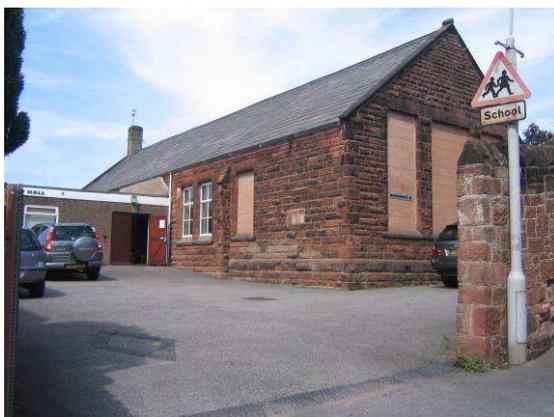
**4.2.3 Richmond Hall** - This is the original school building from 1872, now used as a day nursery. It is a single storey stone built structure with slated roof and lower extensions. A number of the original windows have been covered with plywood or rendered over, which together with the poor state of maintenance and hard surfaced surroundings give the building a rather run-down character.

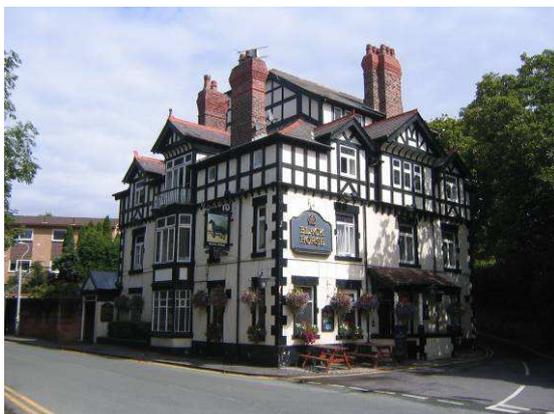
- 4.2.4 Black Horse Inn** - Formerly the Heswall Hotel, the building has a stone built centre section and dates from 1843. It is of four storeys in height, the lower two storeys (on the south and west) being of white painted render with black quoins, the upper two a jettied mock timber frame – the whole making a rather attractive combination. At high level the gables and tall chimneys make for a well broken and interesting skyline. The rear of the building is plain brick and of a more utilitarian appearance. There is a small range of stables.

- 5.3.5 This use of white render with black quoins appears on the Black Horse Hotel, which is taken to the next stage of elaboration by the use of timber framing coloured black and white for the top two floors. Whilst this fashion is widespread in Cheshire and parts of the Wirral there is little in Heswall.

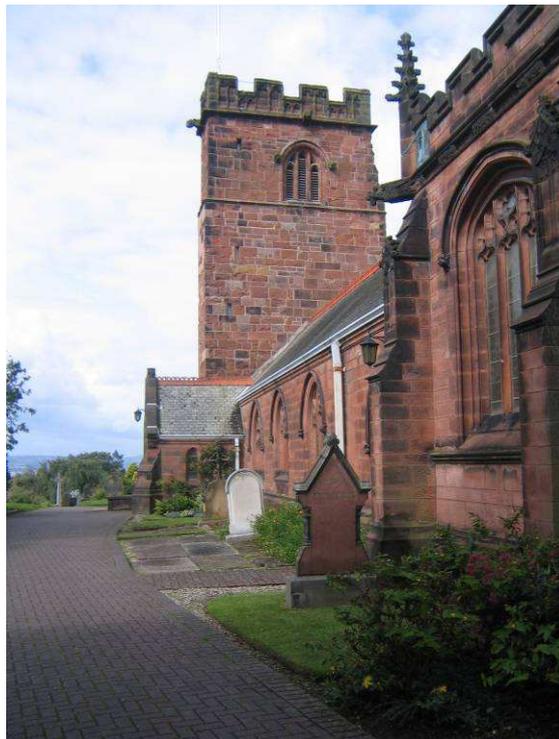
- 4.2.5 St Peter's Church** - Apart from the lower stages of the tower which date from the C14th the church building is now entirely Victorian, the majority from the early 1870s with the Brocklebank memorial chapel from the 1890s. It is built of the local rather hot red sandstone with slated roofs and red clay ridges. For a significant church the building is of a rather modest scale, although the tower on its eminence is prominent in the neighbourhood and from the Dee estuary. Maintenance standards are very high and the surrounds of the church are well planted with shrubs and trees. The approach from Village Road leads through a gateway with stone piers and gives a view of the east window of the church first of all, before opening up to a small semi-enclosed area on the south side of the building. Apart from the view of the tower the general contribution to the main village scene is rather limited. Its access lends it the air of a well kept secret.

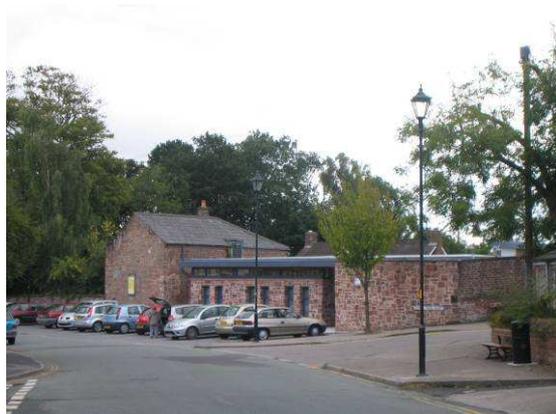
**4.2.6 St Peter's Centre** - This contemporary building, constructed in the early 2000s, is fitted onto the site between the entrance to the churchyard and the rectory stables. Maps show a pre-existing building on the site of a rather smaller plan. The centre is single storey and with an extensive flat roof. It is enclosed by natural rubble stone walls with a rather prominent light mortar. The flat roof sails over a shallow clerestory and there are three pairs of lights to the left of the main entrance. It is a polite building which makes a good contribution to the street scene without hiding the church. Though to Heswall residents it is a well known and used Hall and meeting rooms, its very low key and sensitive presence betrays little of its function, size and community importance to the casual passer-by.

- 5.3.10 Most recently the use of local stone on the St. Peter’s Centre has been a welcome attempt to ‘localise’ the building by re-using stone from the boundary wall (itself re-used when the car parking was provided in the Lower Village)

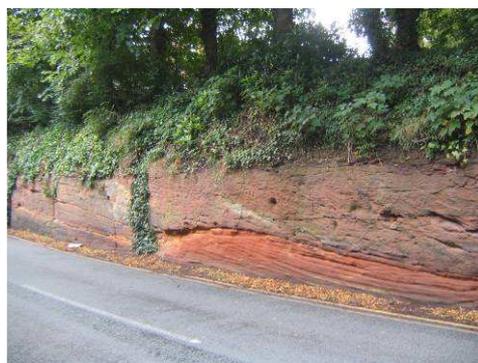
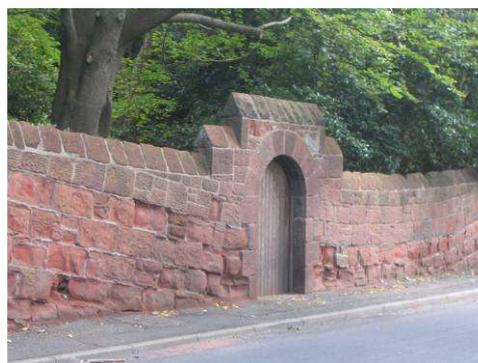
**4.3.1** Walking around the village, particularly along the steeper streets including the lower part of Thurstaston Road, School Hill, Feather Lane and Wallrake outcrops of the underlying sandstone bedrock are readily observed. A number of these streets have been deeply cut into the road, giving almost vertical cliff-like faces on either side. These 'cliffs' sometimes topped with hedges or walling forms the most basic of boundary definitions.

**4.3.2** It is not surprising that there is wide use of the stone walling for older property boundaries in preference to hedges or fences. It may well be that in forming cutting or levelling plots that the stone was a by-product of the process of establishing the plot. This process of carving building sites out of the hill is visible to the rear of the houses on the north east side of Village

4.3.4 Many sandstone walls within the village have deteriorated unnecessarily due to the almost universal use of cement mortar for repointing from the C20th onwards. This practice commonly leads to the accumulation of soluble salts within the pores of the stone, which leads in turn to failure and decay. Measures should be taken to arrest this decline in the area's stone walls through promotion of recessed (re-)pointing and (re-)construction with a soft lime mortar.

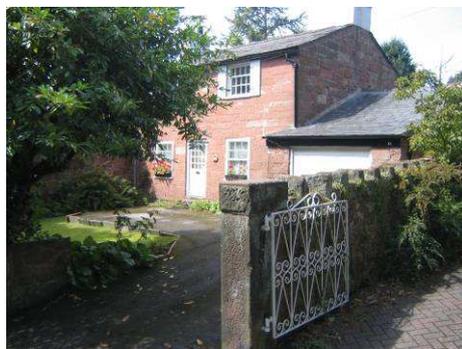
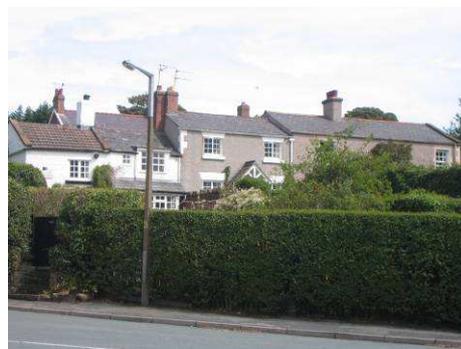
5.1.2 **Local vernacular cottages** - These are mainly C19th low 2 storey buildings of stone with slate roofs. In some cases they have been painted or rendered to match the fashion for light colouring and imitation black and white. The example on the left is on School Hill and has original sash windows. The example on the right is a small row of cottages towards the top end of Thurstaston Road with accesses to both that road and Dee View Road, set back behind high hedges and not very prominent.

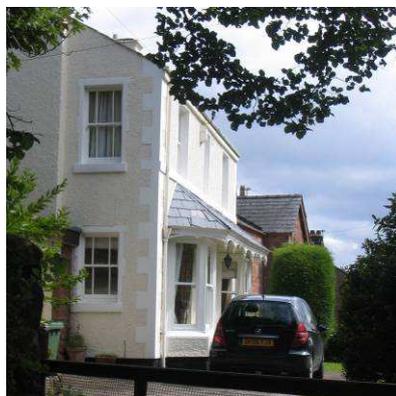
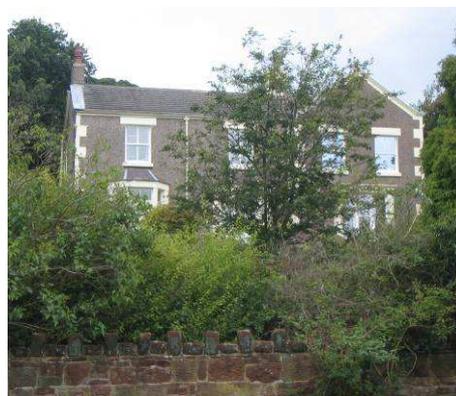
5.1.3 **19th Century Villas** - These are generally single dwellings of a full two storey height with slated roofs. External walls are frequently rendered with a ‘dash’

finish and were usually of a dark brown or grey appearance with smooth rendered quoins. Windows are vertical sashes with smooth rendered surrounds.

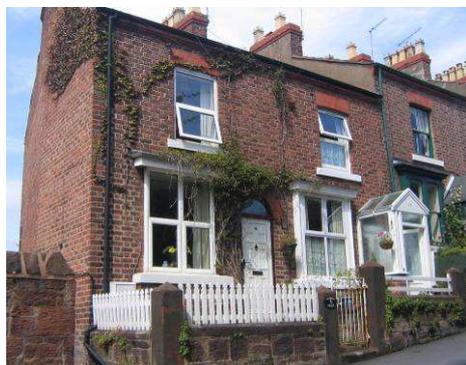
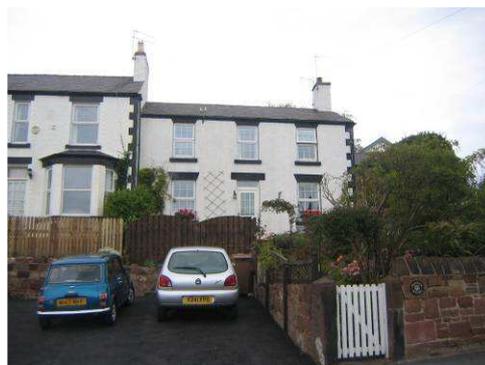
5.1.4 **Late Victorian and Edwardian terraces or semi-detached pairs** - Brick, two storey, usually rendered with slate roof. Some have bay windows.

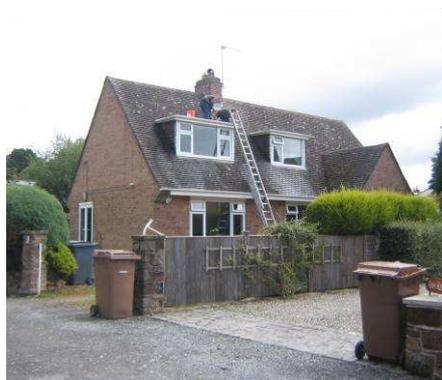
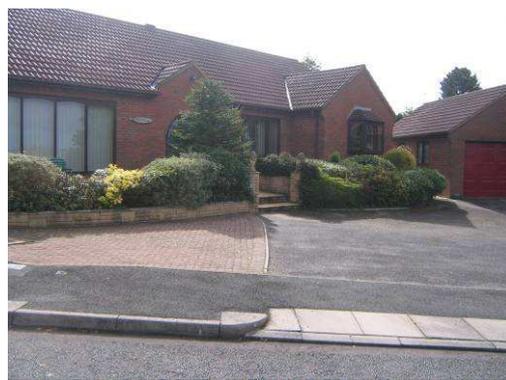
5.1.5 **1950s-80s post war modernist** - These include houses, bungalows and ‘dormer bungalows’, generally in brick with the usual large windows either white or, more recently stained timber.

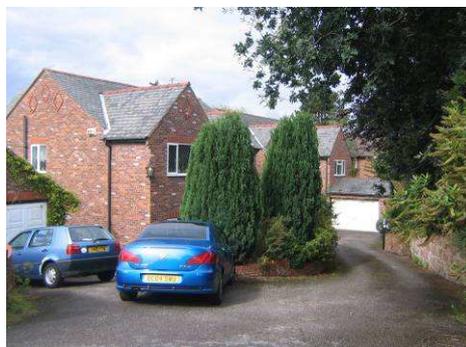
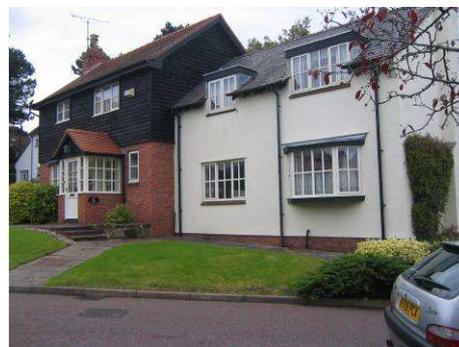
5.1.6 **1980s neo-vernacular** - From the 1980s onwards, inspired by the Essex Design Guide of the 1970s and an anti-modernist view there has been a tendency for developers to utilise a neo vernacular style. This is

characterised by simpler forms, a limited range of more traditional materials, casement or sash windows and minimal bargeboards and fascias. This can tend towards pastiche style but good examples, as in Tithebarn Close produce a development of strong character where the built form dominates and roads and turning areas fit into an interesting pattern of spaces created by the building layout.

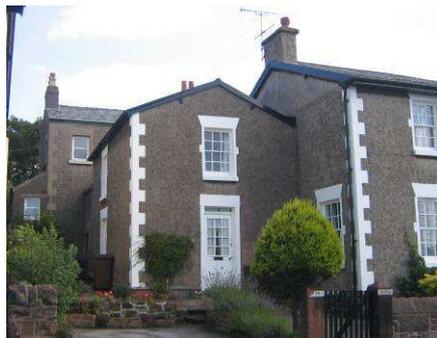
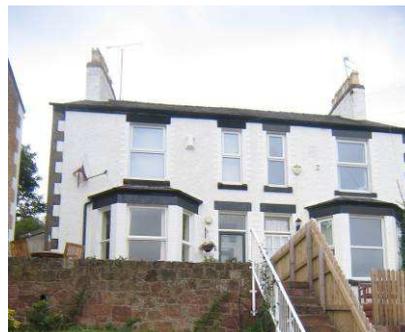
- 5.3.4 The example above on the left shows a property on The Mount with grey/brown dash render and smooth quoins and window dressings. At the rear of the house is a wing where the quoins and dressings are unpainted, but elsewhere they are now white. The next step, as in the example on the right on Dee View Road is to paint the textured render white with the use of black quoins reflecting the late Victorian craze for the use of ‘black and white.’

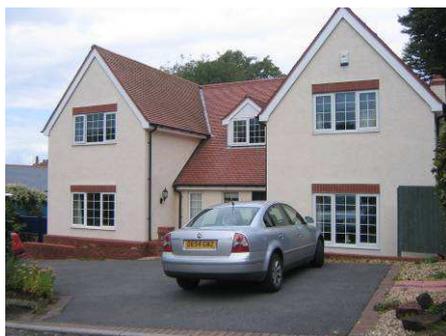
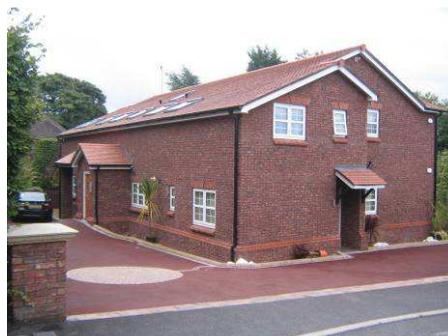
6.2.1 Much of the early C20th development of the area consisted of large plots with individual houses of a modest scale – which left a comparatively large area for gardens, trees and wild areas. As in a number of other areas in the Wirral there has been pressure for larger individual houses. Where there is no green belt land and a general lack of individual plots those existing plots, which are perhaps perceived as ‘under-developed’ have been acquired, and the current houses either extended or removed prior to much larger properties being built. There are examples of this process at the entrance to Roscote Close. At La Casita, a bungalow was extended in plan and made two storey; whilst at Wyncote the existing house was demolished and four apartments constructed.

6.2.2 In both these cases the houses dominate the immediate street scene, particularly as they have almost completely open frontages. There is a preponderance of hard surfacing in the forming of parking for a number of vehicles, and there is little opportunity to mitigate this ‘hardness’ with trees or other landscaping due to the lack of available space. Further up Roscote Close the original leafy character is retained. There is a predominance of trees and high hedges such that the majority of the houses are almost invisible.

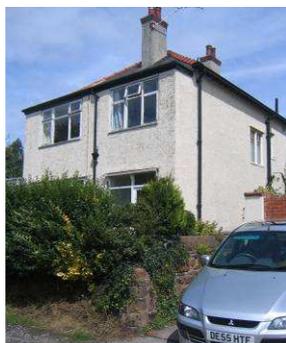
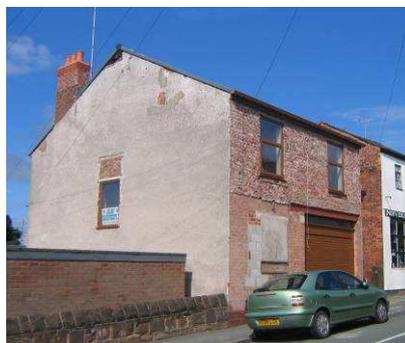
6.3.1 It is not possible to make generalised statements about these. Some appear to be neglected, whilst others have a character which mars the general appearance and quality of the area.

6.3.2 The properties on West Grove (l) and The Mount (r) are in need of repair, that on The Mount being particularly obvious and the cause of local concern as it lies on the main street.

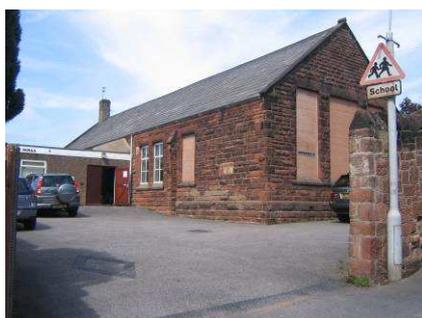
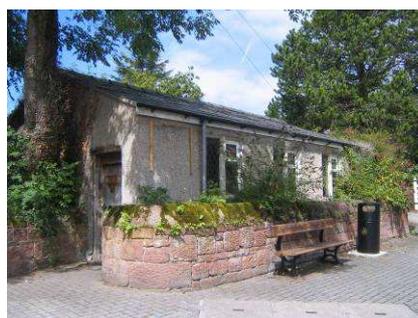
6.3.3 Richmond Hall on School Hill (l) is in particular need of refurbishment. The blocked up windows have a particularly unfortunate effect in that, from the street the building looks unused. The large area of tarmac which butts right up to the walls, and is typical of a school playground produces a very urban appearance and does not set off the architectural quality of the school building. Breaking up of this hardness by introducing planting and a more varied zoned surface would improve the setting. The flat roofed extensions on the east and west sides do not complement the architecture of the school itself, and if still needed could be replaced in a more harmonious style.

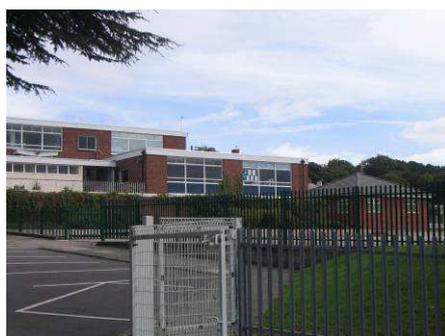
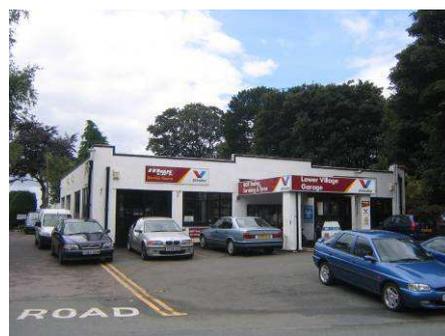
6.4.1 The primary school (l) is from 1961, a period when school design was dominated by large flat-roofed structures with extensive areas of single glazing. The large areas of broad white fascia, with horizontal pattern windows emphasise the horizontal, spreading nature of the buildings, whereas most of the traditional structures have a more obvious vertical emphasis. More recent buildings in the group have low pitched roofs which pay more respect to local tradition.

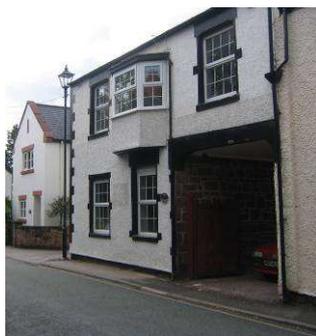
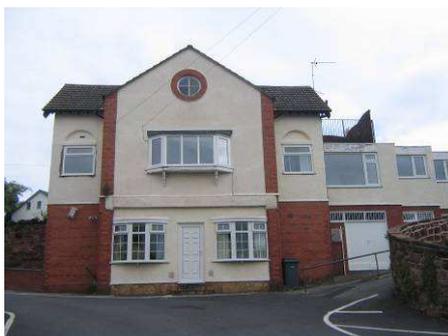
6.5.1 Houses on Village Road (l) and School Hill (r) with UPVC windows. The example on the left shows windows which bear some relation to the pattern of the original glazing and work within the original openings, but with the use of standardised sections the subtlety of the original detailing is lost. The inserted glazing bars bear only a passing resemblance to the original as they do not break the glass line, and therefore the glass itself does not have the ‘life’ and varied reflection of individual small panes.

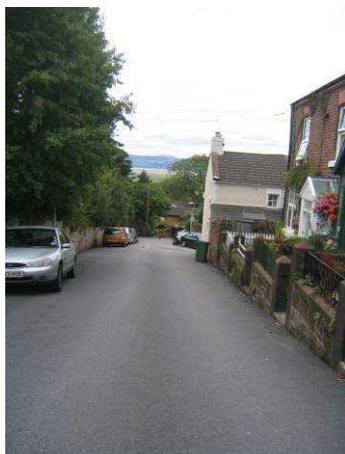
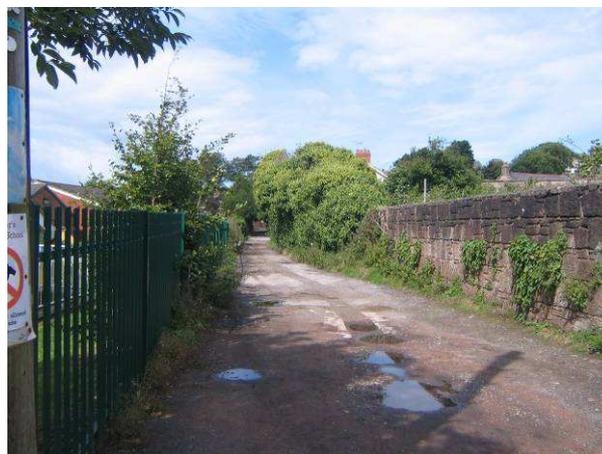
6.6.2 The upper part of School Hill (1), particularly would benefit from a scheme of enhancement involving the wall to the park, the paving surfaces, the area around the former school and the terrace of houses on the north side of the road. There is little through traffic and so the need for a tarmacadam surface is less pressing. A surface of setts or other appropriate small units giving a better grip may be advantageous.

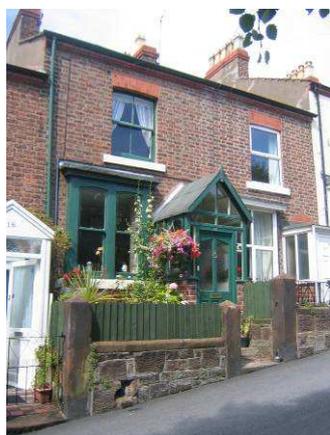
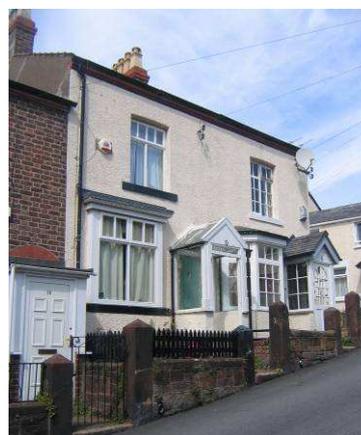
6.6.4 The need for improvements in the area identified extends also to some of the properties. There is an attractive stepped terrace of six houses on the north west side of School Hill at the top. It seems that these were originally of a consistent pattern, being of brickwork with a small porch and shallow flat bay at the front at ground level and a single sash window at first floor level, as in the left hand image above. The brickwork is Flemish bond with rubbed brick arches and decorative cornice. Unfortunately only one house remains with its original design, as all the others have been changed by the alteration of windows, door, porch or the addition of render, or indeed all the elements, as in the example on the right above.

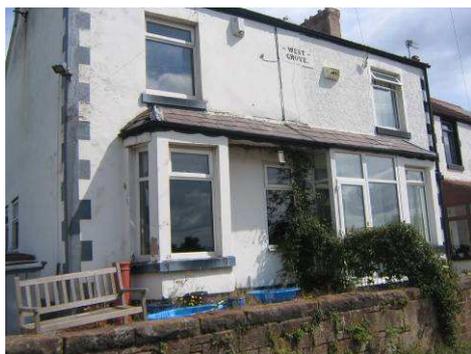
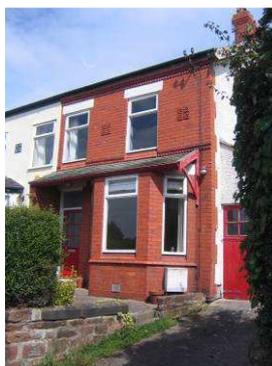
6.6.5 Similarly in West Grove a scheme of enhancements for the properties would be desirable. There is a general loss of detail of the older properties, with the usual instances of the replacement of windows by unsatisfactory plastic equivalent, as in both examples above, and by the rendering over, or otherwise covering up of good brick detailing.

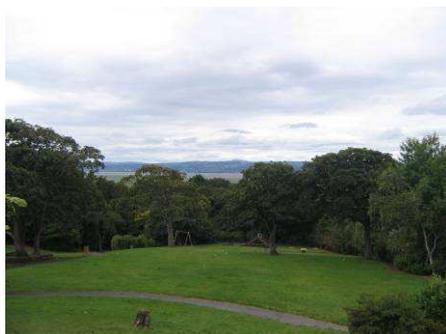
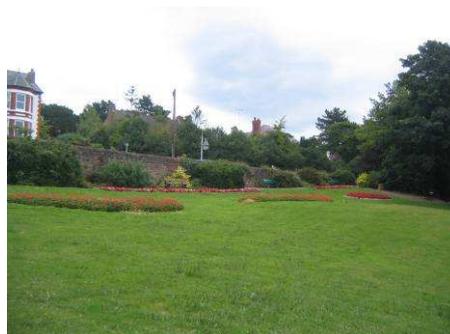
6.7.1 Dawstone Park was laid out in the 1930s on a triangle of vacant land between Dawstone House, School Lane and Dawstone Road. There are access points more or less coinciding with the three corners but it seems not to be used as a through – way by walkers. The houses on the east side of Dawstone Road face onto the park but the elevated road and retaining wall screen most of it from view. This lack of overlooking mean that there is opportunity for minor vandalism which is evident in the graffiti on some walls, uprooted bins and the use of the children’s play corner as an illicit smoking area.

6.7.2 Using the basic infrastructure of perimeter walls and enclosures and the good quality trees it would be desirable to re-landscape the park, perhaps incorporating a small pavilion for shelter and refreshments so that it is a well used place of recreation for a wider section of the local and wider communities.

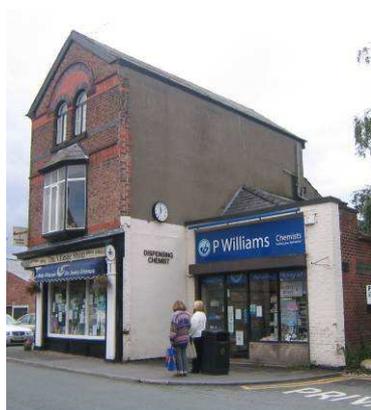
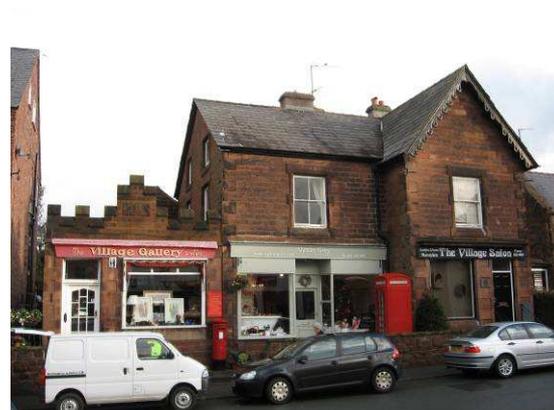
6.8.1 The illustrations above offer the opportunity to compare hand-lettered shop fascias with printed acrylic signs. In the left hand picture the good quality and distinctive 'Village Shop' sign with its canvas awning has real character compared with the overlarge 'P Williams' sign and its roller shutter box. Similarly in the right hand illustration there is the standard, and over large 'Oyster Grey' (the old post office) sign, between the hand lettered 'Image Gallery' and 'The Village Salon'. Hand lettering need not be too fancy or elaborate – indeed it is less effective if done this way, but it offers scope for local distinctiveness.
