ROCK PARK CONSERVATION AREA APPRAISAL AND MANAGEMENT PLAN

PART 1 - CONSERVATION AREA APPRAISAL

Prepared for Wirral Council by Donald Insall Associates Ltd, 2007 – Wirral Council 2009

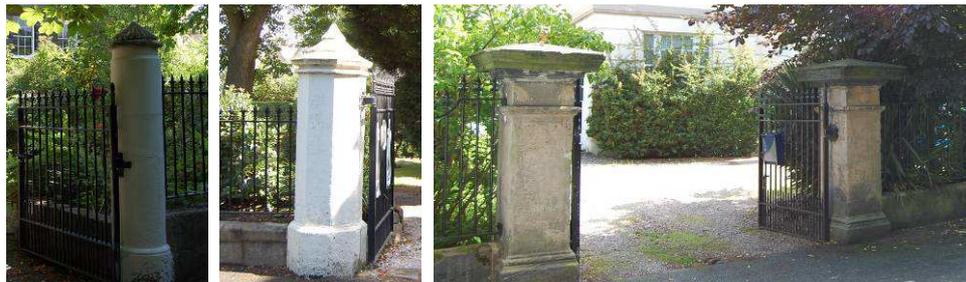
replacements sympathetic to the character of the area. There are a number of different shapes of gateposts, often repeated elsewhere in the area, possibly signifying the original owner or developer of the land. All gateposts to villas are of a relatively consistent height, but their plan forms include circles, octagons and squares. Most plinth walls are low and of a simple form. The majority are of sandstone but some are of brick with a rendered finish. Railings have recently been reinstated to almost all of these walls. These are thought to be approximately to the original design, but are constructed from steel.

Original gatepost and boundary wall treatments

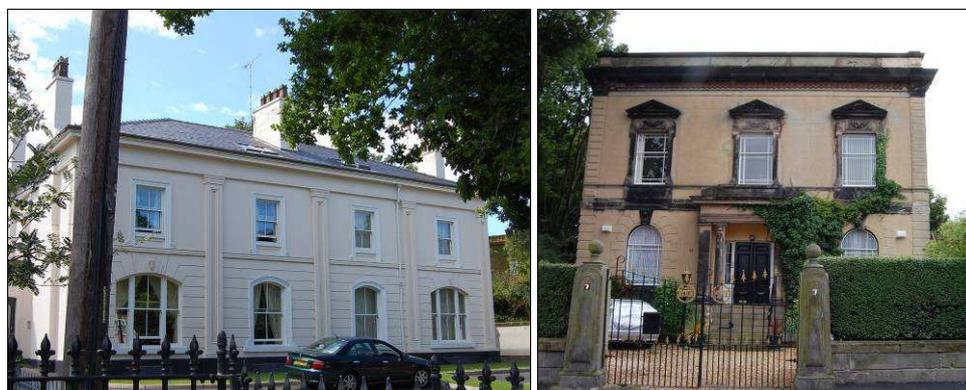
- Classical / Italianate –These buildings are proportioned loosely according to classical rules and adopt features such as cornices, quoins, pilasters and ground floor rustication. Many of the buildings have an Italianate character created through particularly projecting cornices at eaves level and in their detail around openings. Most roof pitches are relatively low and occasionally behind a parapet. All windows are sash windows and openings are positioned in a regular rhythm across the façade.

Buildings of a classical or Italianate influence

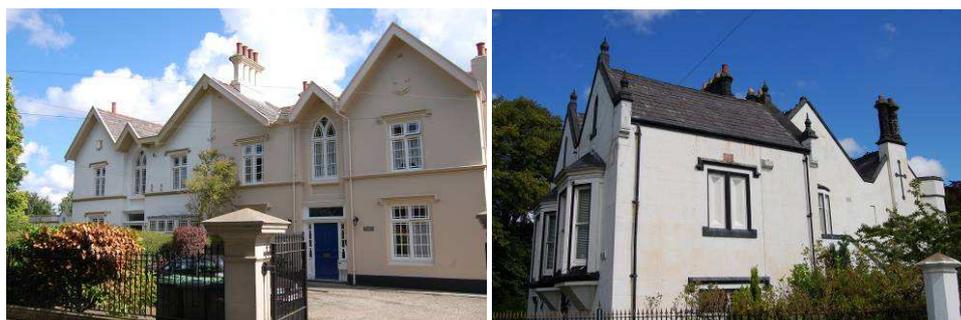
Buildings of a vernacular revival or gothic influence

- Vernacular Revival / Gothic – Buildings with details derived from other traditional building types. Influences include Gothic, Jacobean, Elizabethan and Medieval building periods. In contrast to the Classical / Italianate buildings, roofs are more steeply pitched and elevations have fewer formal proportions and design rules used. Plan forms are generally more complex and buildings are less likely to be symmetrical. Gables are used regularly as features in the design of buildings, and like openings, are shaped to reflect the style of the building. Chimneys are typically more prominent on buildings of these styles.

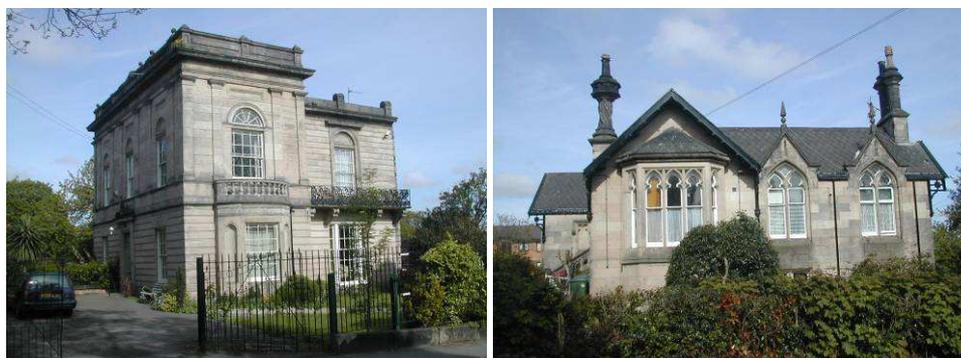
- 5.2.1 No information concerning the architects of any of the individual buildings is readily available or understood to exist during the writing of this report. The buildings of rock Park share similarities with the slightly later (1840s) buildings in nearby Clifton Park and Birkenhead. Architect Walter Scott designed numerous buildings both classical / Italianate styles in these two areas. Although these buildings bear some resemblance to the houses in Rock Park, there is no replicated detailing apparent which would indicate that Scott worked there.

Similar buildings in Clifton Park

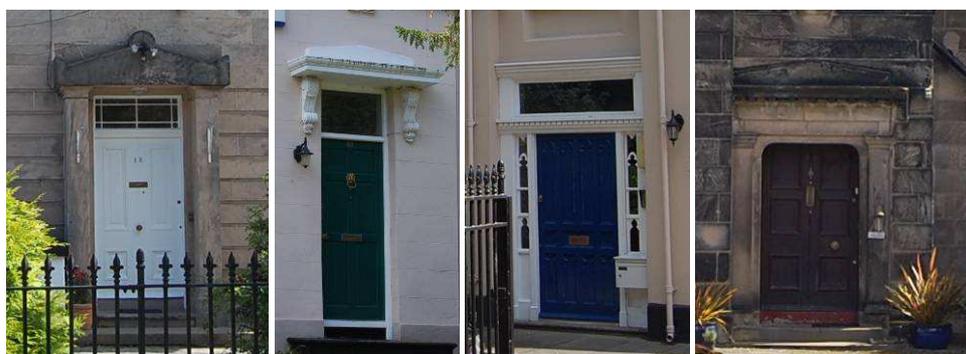
- 5.4.4 **Doors** themselves within the conservation area are often not highly apparent from the road, being either recessed from the building frontage or on a side elevation. The door surrounds and entranceways are generally celebrated architecturally, however, with carved stone canopies, porches and surrounds.

Doors within the conservation area

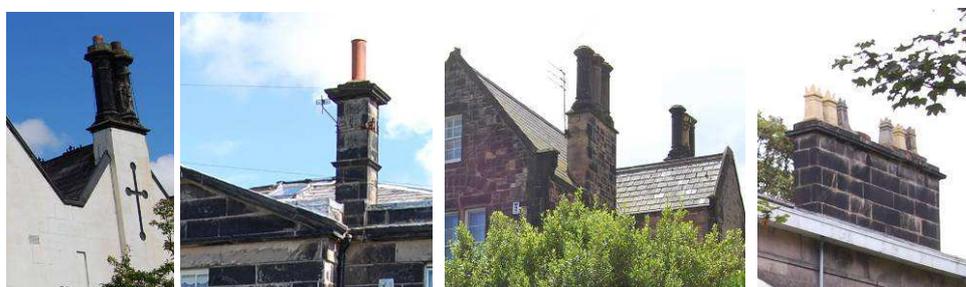
- 5.4.5 **Chimneys** play a part in the visual composition of most buildings, although they are typically of a simple rectilinear design. A few buildings have more ornate or visually dominant chimneys; these buildings generally have a more gothic inspired design. These chimneys have separated flues for approximately the final 1 metre of their height, built in a circular or octagonal shape, before they rejoin at the top with a projecting moulding.

Chimneys within the conservation area.

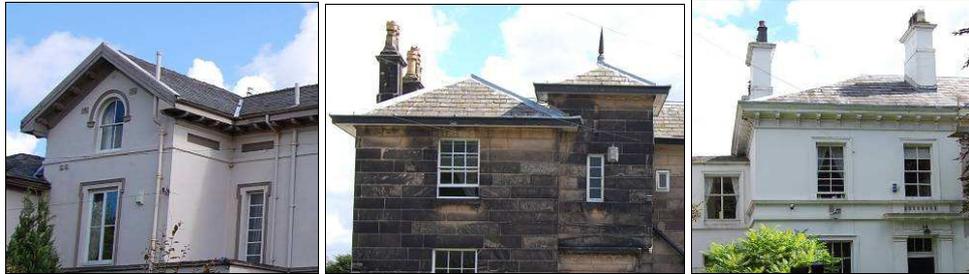
- 5.4.6 As many of the lower storeys of the buildings are obscured, the **roof details** of the buildings in Rock Park are critical to their contribution to the character of the area, being often the most prominent feature. A few of the more

classical buildings have deep, ornate cornices, but otherwise simple roof forms. Where buildings have gables facing onto the street, the verge projects and they are generally supported on a number of brackets. These brackets are often a feature along the eaves of building, also to form dentils in the cornice.

Roof details in the conservation area

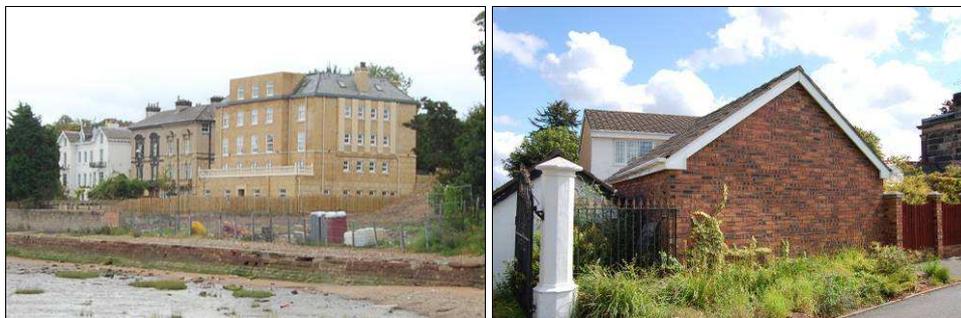
Development in the conservation area which is detrimental to its character or to the setting of its listed buildings: (left) new flats adjacent to 1 Rock Park; (right) Nova House on Rock Park Road

6.2.3 Nova House, on Rock Park Road, however, has a detrimental effect on the setting of both adjacent listed buildings and the character of the conservation area as a whole. Particularly obtrusive are the elements of the site along its road facing boundary: a garage is cited immediately adjacent to the road and is constructed of basic readily available materials to a fairly standard design without reference to the special characteristics of the conservation area. The garage has a direct and adverse effect on the visual relationship between the two neighbouring listed buildings. The fence along the front boundary is also of a basic construction and it detracts from the quality and appearance of the streetscene as a whole. The house itself is of an entirely incongruous scale to the rest of the conservation area and built of inappropriate standardised materials, however, it is slightly set back from the road and the building line, which means that there is the potential for its detrimental visual impact to be lessened by good landscaping in the future.

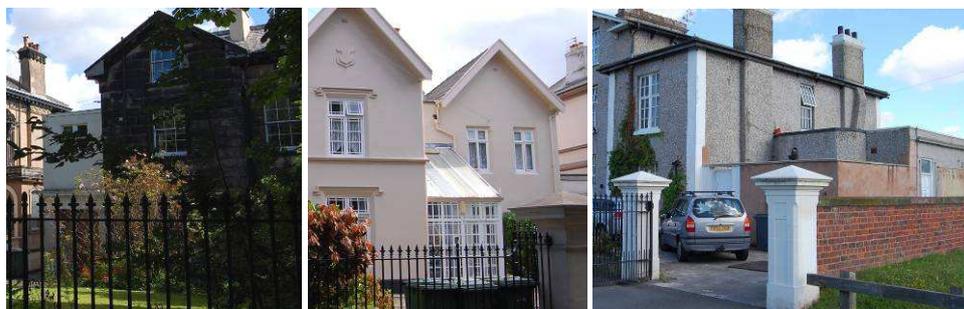
Extensions within the conservation area. The first two images show extensions of a similar form to elements of the original building, but lacking the quality of detailing, the third shows very poor quality and highly visible single storey additions.

- 6.3.1 There are relatively few extensions within the conservation area of a significant size. Most extensions have been to the rear or sides of houses to provide ancillary accommodation such as porches. In many cases extensions have involved the alteration of existing outriggers and therefore have not substantially changed the form of the building. The most unsympathetic of extensions are likely to be those that confuse the original form of the building and lessen the overall perception of quality. Good extensions would either use the materials and detailing of the original building or be of a modern design and construction that is of a high quality but adequately contrasting to the original.

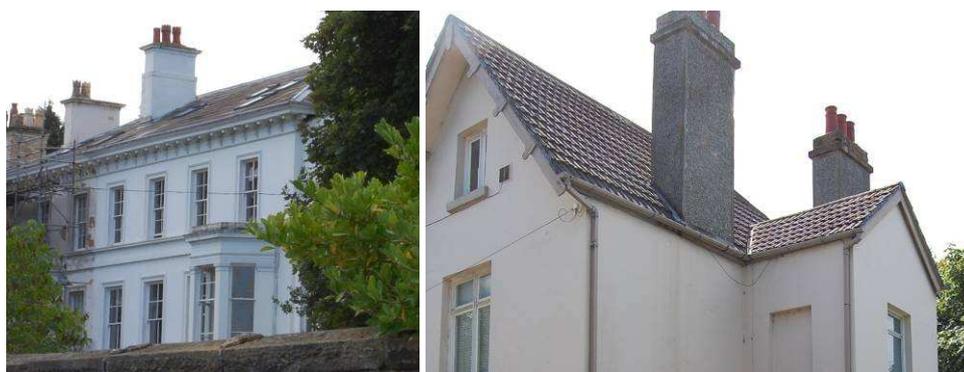
Unsympathetic alterations within the conservation area: (left) rooflights inserted into the roof slopes; (right) concrete pantiles

- The insertion of new or alteration to existing openings
- Replacing original windows, within modern designs and materials such as UPVC
- The replacement of doors
- The replacement of slate roof coverings with modern tiles
- Rendering or painting over originally exposed stonework
- Poor quality repairs, particularly where using a change of material
- The installation of rooflights
- Changes to chimneys

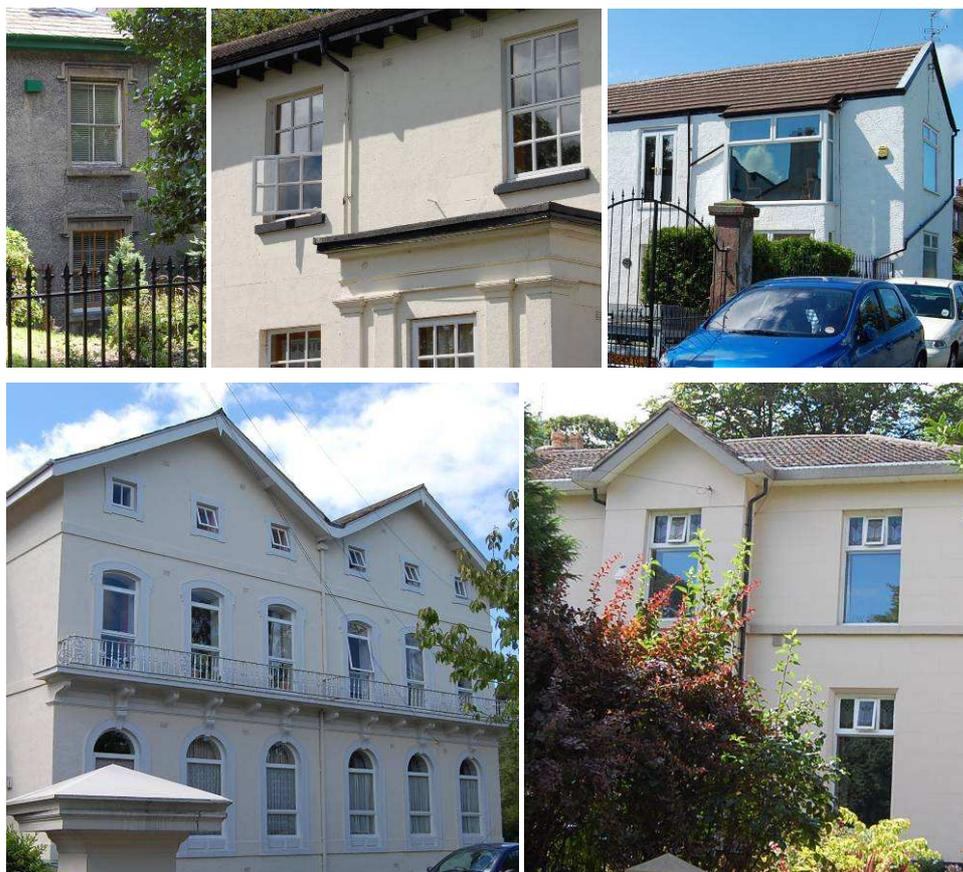
Replacement windows within the conservation area: (top left) an example of an instance of two different configurations of sash window within a building. It is not clear which is original and either may be appropriate but together they are detrimental to the rhythm of the façade. The bottom windows is an example of a stained finish which is inappropriate to the character of the building; (top centre) the detrimental impact of casement windows feigning to be sashes; (top right) large picture windows which result in an historic building appearing to be modern; (bottom left) illustrating the way that modern windows can adversely affect the overall perception of quality to a façade; (bottom right) modern casements again changing the character of the building.

6.4.2 The foremost alteration to historic fabric within the conservation area is the replacement of original doors and windows. These alterations are often well intentioned – to improve the thermal or acoustic performance or to reduce maintenance requirements for instance, but the visual effect, particularly on the architecturally simple buildings is immense. The original sash windows would have had very slim profiles, giving an elegant appearance. In contrast, a UPVC or aluminium replacement, particularly when holding a thick double glazed unit, has considerably thicker framing elements, which are more obtrusive visually and will let much less light into the building. To exacerbate this problem, it appears as though many of the buildings' sash windows were replaced with casements (albeit of a relatively sensitive design) many decades ago, confusing the original design intention of the building.

6.4.3 The reconfiguration of opening panes (particularly when replacing sashes with top-hung casements) dramatically changes the architectural character of the building. Where windows are replaced in timber, these can also

adversely affect the appearance of the building where the original detailing is not followed and often the quality of the timber is far substandard to the original, giving it a short lifespan. There are a few instances where secondary glazing has been used in the village (e.g. in the village hall), which will always produce a more satisfactory visual result than a double glazed equivalent. The use of UPVC windows is more prevalent amongst, although not restricted to, the unlisted buildings.

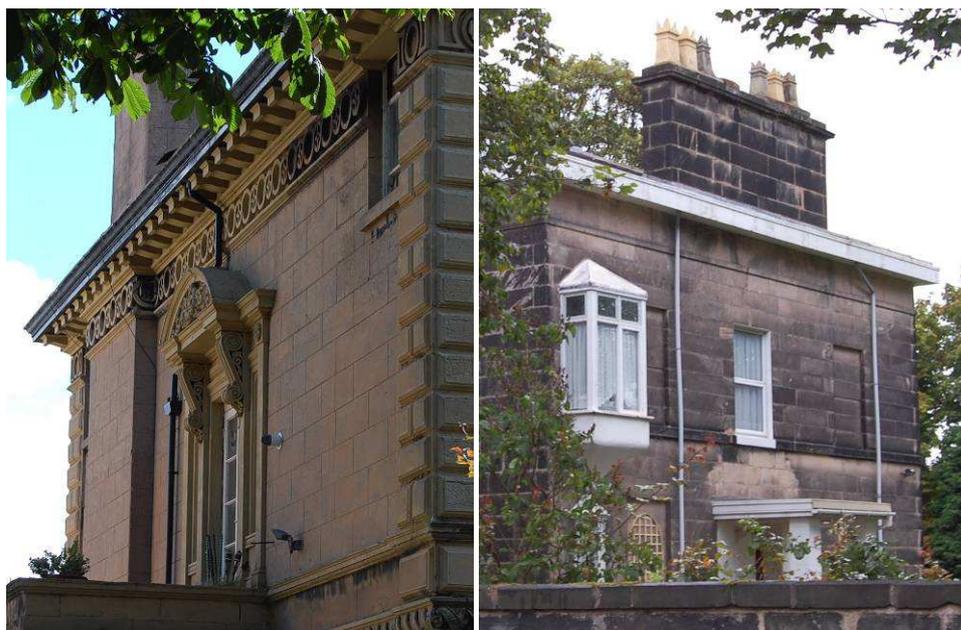
Photographs illustrating the detrimental impact of inserting new openings. The left-hand example shows a small window penetrating through the decorative cornice, the right shows an oriel window (possibly older) and a modern canopy that have unbalanced and changed the architectural quality of the façade. Both of these facades are particularly prominent.

- 6.4.4 There are a number of instances where new openings have been inserted into the walls of historic buildings. The carefully elevations of the buildings are generally particularly well proportion and as a result any new opening upsets the balance rhythm and geometry of the existing fenestration or may change the character of an intentionally plain façade. The effect of inserting a new opening through existing fabric where it penetrates through details such as cornices is particularly great.

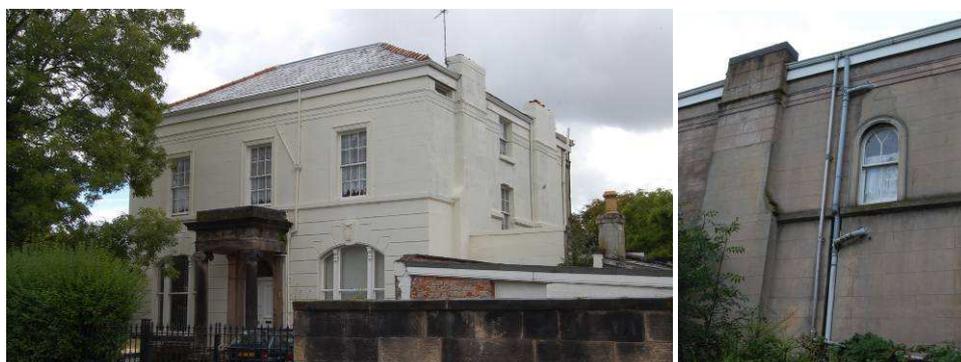
Management issues: (left) a recently painted façade; (right) waste and soil vent pipes, together with a modern fascia treatment.

- The installation of service fixings and fixtures such as rainwater and waste pipes in prominent positions
- The repainting of facades in inappropriate colours
- Changes to the landscape setting, for example large areas of hard landscaping for car parking.
- The installation of satellite dishes and aerials.
- Bins stored in front gardens, presumably due to a lack of facilities at the rear.

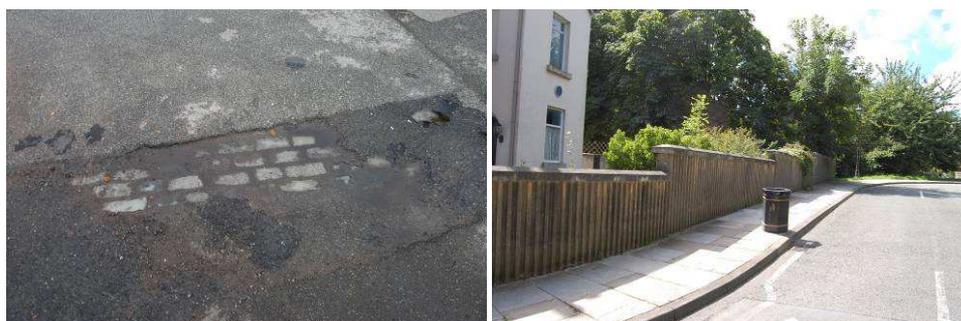
(left) granite setts beneath tarmac; (right) modern concrete slab pavements with concrete walling, presumably constructed at the time of the by-pass

6.5.1 Many of the roads (most notably Rock Park itself) do not have pavements, however, where pavements exist, they are of modern materials, such as concrete slabs, with the exception of some stone kerbs. Roads are all tarmaced, although there are some areas of granite setts showing through around the junction of Bedford Road East and Rock Lane East. Although these surfaces are generally fit for purpose, they are not of a quality that corresponds to that of the listed buildings.

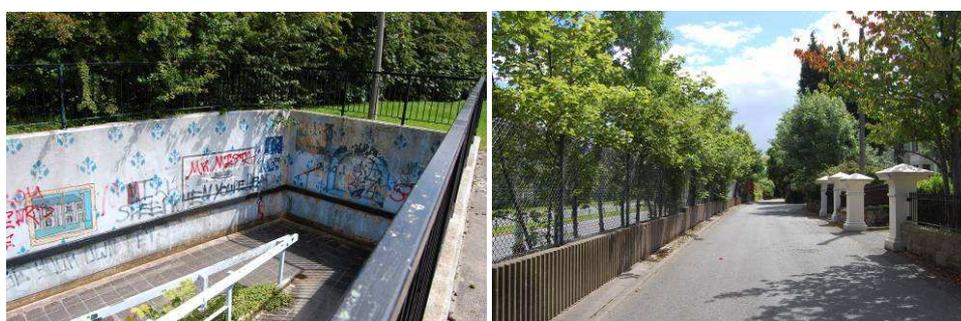
(left) the underpass; (right) wall and fencing alongside the by-pass

6.5.2 Many of the most obtrusive public realm works are associated with the bypass. The underpass, connecting the two halves of Rock Park, despite decoration by the residents at the same time as the Conservation Area Partnership Scheme, has been covered in graffiti making it intimidating and an undesirable means of access, even during the day. As a result of resident pressure it has now been closed as a right of way. There are also long lengths of concrete walling which does not reflect the high quality natural materials seen in the original Rock Park elements. Immediately alongside the bypass the walling has additional chain-link fencing behind it or in other areas basic aluminium fencing is used. All of these elements are entirely unacceptable within an area of historic interest and add to the detrimental impact of the modern road itself.

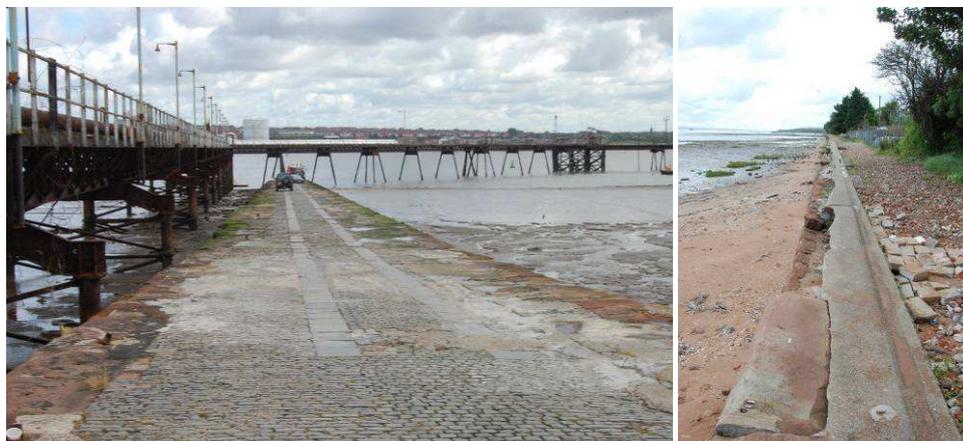
- 6.5.3 The jetty, pier and esplanade are all historic features of great tourist potential but in an unsafe condition. Despite their appearance, considerable amounts of historic fabric remain, but are being lost due to erosion, vandalism and poor maintenance.

The jetty, pier and Esplanade

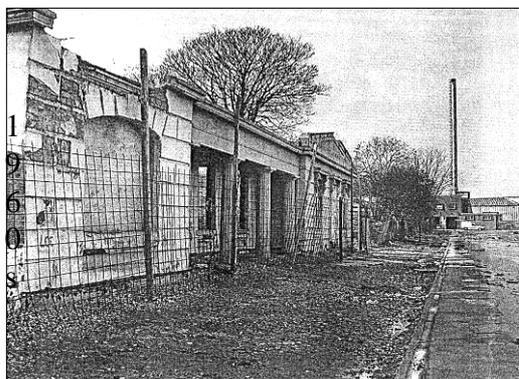
6.6.3 Despite the declaration of Rock Park as a conservation area in 1979 and the listing of most of the remaining villas, which should have raised the public's awareness of the significance of the area, the destruction continued. Number 1A Rock Lane East, a detached sandstone villa and the Bath House, one of the earliest structures, were both lost. These buildings had both fallen into a very poor state of repair and their demolition was apparently justified on the grounds of them being an eyesore and on public safety grounds. The Royal

Images of 1A Rock Lane East and the Baths taken from newspaper cuttings shortly before their demolition
