THORNTON HOUGH CONSERVATION AREA APPRAISAL AND MANAGEMENT PLAN

APPENDICES

Prepared for Wirral Council by Donald Insall Associates Ltd, 2007 – Wirral Council 2009

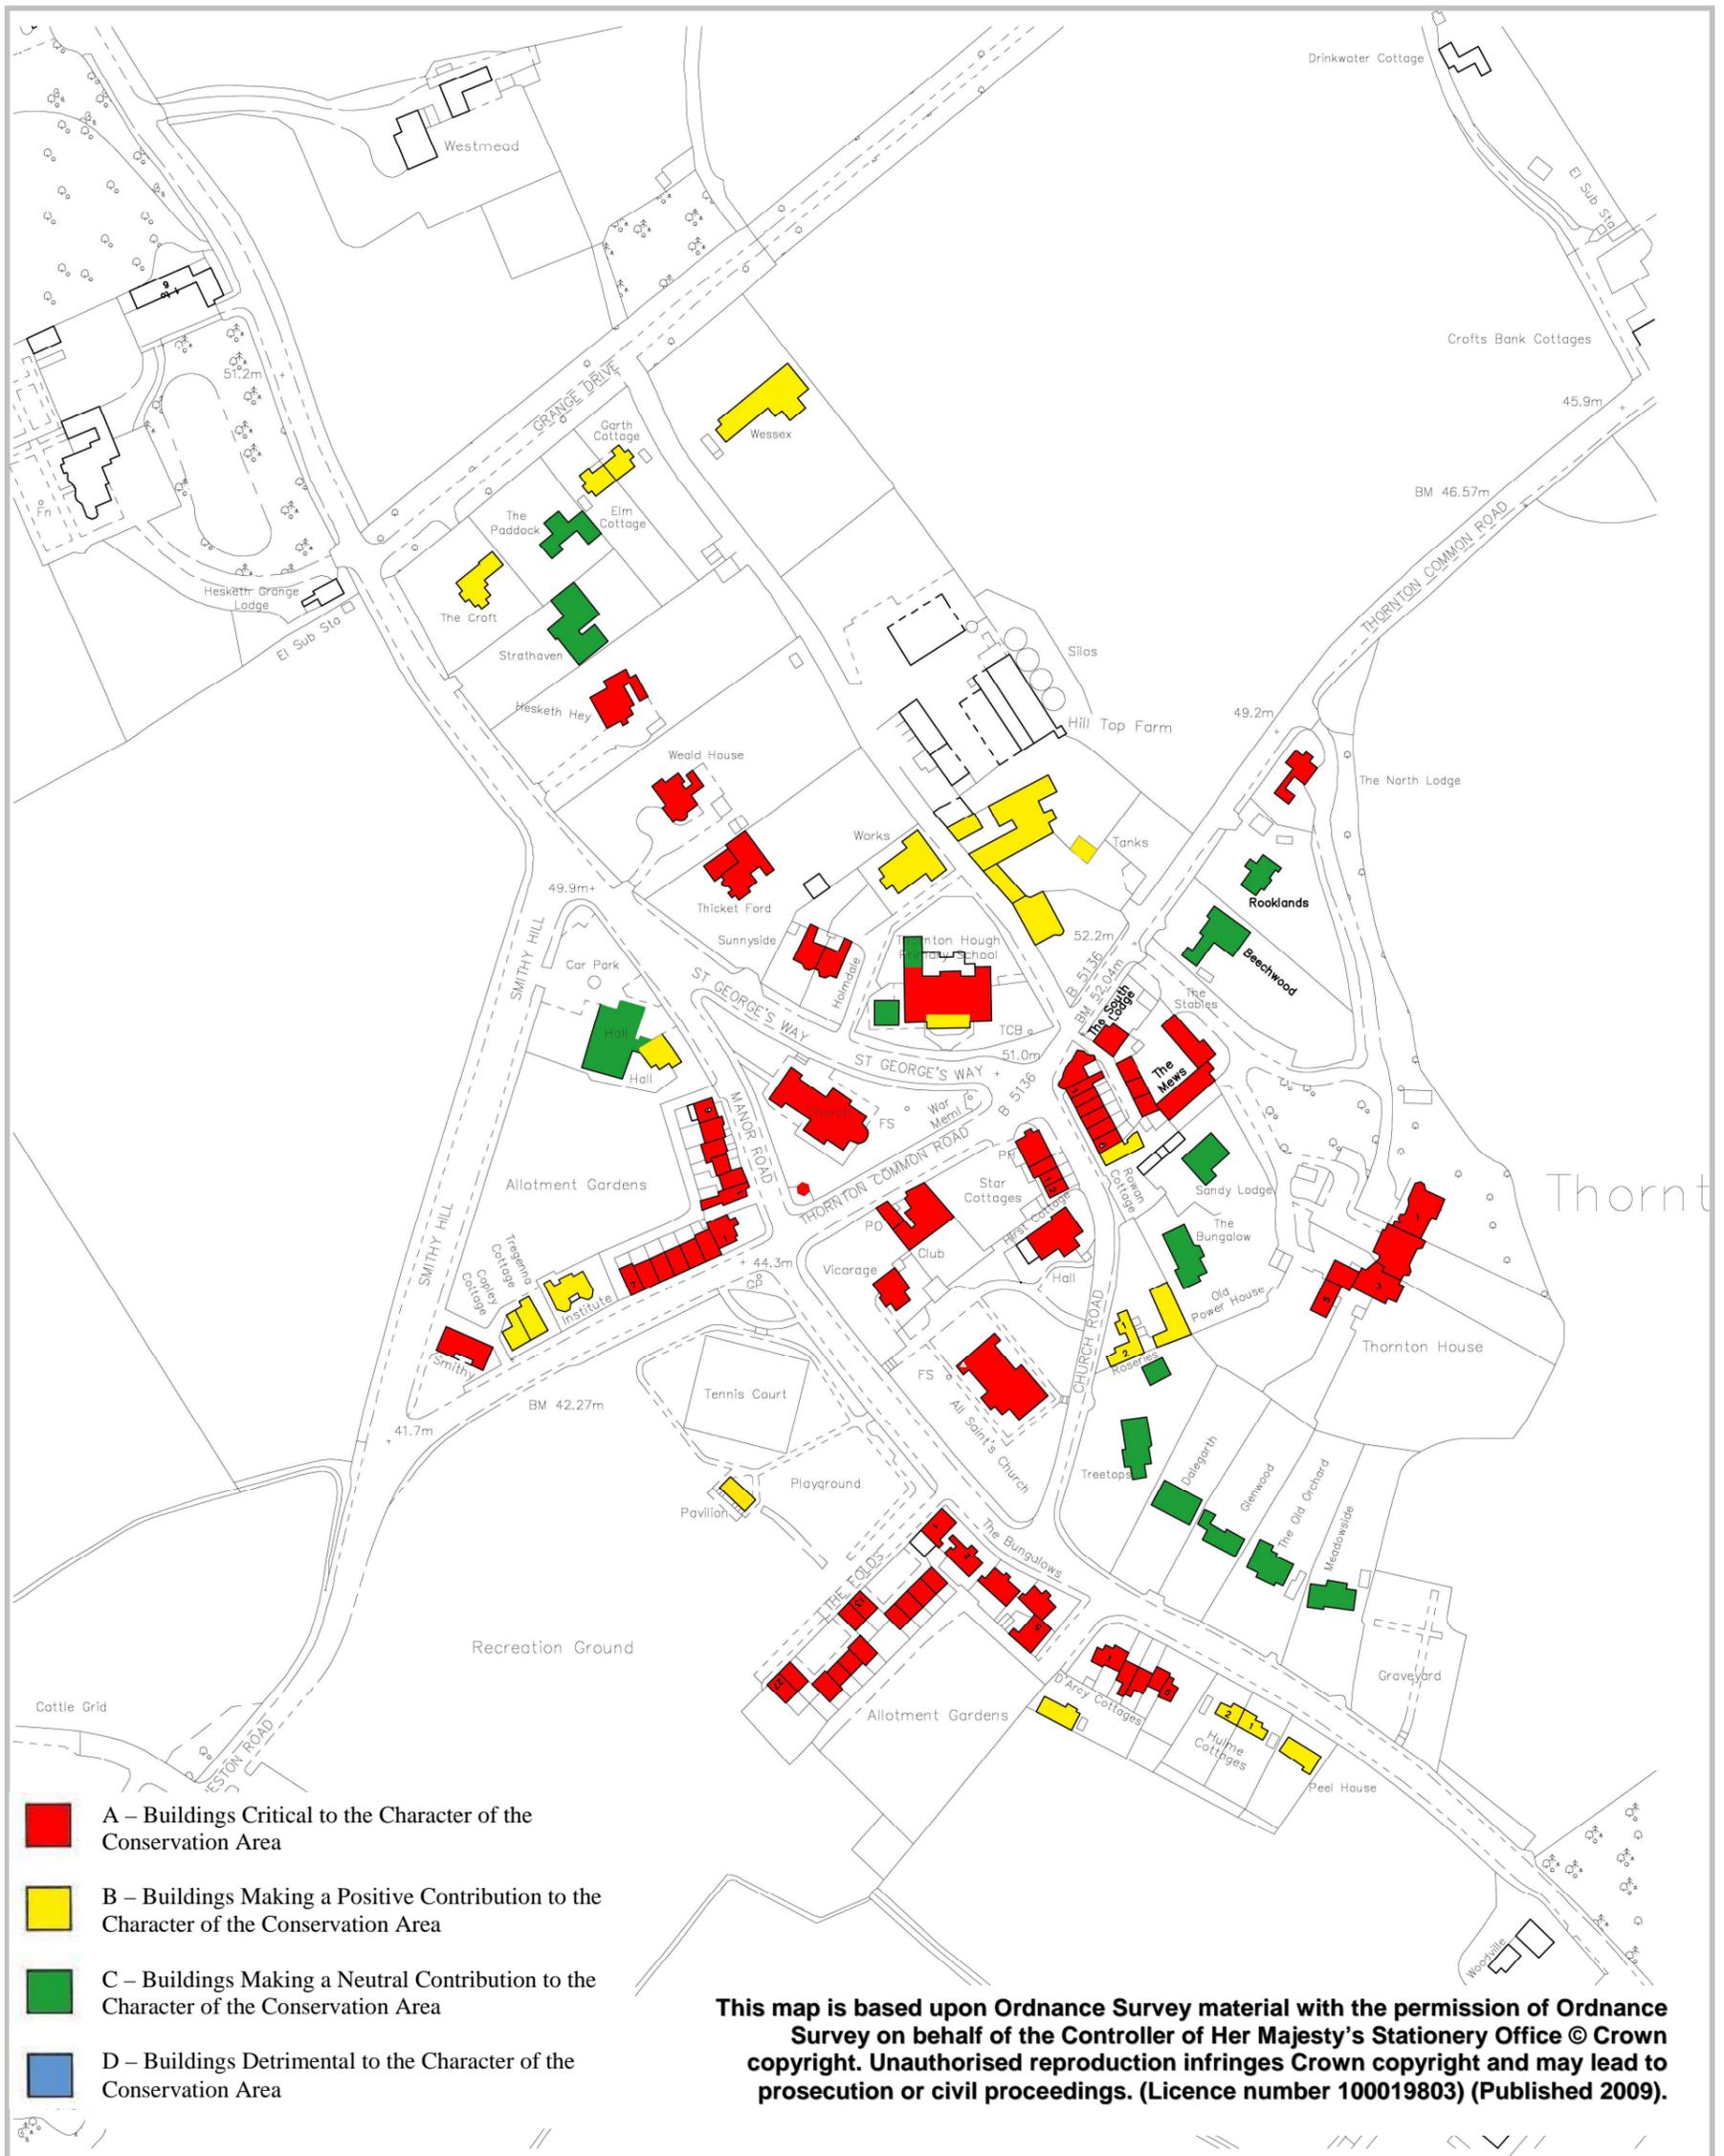
APPENDIX C – PLAN SHOWING CONTRIBUTION OF BUILDINGS TO THE CHARACTER OF THE AREA
 Donald Insall Associates Ltd, 2007 – Wirral Council 2009

- A: (Red) – Buildings that are critical to the character of the area: typically these may be landmark buildings and / or buildings with most of their original character retained
- B: (Yellow) – Buildings that contribute positively to the character of the conservation area: buildings may have some alterations but original character is still prominent
- C: (Green) – Neutral - Either modern buildings of little interest or buildings where character has been lost beyond economic redemption.
- D: (Blue) – Buildings that detract from the significance or character of the area.

There should be a general presumption in favour of retaining all category A and B buildings. Policies should be put in place to encourage the enhancement of, in particular, category B and C buildings. Category D buildings are considered of negative value therefore opportunities should be sought to achieve their replacements or at least improvement.
