## BIDSTON VILLAGE CONSERVATION AREA APPRAISAL AND MANAGEMENT PLAN

### PART 1 – CONSERVATION AREA APPRAISAL

Prepared for Wirral Council by Donald Insall Associates Ltd 2007 - Wirral Council 2009

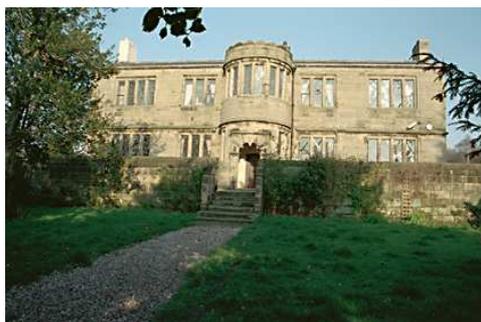
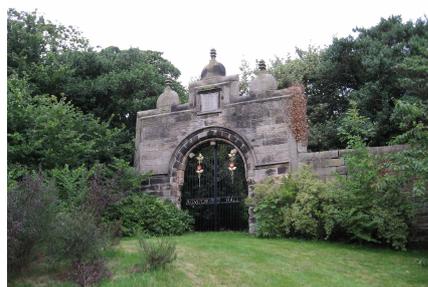
*Bidston Hall*

4.1.3 Within the historic buildings of Bidston, there is no repetition but buildings are united by the use of local sandstone. Common architectural features include stone mullioned windows, stone coped gables, steep pitched roofs.

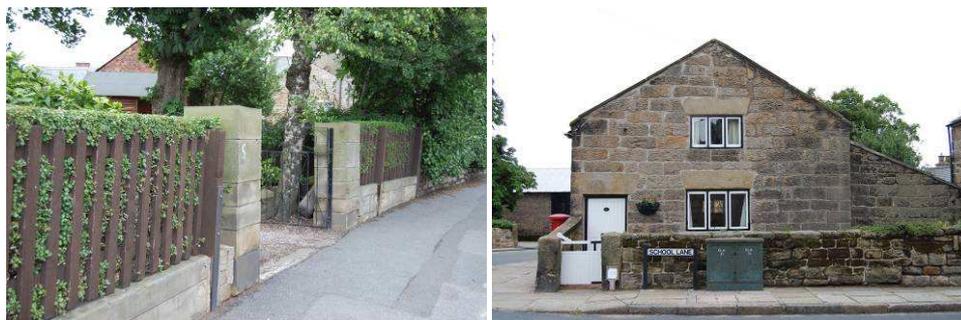
*(Left) Gate posts to Clover Cottages; (Right) Boundary wall to Stone Farm*

4.3.2 Most walls are constructed from regularly coursed large square cut blocks. They are approximately 1 metre in height, however this does vary throughout the area towards a less coursed and more random construction. The copings are largely of neatly dressed coping stones, however there are subtle variations such as the boundary wall to Stone Farm where large coping stones are laid along the bed cope of the wall.

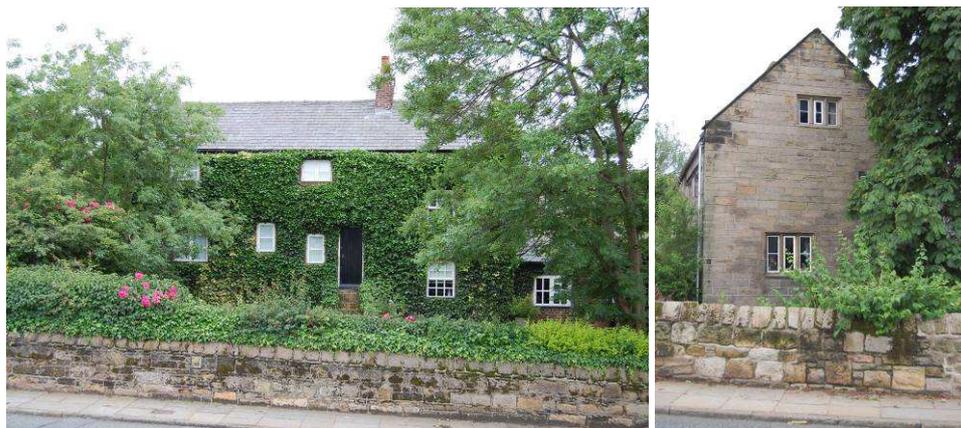
*(Left) Boundary wall to Ivy Farm; (Right) Boundary wall to Church Farm*

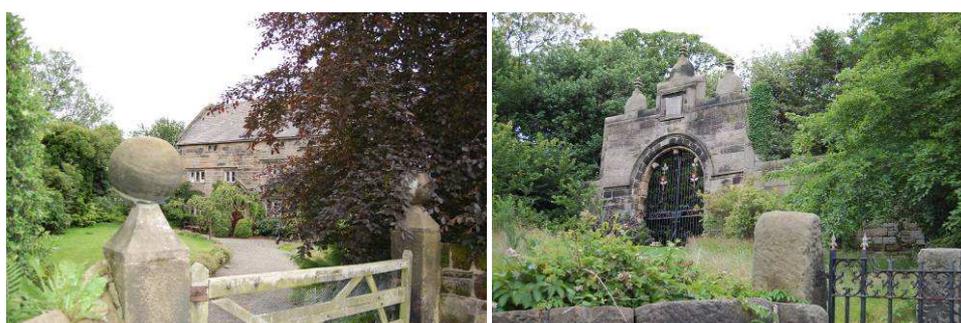
4.3.3 Clover Cottages are bound by a dwarf wall of ashlar faced block with gate posts that have an elegantly concaved profile but have lost their caps (they are reportedly used to form part of the building's chimneys). However, typically within the village, the gate posts are large stones possibly laid to access and enclose former agricultural fields. Entrances to Church Farm and Lilac Cottages are framed by stone gate posts with ball finials copings. The enclosing wall and gates to Bidston Hall are surmounted by domed finials. It should be noted that many boundary walls were constructed from 'recycled' stone from earlier uses in the village and therefore may have some archaeological significance.

*(Left) Gate posts to Church Farm (Right) Grade II\*listed gates to Bidston Hall*

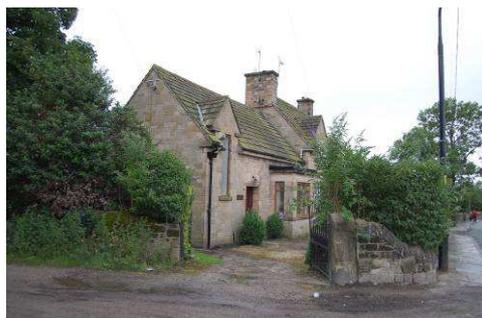
*Typical former agricultural stone gate posts.*

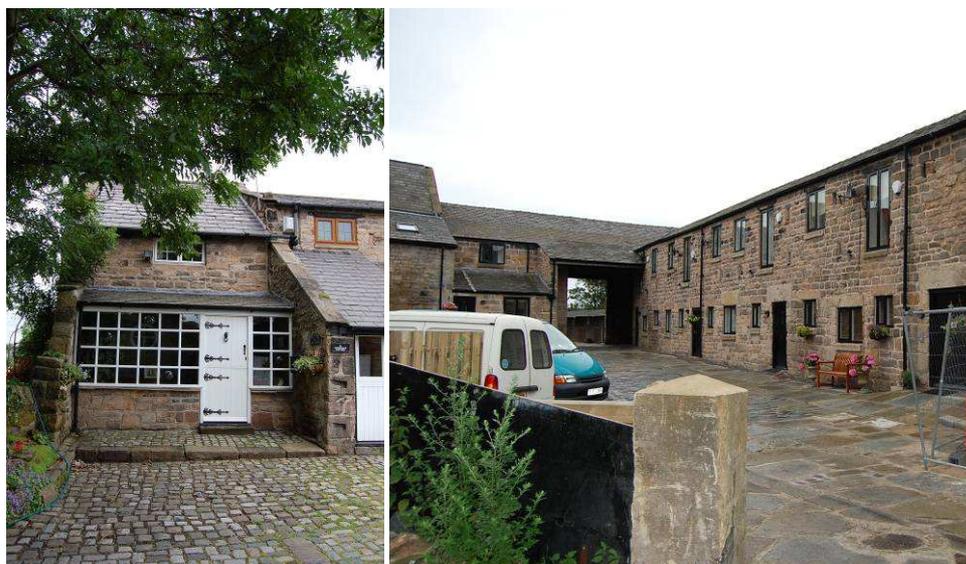
4.3.5 Many of the pavements within the conservation area have a modern tarmac surface. However there are stretches of pavements to Bidston Village Road and School Lane that are of attractive York Stone flags with stone kerbs. There are some attractive yards, of granite setts (Lilac Cottages), cobbles (Church Farm, Yew Tree Farm) and stone flags (Bidston Hall Farm).

*(Left) stone setts to Lilac Cottage Outbuildings, (Right) Bidston Hall Farm*

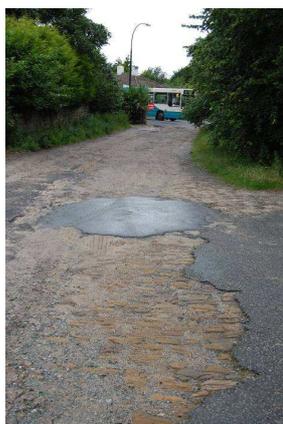
4.3.6 Whilst not enhancing the setting of the historic building as a high quality natural stone surface would, tarmac surfaces for roads do not significantly detract from the setting of the historic buildings. However, the quality and maintenance of the tarmac surface is key. Loose gravel surfaces are generally more in keeping with the likely historic treatment of the road surface and on unadopted roads, such as the unmade stretch of Eleanor Road, the original sandstone surface is often seen which adds to the character of the area.

*Eleanor Lane, where the original sandstone surface and bedrock is visible beneath modern loose surface and tarmac patching.*

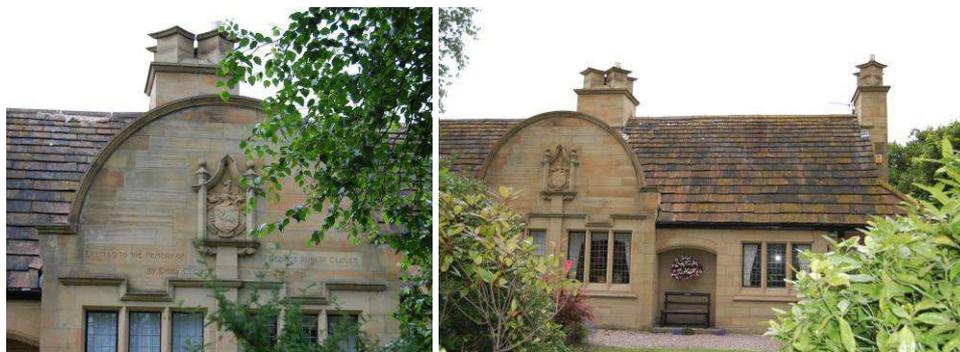
- 5.2.1 Clover Cottages on Bidston Village Road are Almshouses, dated 1901 designed by Liverpool based architects ‘Woolfall and Eccles’ in a free Elizabethan style with semi circular gable.

*Clover Cottages*

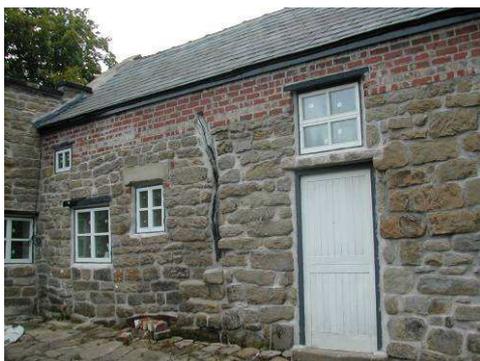
*Barn to Stone Farm; stone with cruck frame evidence. Brickwork possibly resulting from lowering the roof pitch following replacement of thatch by slate.*

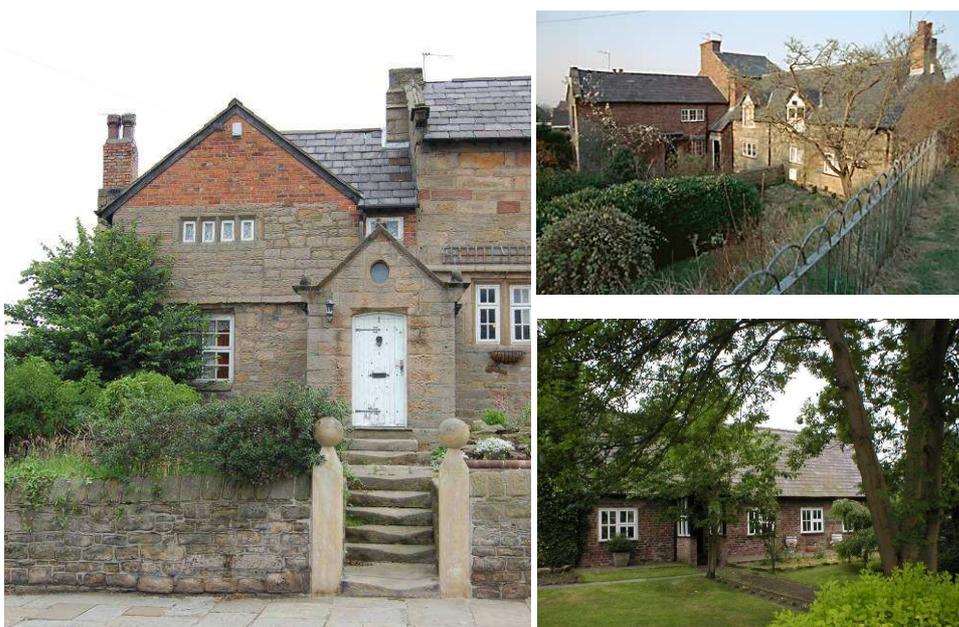
5.3.2 Red brickwork is a characteristic feature of the Wirral and Cheshire. Seen more commonly in slightly later buildings, as the use of brick increased throughout the 18<sup>th</sup> century and became common in the 19<sup>th</sup> century where access to building stone was limited. It is often used as a later alteration (for instance chimneys, later storeys, extensions) to a stone building, most notably in 2-4 School Lane.

*(left) Lilac Cottages, (right; upper) School Lane Cottages (right; lower) Ivy Farm*

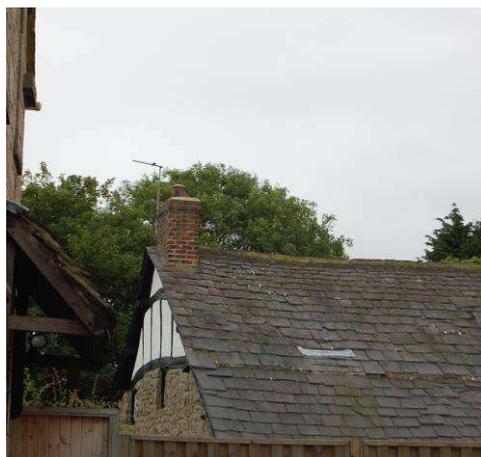
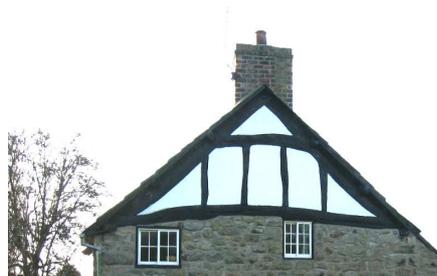
5.3.3 The listing descriptions of Yew Tree Farm house and stables and Church Farm identify cruck frame construction. The only external timber framing visible to the street is the gable of Yew Tree Farm. The infill between the timber frames would be wattle and daub.

*Gable to Yew Tree Farm*

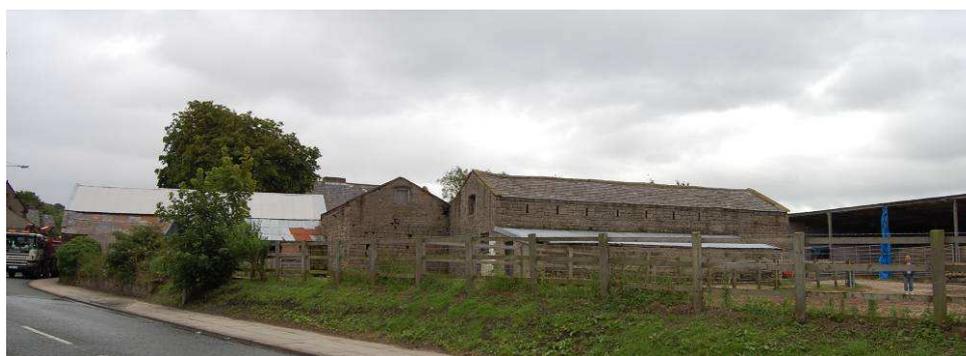
5.3.4 Corrugated iron was used in England from the 1820s, initially for industrial buildings. By the First World War corrugated iron was in general use for the repair of roofs on farm buildings, particularly thatch. From the 1940s asbestos cement cladding was used on the farmstead. Hit and miss vertical boarding has been used as a cladding since the 1970s.

*Barns to Church Farm*

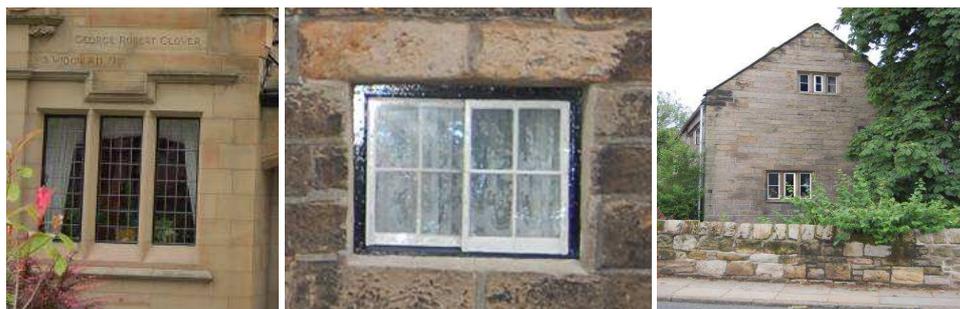
5.4.1 **Window** openings are typically small with stone lintels and sills, stone mullions, with hood moulds to the higher status houses (Church Farm, Bidston Hall). All traditional windows in the conservation area are timber and have either a white or black painted finish.

*Windows in the conservation area (1) leaded lights (2) sliding casement windows (3) stone mullioned, window casements*

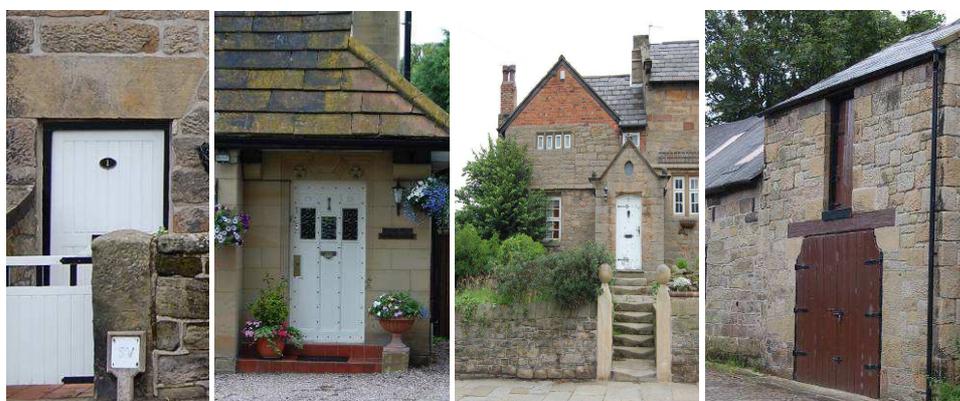
5.4.2 **Doors** within the conservation area are often simply constructed with timber vertical boarding as detailed for the doors to barns, stables etc.

*Doors in the conservation area (all); vertical boarding (2) including lights*

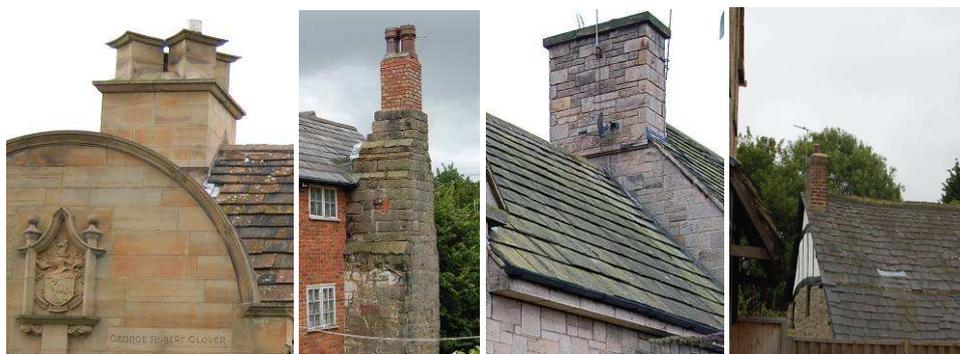
5.4.3 **Chimneys** within the conservation area are either stone or brick, typically rectangular in plan and plain with a simple coping. The chimneys stacks to clover Cottages are a prominent, decorative feature of the architectural design.

*Chimneys in the conservation area; (1) Clover Cottages (2) stone with sections rebuilt in brick seen extensively (3) simple copings to stone chimneys(4) plain brick stack.*

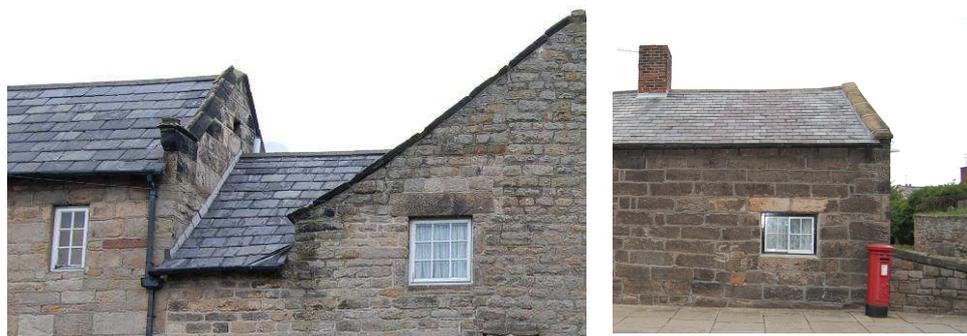
5.4.2 **Eaves, gables and verges** tend to be of traditional details. Most gables have stone parapets but range in character from the decorative mouldings and kneelers seen at Lilac Cottages, to simple stone coped details seen in the majority of buildings.

(1) Parapet detail to Lilac Cottage (2) simple stone coped gables seen extensively

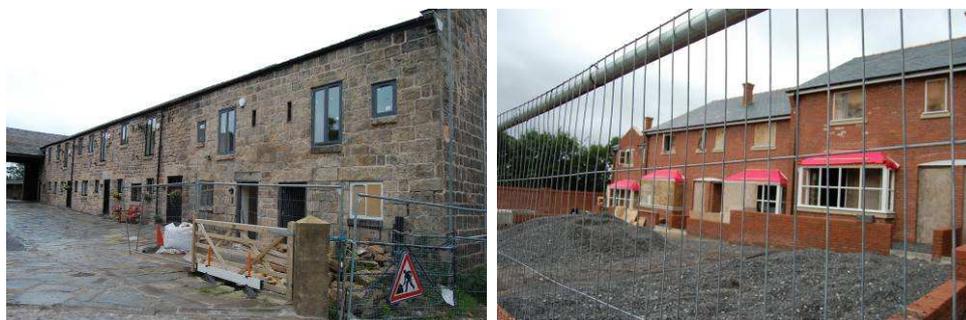
- 6.2.1 There are currently two fairly large projects under construction in the conservation area; a new build project of 5 terraced houses are being built in the centre of the village on Bidston Village Road and Bidston Hall Farm is currently being converted into 10 properties.

*(Left) Conversion underway to Bidston Hall Farm (Right) Construction in progress on Bidston Village Road*

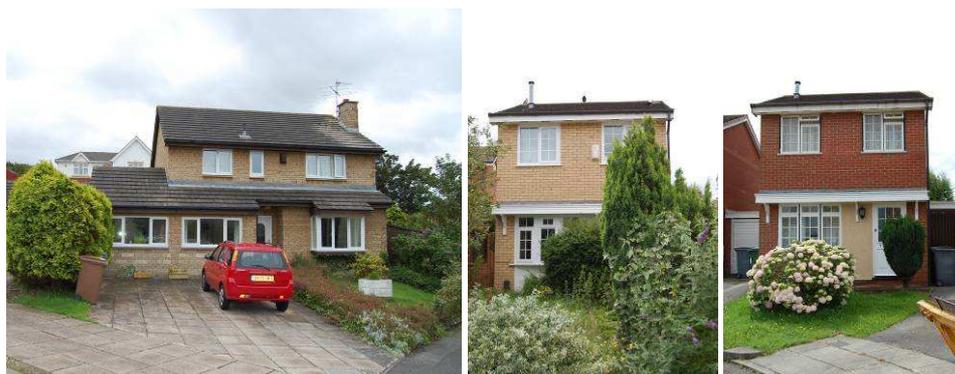
- 6.2.2 Housing developments to the south of Bidston Hall Farm are included in the conservation area. There are generally 3 house types; the houses to Statham Road, Lindwall Close and Ikin Close. All are under concrete tile roofs with a range of masonry wall finishes of stone effect textured facing, red brick and buff brick. The brick and stone effect blockwork are not of high quality and detract from the quality of the conservation area and the neighbouring Bidston Hall Farm. However the effect is slightly reduced by the general buff appearance of the facing material and the larger plot size of the houses on Statham Road with well presented gardens.

*(Left) House on Statham Road (Centre) Cowdrey Avenue (Right) Ikin Close*

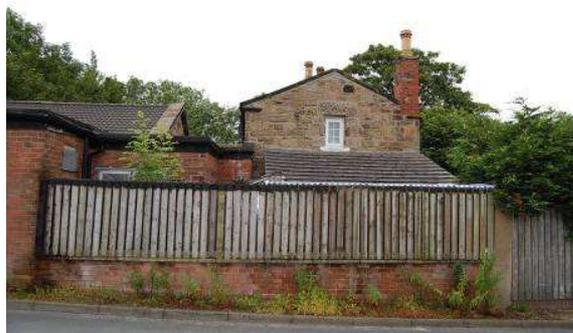
6.3.2 The large flat roofed extension and concrete tiled roof with boarded windows to Bidston Old School House are not sympathetic alterations to the original character of the building although the principal impact on the village is from Ballantyne Drive, outside the conservation area boundary..

*(Left) rear and side extension to Old School House*

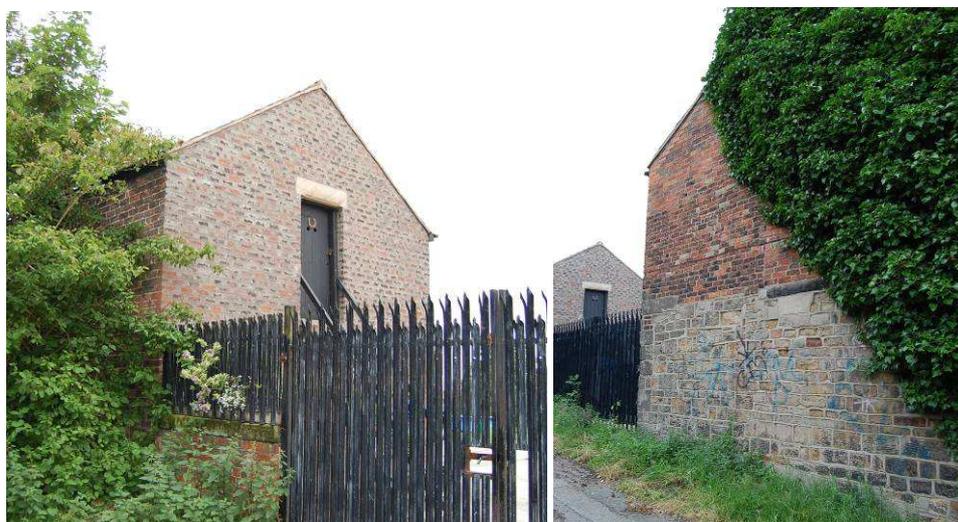
- Rendering of brick and stonework.
- Damage to historic building fabric as a result of changes to the traditional building materials. The use of hard pointing and impermeable coatings generally accelerated the rate of decay of the softer historic materials, most notably sandstone. In certain instances the effect of this phenomenon threatens not only the physical fabric but also the appearance of that part of the conservation area.
- The insertion of injected damp proof courses into stonework. This practice is generally ineffective and damaging to the appearance of the building.
- Loss of natural bedrock – excavated during alterations/extensions
- Fencing behind stone boundary walls as at 41 Bidston Village Road

*(left and right) poor quality pointing to stone and brickwork as well as highly detrimental palisade fencing at Ivy Farm.*

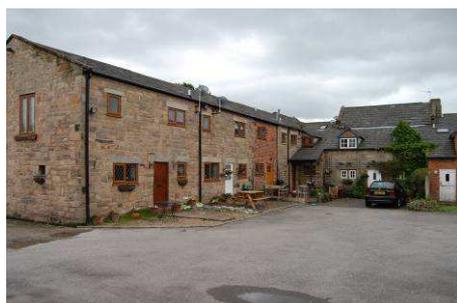
*(Left) Bidston Hall Farm - Former farmstead outbuildings converted to cottages, by extensive alteration. The original character of the outbuilding has been permanently affected.*
