BARNSTON VILLAGE CONSERVATION AREA APPRAISAL AND MANAGEMENT PLAN

PART 1 - CONSERVATION AREA APPRAISAL

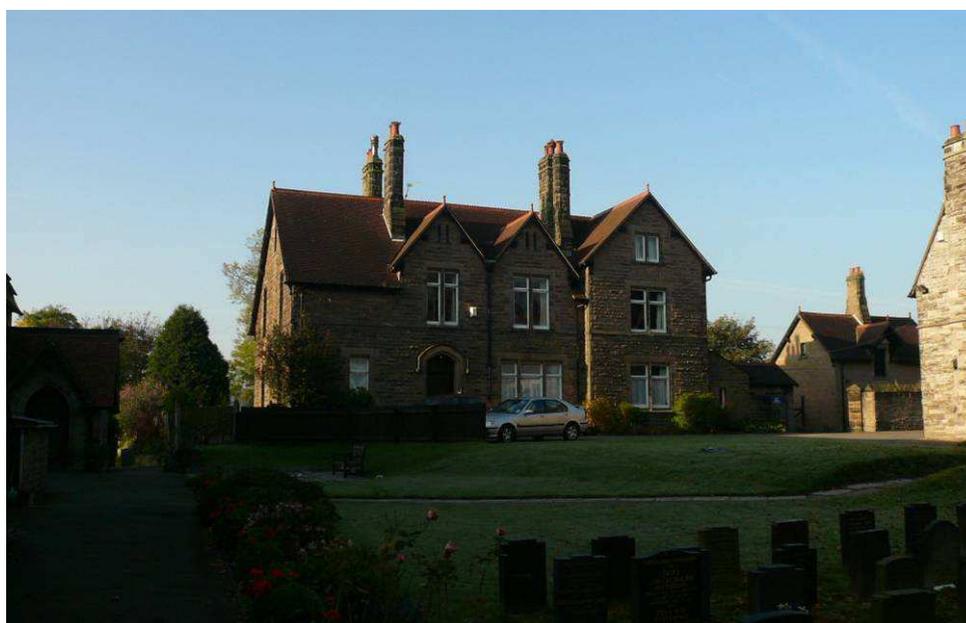
Small green in front of the vicarage

3.2.1 The character of Barnston is distinctly one of a small rural village that has gradually grown up over a number of centuries. Buildings are all located along or near Barnston Road, Storeton Lane or the small lane leading from between Beech Farm and Laburnum Cottage. Due to the linear nature of the village, few defined spaces are created. There is a small widening of the road at Beech Farm, which marks the site of the former village green. The church, vicarage and village hall (former school) are positioned relative to each other to create an attractive small green.

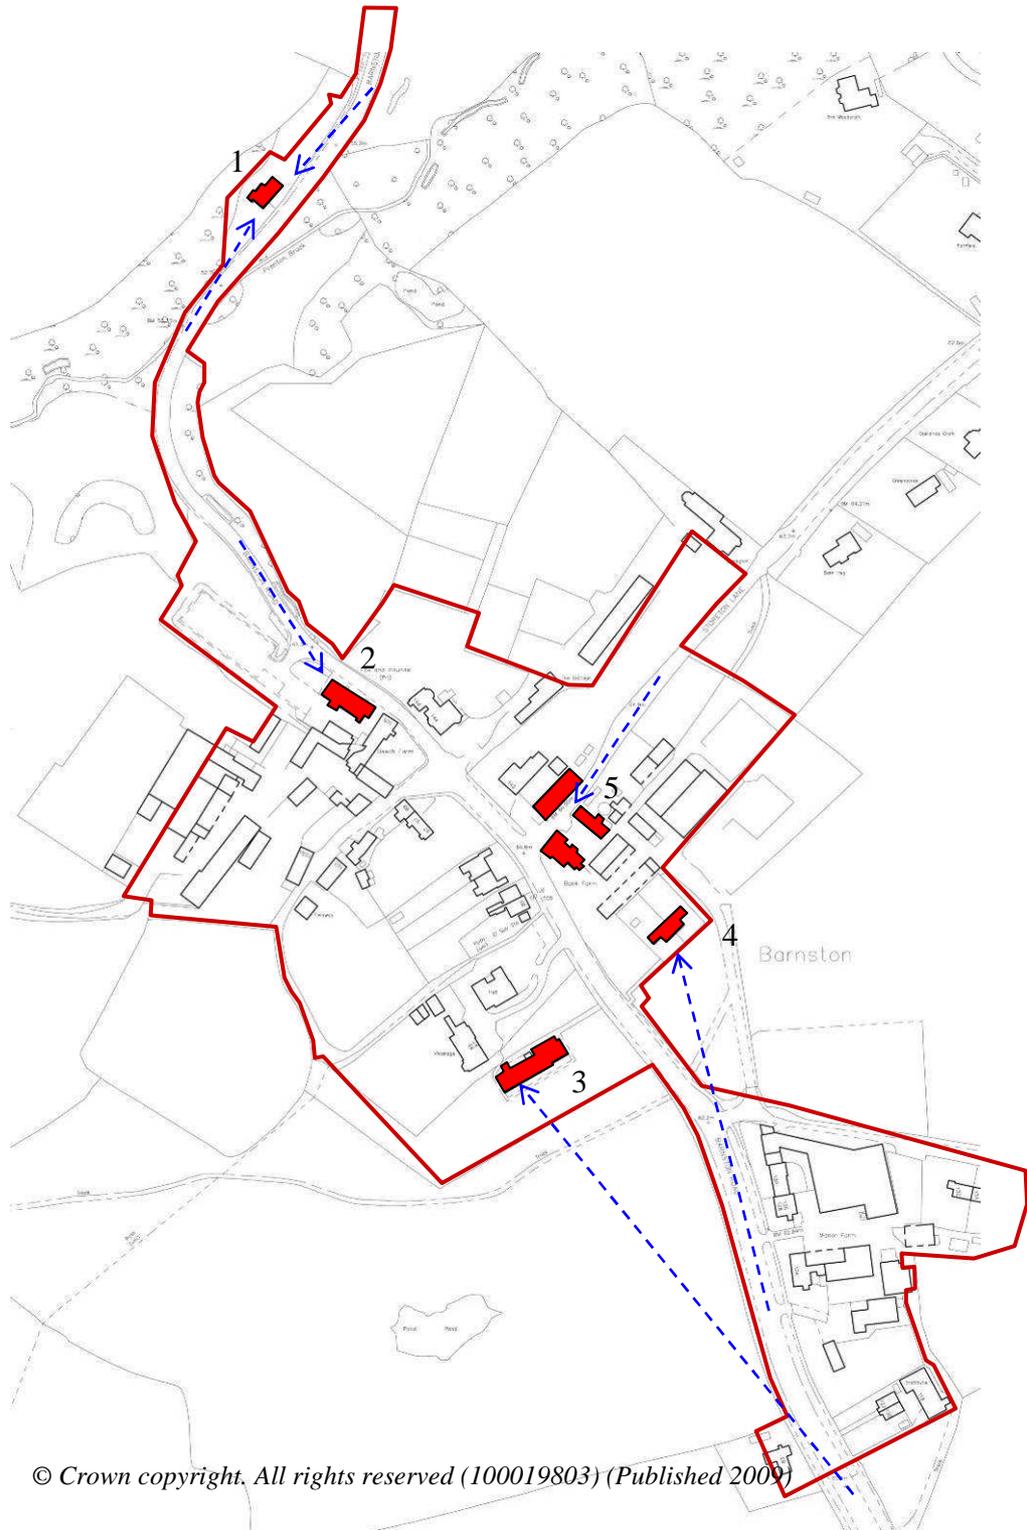
Map showing key views and vistas within the conservation area

3.3.1 There are relatively few important views within the conservation area, largely due to its linear form. In Barnston, important views tend to be at

points where there is a change in the topography of the land or direction of a road. The following is a list of such views as shown on the map above:

- (1) View from either direction along Barnston Road towards no. 109 / 111
- (2) View from Barnston Dale up towards the Fox and Hounds
- (3) Glimpse view towards the Church from entering the conservation area from the south-east along Barnston Road.
- (4) View towards 136 / 138 Barnston Road from entering the conservation area from the south-east.
- (5) View along Storeton Lane towards the junction with Barnston Road, featuring the converted barn and Bank Farm

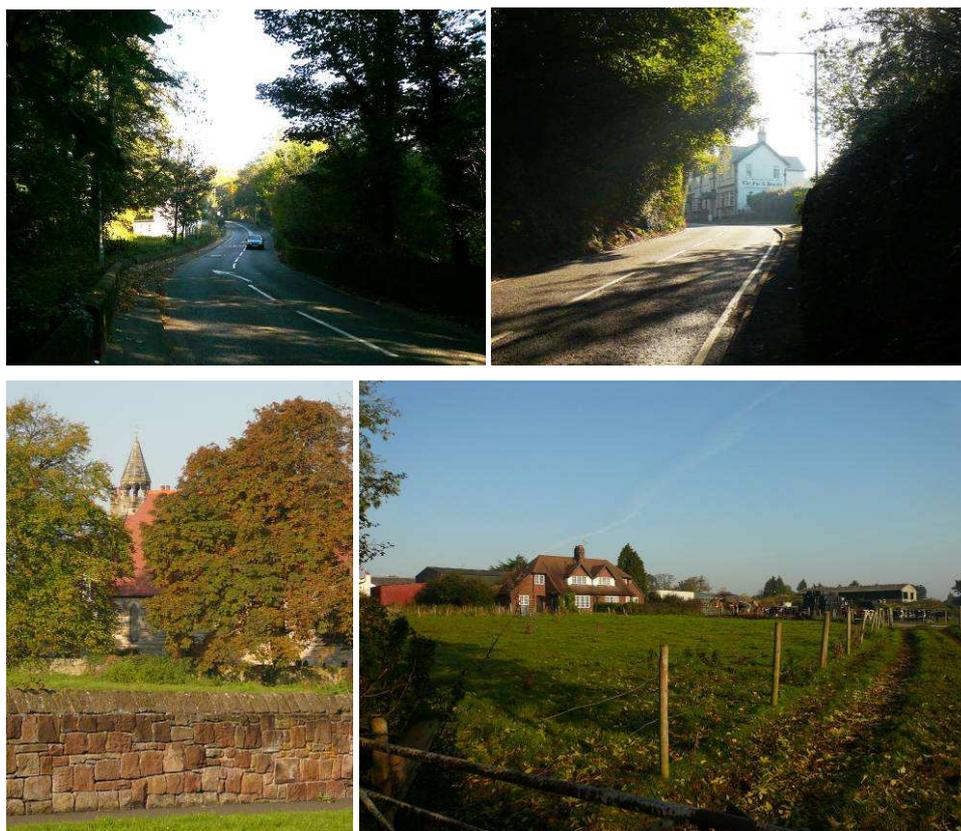
(Top left) View towards no. 109 / 111 Barnston Road; (top right) View from Barnston Dale up towards the Fox and Hounds; (bottom left) Glimpse view towards the Church from entering the conservation area from the south-east along Barnston Road; (bottom right) View towards 136 / 138 Barnston Road on entering the conservation area from the south-east

3.3.2 Numbers 109 / 111 and 136 / 138 Barnston Road, together with the Fox and Hounds public house are important as buildings acting as visual gateways to the village.

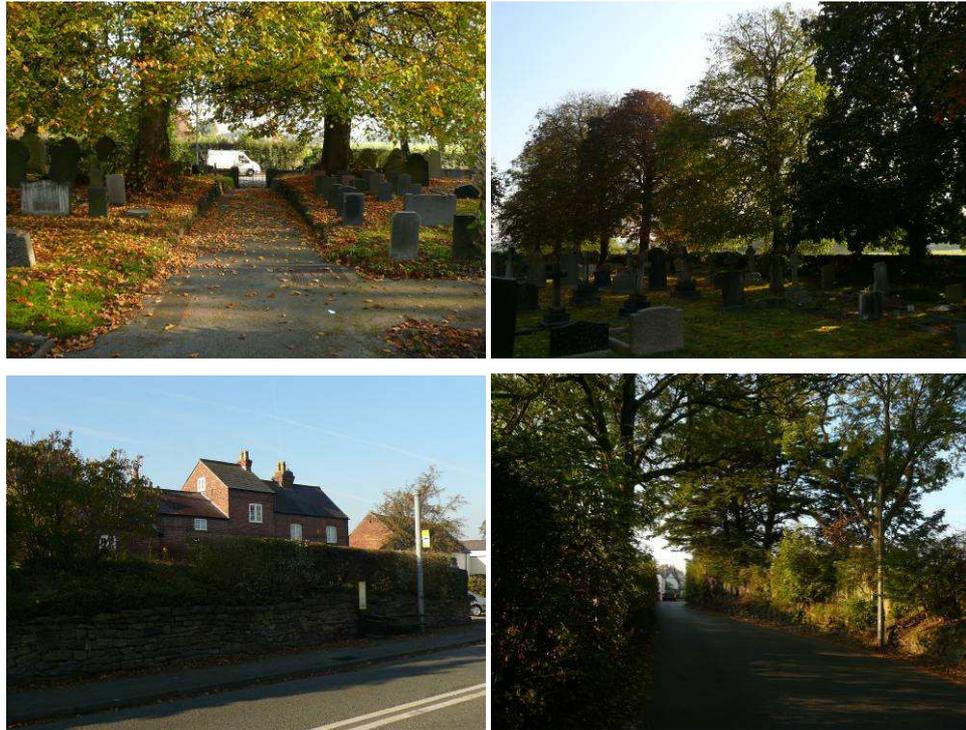
(Top left and right) trees within the church yard; (bottom left) an attractive hedge along the front boundary to a dwelling; (bottom right) trees and hedges / shrubs along Storeton Lane.

- 3.4.4 **The Churchyard and surroundings** have their own distinct landscape character. The approach to the church from Barnston Road is via a pathway lined with mature trees. The trees, of a variety of species, continue around the churchyard, visually enclosing the space. The rear of the vicarage also appears to be attractively planted with trees and shrubs, but to its front there is a large area of lawn, which allows for a largely uninterrupted visual connection between the church and the church hall (former school).

- 3.4.5 **Domestic planting and landscaping** is seen around most houses. Although not of a particularly agricultural character, many of the gardens are attractive and appropriate within a rural setting. Gardens that contribute to the character of the conservation area are typically not particularly formal, with large shrubs or trees ‘softening’ the handmade lines of buildings and hard landscaping. Native species of planting such as holly, yew and hawthorn are regularly seen and are visually appropriate, even when used in ‘well-manicured’ shapes and forms. The use of native species also helps promote wildlife, even within domesticated areas of land. There are a number of good examples of hedging along front boundaries to Barnston Road.

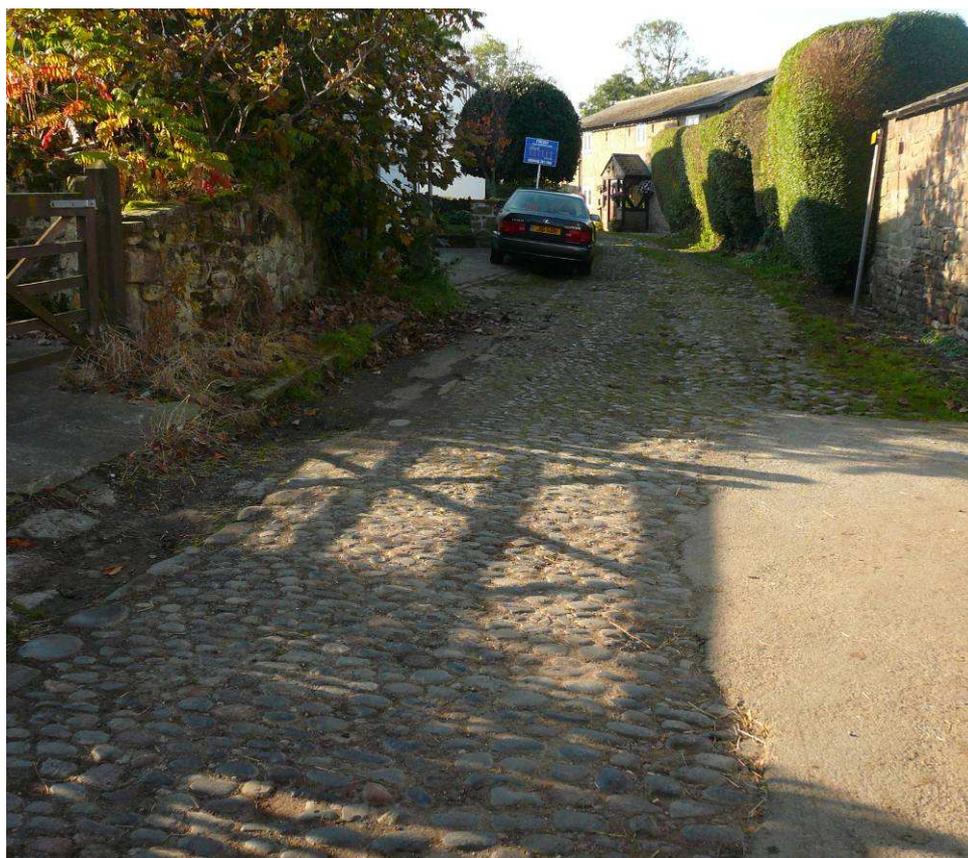
Cobbled surface to the lane leading south-westwards from Beech Farm

4.3.2 Leading off the public adopted roads, are a few areas where historic surfaces are visible. There is a cobbled surface with rough stone channel to the lane leading south-westwards from Beech Farm. The small path to the north of the village hall has a surface made up with textured engineering pavements.

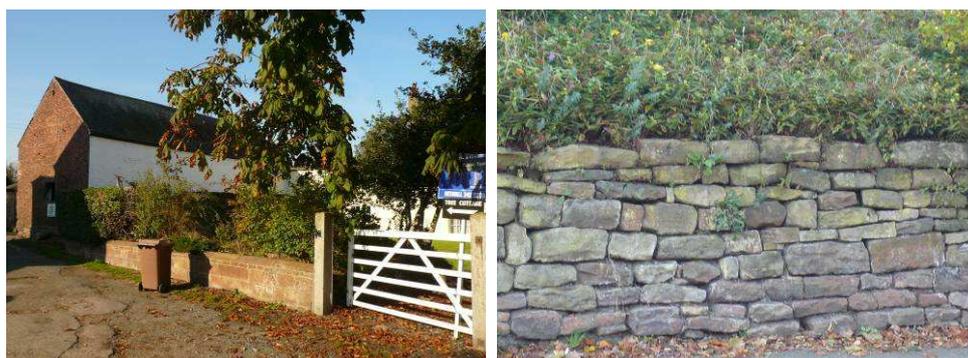
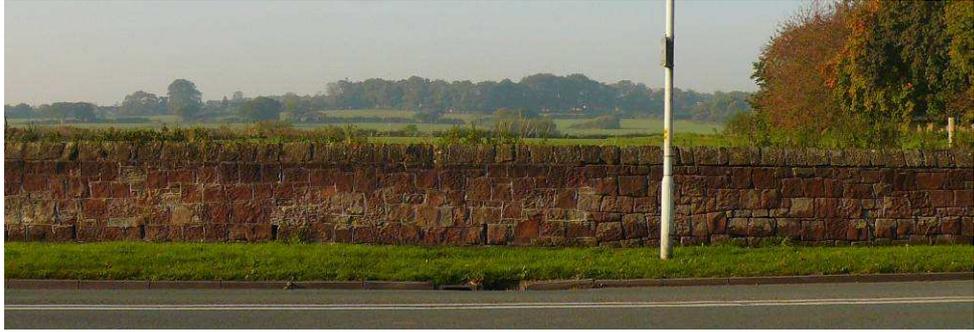
Stone boundary walls in the conservation area.

4.3.3 Boundary walls within the conservation area are a key part of its visual character. Most walls are constructed of local red sandstone. These walls are used around both agricultural and domestic properties. These vary slightly in construction and design, but are all of coursed rubble, with very little dressing or squaring-off of stones. In some instances walls have capping stones of a simple shape, in others they larger heavier stones capping the wall. Some walls appear to be of a dry-stone construction, apparently without mortar.

4.3.2 In some instances, walls perform a retaining function, such as when Barnston Road winds down into Barnston Dale. Buildings can also form a boundary to the road as on the Storeton Lane defile towards its junction with Barnston Road.

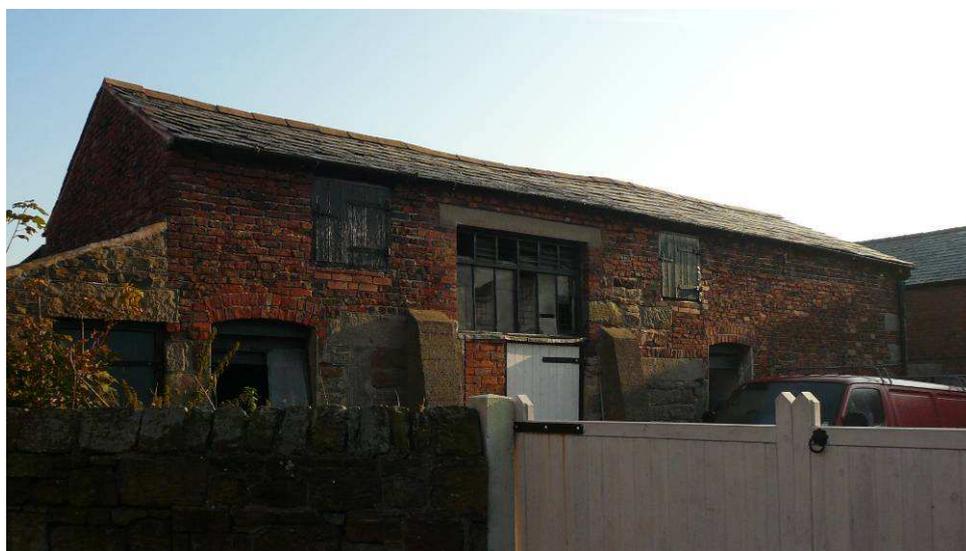
Agricultural building in the conservation area

- Agricultural buildings – constructed from locally sourced materials of brick and stone with slate roofs and often extended or altered in an ‘ad-hoc’ manner. Forms are simple and rectilinear and the buildings have relatively low pitched roofs. Openings are generally small and the buildings have a ‘robust’ character.

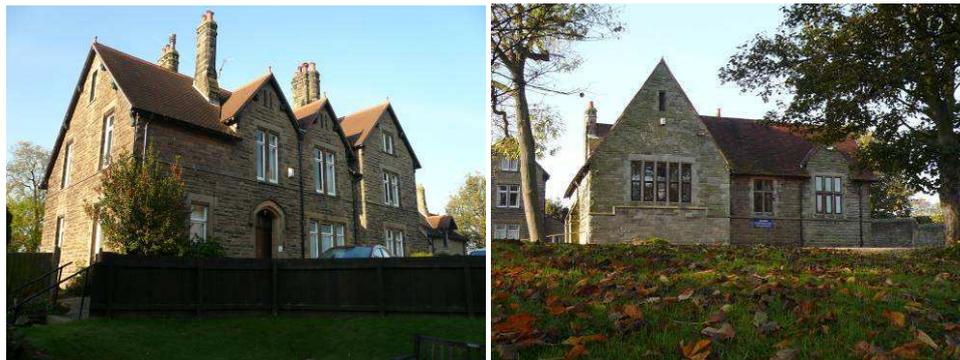
Buildings of a Vernacular Revival / Gothic influence in the conservation area

- Vernacular Revival / Gothic – Buildings with details derived from other traditional building types. Influences include Gothic, Jacobean, Elizabethan and Medieval building periods. In contrast to the traditional agricultural buildings, roofs are more steeply pitched and elevations are relatively detailed. Plan forms are generally more complex. Gables are used regularly as features in the design of buildings, and like openings, are shaped to reflect the style of the building. Chimneys are typically more prominent on buildings of these styles. Buildings in this category include the church, vicarage and village hall.

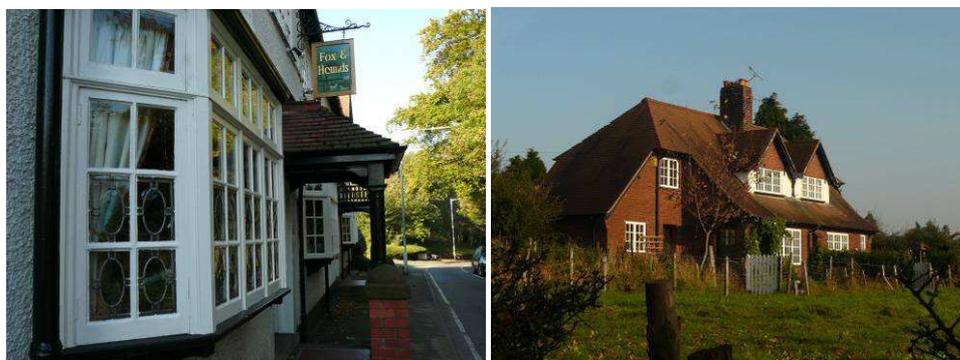
Buildings within the conservation area with details / form originating in the Arts and Crafts style.

- Arts and Crafts – buildings with particular attention to detail and using elements of traditional craftsmanship in their decoration. The Fox and Hounds Public House has decorative leading to its window panes, some decorative timberwork and oriel windows. All these features are reminiscent of Arts and Crafts buildings, although it is simpler in its level of decoration. Similarly, no. 136 / 138 Barnston Road, is an attractive semi-detached building, drawing its form from Arts and Crafts houses built a couple of decades earlier. However, its level of decoration is noticeably simpler. The design and good maintenance of the building possibly indicates that it may be, or may have been an estate cottage.

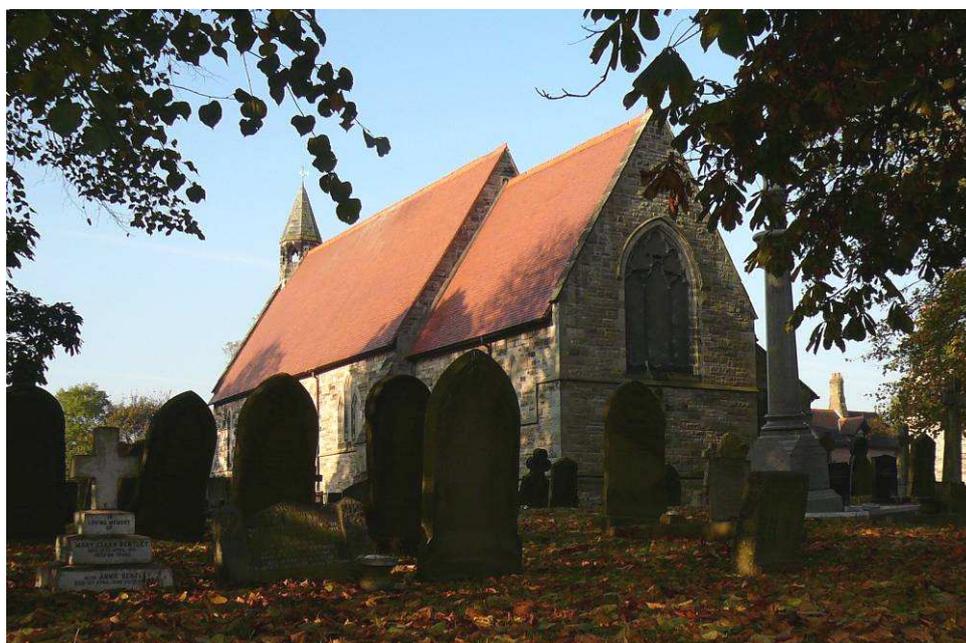
Christ Church, designed by prominent London based architect G.E. Street

5.2.2 The prominent 19th century architect George Edmund Street (1824-1881) designed Christ Church and the village hall (former school). He was based in London and his most important work was the Royal Courts of Justice, built between 1868 and 1881. He was a prolific designer of churches and designed a number within the north-west including: St John, Cotebrook,

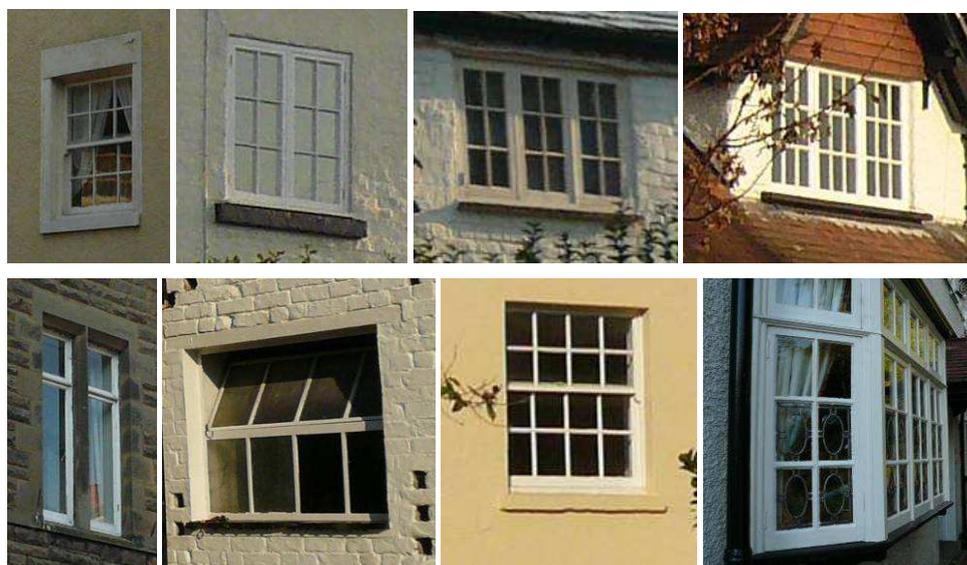
Windows in the conservation area

- Painted timber vertically sliding, multi-paned sashes – seen on the higher status houses. A few of these are arch-headed.
- Painted timber, multi-paned casements – on most low key houses and many agricultural buildings. These are likely to have been horizontal sliding sashes originally.
- Metal multi-paned windows on agricultural buildings with inward-opening upper panes.
- Decorative windows, often with leaded lights.

5.4.2 Windows within the conservation area are generally relatively small, positioned as single windows and have little or no decoration to their surrounds.

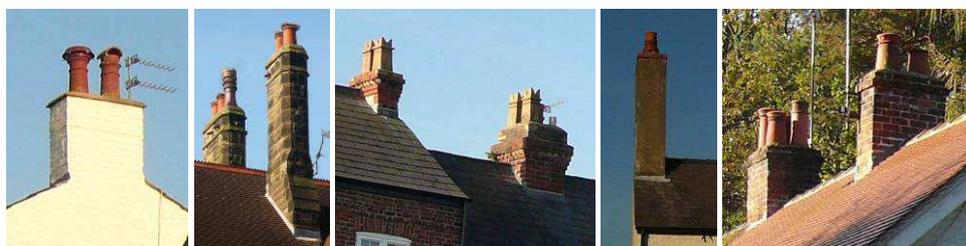
Chimneys within the conservation area.

- 5.4.5 **Chimneys** play a part in the visual composition of most buildings, although they are typically of a simple rectilinear design, with little in the way of projections. Only a few buildings have tall, visually dominant chimneys; these buildings tend to be of a higher status. Terracotta or buff clay pots of varied design are generally seen on top of most stacks.

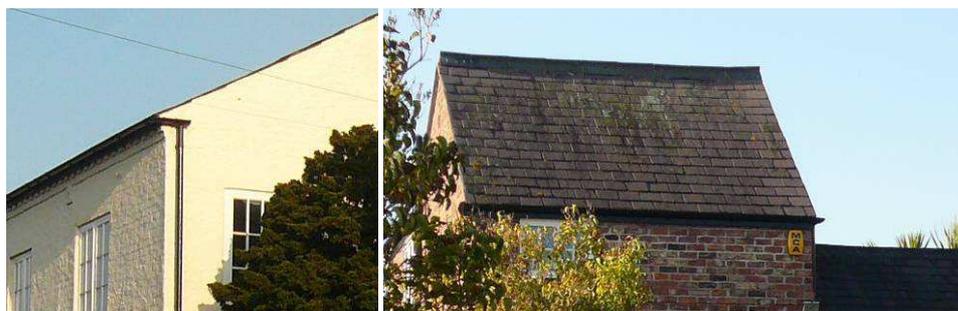
Roof details in the conservation area

- 5.4.6 **Roof details** to almost all buildings within the conservation area are, or once would have been, very simple. There are few barge board or parapets on gables. Eaves have little in the way of an overhang and any detail is provided by 1 or 2 courses of projecting / dentilled brickwork. Ridges are generally unadorned.

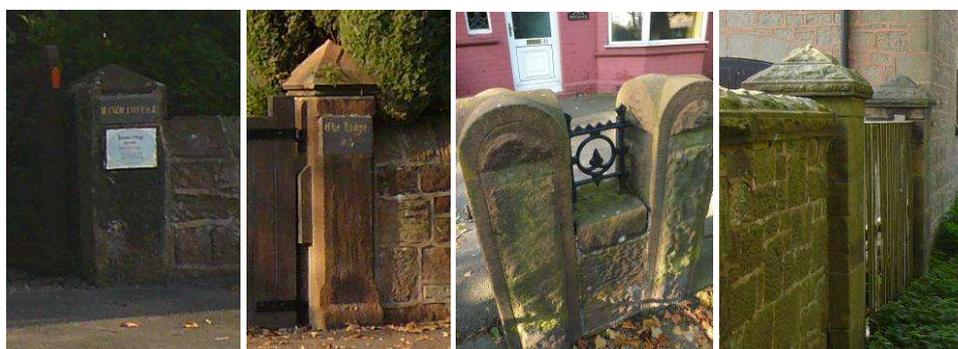
Stone gate posts with the conservation area

- 5.4.7 **Gateposts** are either of a simple timber construction (to farm buildings) or of a large, simple / unornamented sandstone shape. Both are of an agricultural character.

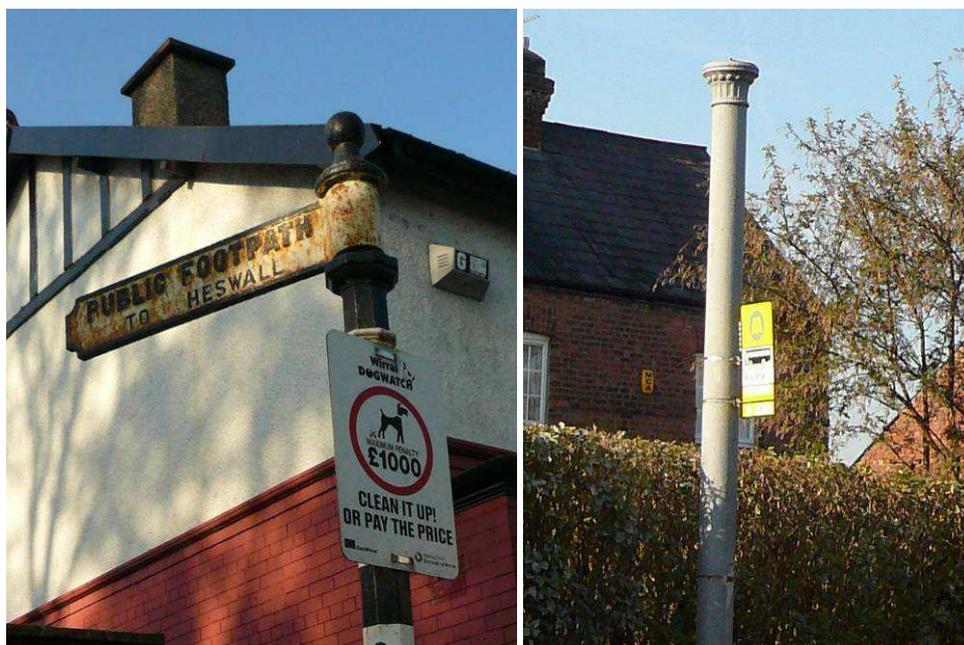
Cast iron sign and post.

5.4.8 **Public realm features** within the village are relatively simple and often of a traditional form. There are a few examples of historic public realm features such as signs, posts and gates constructed of, or at least made to appear to be of either cast or wrought iron. Whilst generally more modern, simple timber signs and posts are appropriate within the conservation area and can enhance its appearance

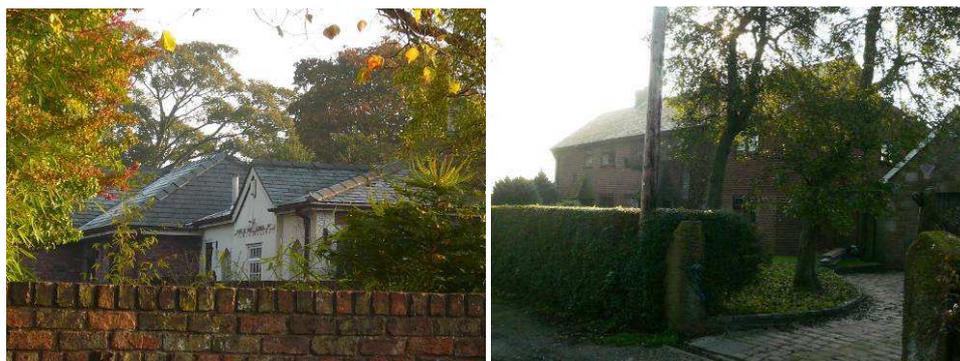
Modern buildings within the conservation area

6.2.1 There have been very few buildings built since the middle of the 20th century. A relatively small number of barns have been constructed next to older farmsteads. The few modern houses (132/134 Barnston Road and a new building forming part of ‘The Cottage’ on the eastern side of the road) are set well back from the road and of inauspicious materials and forms. In such low numbers these modern buildings have a neutral affect on the historic character of the conservation area.

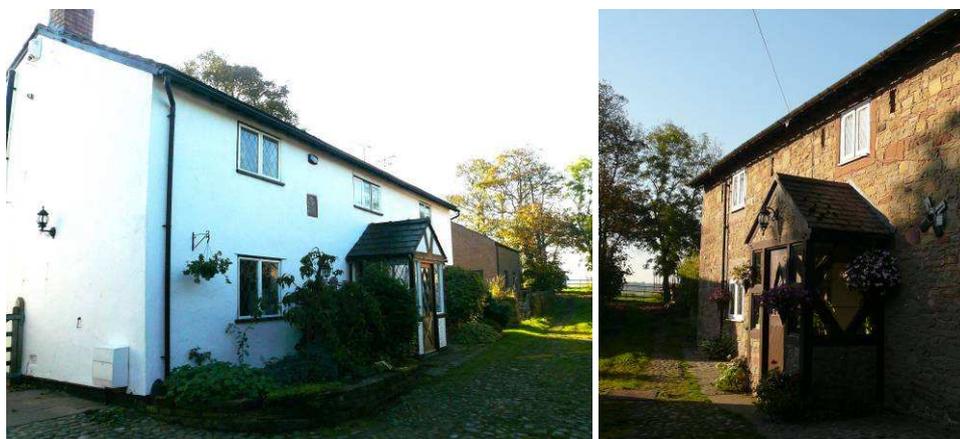
Extensions within the conservation area. The left hand photo shows a cottage that has been extended in recent years by about 50%. The modern render over both the older and modern parts confuses the original form. The right hand photo illustrates how an attractive porch added to the front of a building (together with other changes) can have an adverse effect on its original agricultural character.

- 6.3.1 There are relatively few recent extensions within the conservation area of a significant size. The most unsympathetic of extensions are those that confuse the original form of the building and lessen the overall perception of quality. Good extensions either use the materials and detailing of the original building or are of a modern design and construction that is of a high quality but adequately contrasting to the original. In conversion a number of former agricultural buildings, forms associated with domestic buildings, such as porches, have been attached to the original structure.

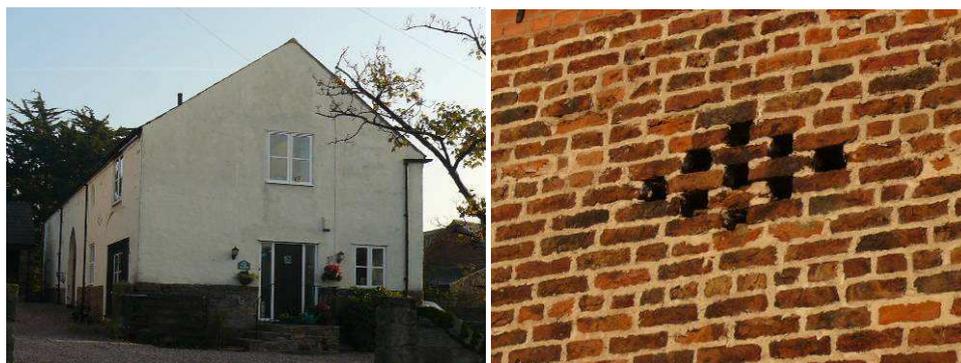
To the south-west and north-west elevations of Barn House, most of the building's agricultural character was apparently lost during conversion. The domestic nature of the windows and doors together with the render finish to the walls disguise its original appearance. To the south-east the barn's largely blank brick / stone elevation retains the legibility of the original form, although the building's appearance is marred by obtrusive modern pointing.

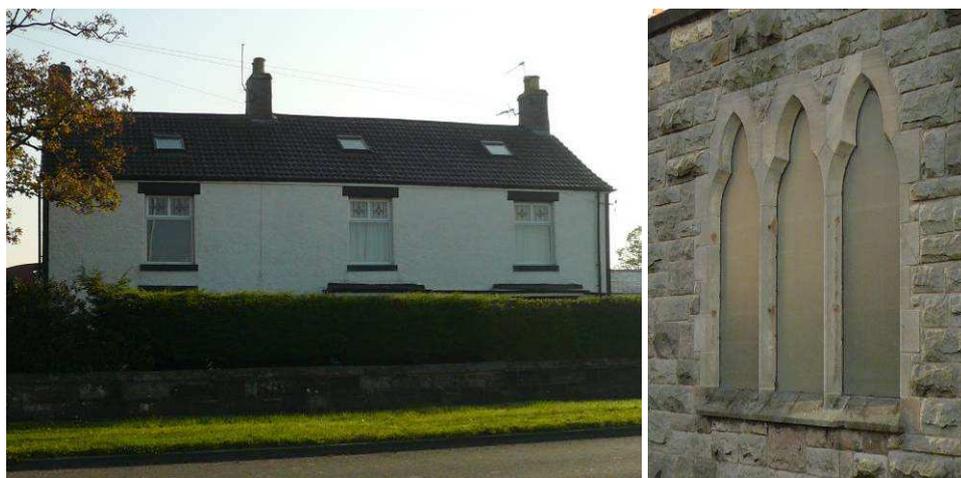
(left) Changes to the windows and roof covering adversely affect the building's character and its contribution to the conservation area. (right) Although probably necessary to prevent damage by vandals, the application of perspex over the leaded lights of Christ Church's windows makes it impossible to appreciate their intricacy from the outside.

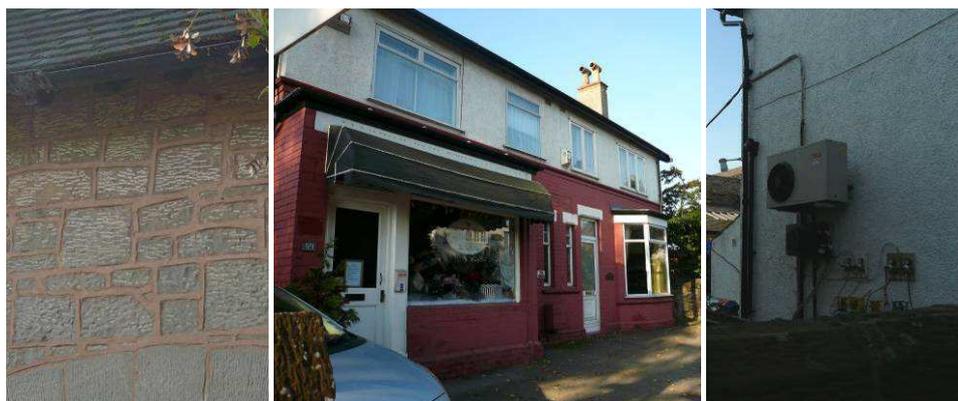
Management issues with the conservation area: (left) obtrusive modern pointing over the face of stonework. Artificial colorants are also used giving it an unnatural colour; (middle) Painted brickwork and inappropriate modern windows; (right) An air conditioning unit mounted in an obtrusive position on the Fox and Hounds.

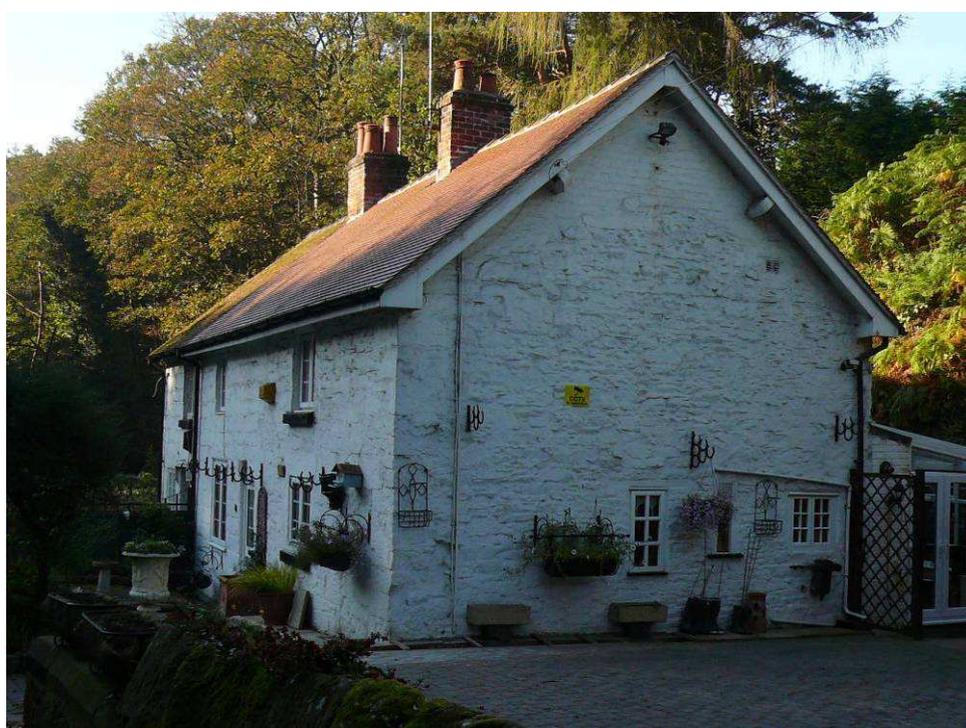
A particularly historic house that has unfortunately had a number of modern alteration carried out, including the installation of UPVC windows and boxed soffits. These changes particularly jar with the original character of the building.

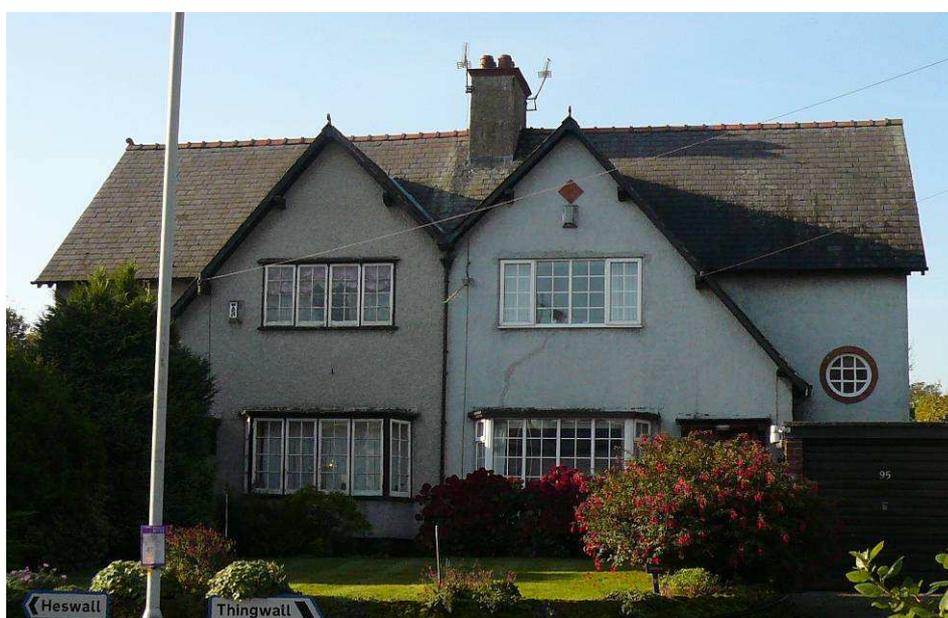
Replacement windows within the conservation area: this photo illustrates that even though UPVC windows can be manufactured to approximately the same form as an original casement, they are of a lesser quality visually. In this instance the opening lights require much larger frames than the fixed ones and the intermediate mullions (painted black on the originals) are lost. The glazing beads are within the double glazed unit, instead of forming an integral part of the casement. This is immediately apparent and this adversely affects the visual character of the window.

6.4.2 The foremost alteration to historic fabric within the conservation area is the replacement of original doors and windows. These alterations are often well intentioned – to improve the thermal or acoustic performance or to reduce maintenance requirements for instance. However, the visual effect of the replacement windows, particularly on the architecturally simple buildings, is immense. The original sash windows would have had very slim profiles, giving an elegant appearance. In contrast, a UPVC or aluminium replacement, particularly when holding a thick double glazed unit, has

considerably thicker framing elements, which are more obtrusive visually and will let much less light into the building.

- 6.4.3 The reconfiguration of opening panes (particularly when replacing sashes with top-hung casements) dramatically changes the architectural character of the building. Where windows are replaced in timber, these can also adversely affect the appearance of the building where the original detailing is not followed and often the quality of the timber is far substandard to the original, giving it a short lifespan. Secondary glazing can be used and will always produce a more satisfactory visual result than a double glazed equivalent. The use of UPVC windows is fairly prevalent amongst the unlisted buildings.
