FLAYBRICK MEMORIAL GARDENS
CONSERVATION MANAGEMENT PLAN
VOLUME FOUR: APPENDICES
DECEMBER 2018

FLAYBRICK MEMORIAL GARDENS: CONSERVATION MANAGEMENT PLAN: VOLUME FOUR: APPENDICES

APPENDIX C: TREE SURVEY

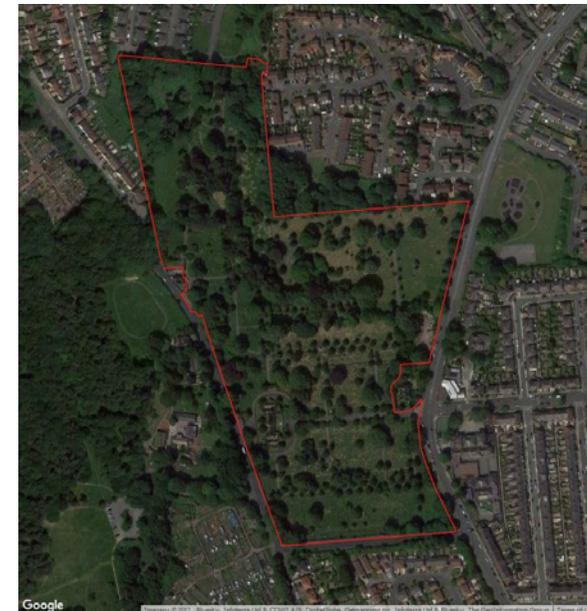
Fig 1: Aerial photograph and site boundary

The site centre OS grid reference is SJ 2931 8953. The site boundary is illustrated in Figure 1 below.

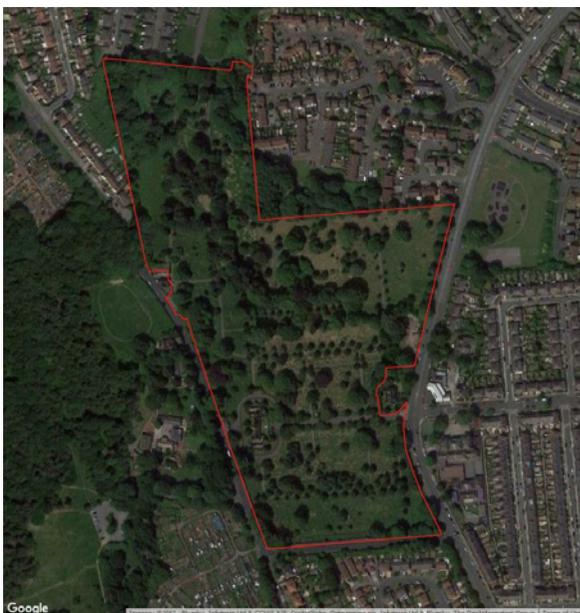
Fig 1: Aerial photograph and site boundary

Flaybrick Cemetery is located approximately 3.2km west-north-west of Birkenhead town centre, and 0.4km north-west of Birkenhead Park. The cemetery is located off Tollemache Road, which forms the eastern boundary of the site. Boundary Road forms the cemetery's western boundary and Upper Flaybrick Road bounds the cemetery to the south. The site centre OS grid reference is SJ 2931 8953. The site boundary is illustrated in Figure 1 below.

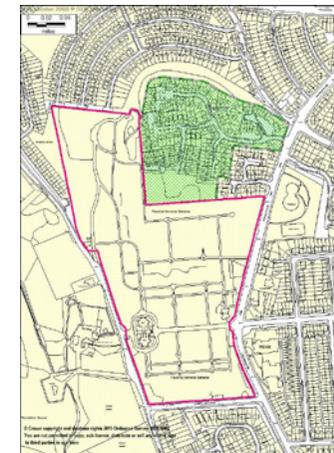
The Wirral Borough Council's online planning map⁴ shows that there is a group Tree Preservation Order (TPO) (WR0097A001) located beyond the northern boundary of the site, within the grounds of the former St James' Hospital, Tollemarche Road. The precise extent of the TPO has been confirmed by Wirral Borough Council (2 February 2017, pers. comm.), and is illustrated in green below:
