# Wirral Borough Council:

## Section 19 Flood Investigation: 22<sup>nd</sup> August and 2<sup>nd</sup> September 2015

May 2016

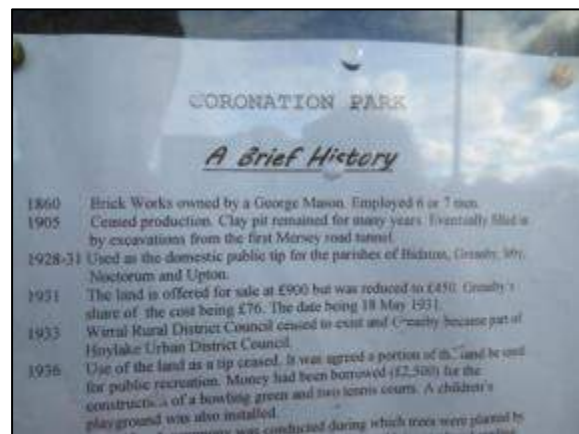
The grassed areas of the park were waterlogged (Photograph 5-4), with multiple instances of standing water observed. The park itself covers an area of approximately 8 hectares. A notice in the park’s information board suggests that the park was previously a clay excavation pit which was later capped with excavation material from the Mersey tunnel (Photograph 5-5).

Significant clay deposits and low permeability soils may prevent the infiltration of surface water into the ground and result in the generation of overland flow which residents indicated has happened historically (including on both the 22<sup>nd</sup> August and the 2<sup>nd</sup> September 2015). A drainage ditch is present on the park’s western boundary (adjacent to the allotments) and was observed to be conveying a small volume of water at the time of the visits. This feature may afford a low level of protection to the playing fields and the adjacent residential properties.

**Photograph 5-5 A Brief History of Coronation Park (1/3/16)**

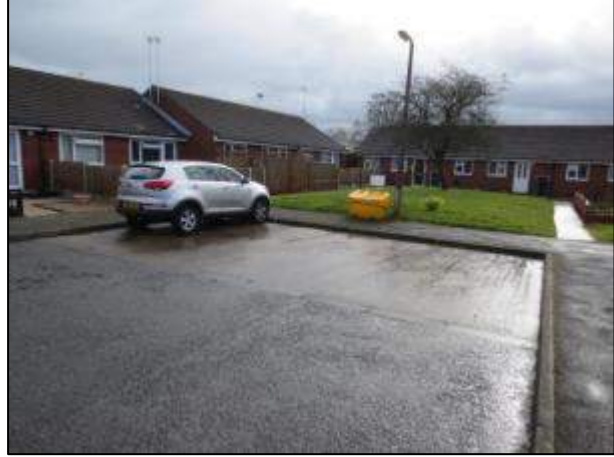
Dialogue with stakeholders and local residents at Brookdale Close indicated that water from Coronation Park is routed overland in a northerly direction following heavy rainfall. This subsequently pools against the fences at the back of Brookdale Close and then seeps beneath the garden fencing to the rear of the properties (Photograph 5-6). The properties are also at the bottom of a topographic gradient at this location.

Photograph 5-7 Brookdale Close (1/3/16)

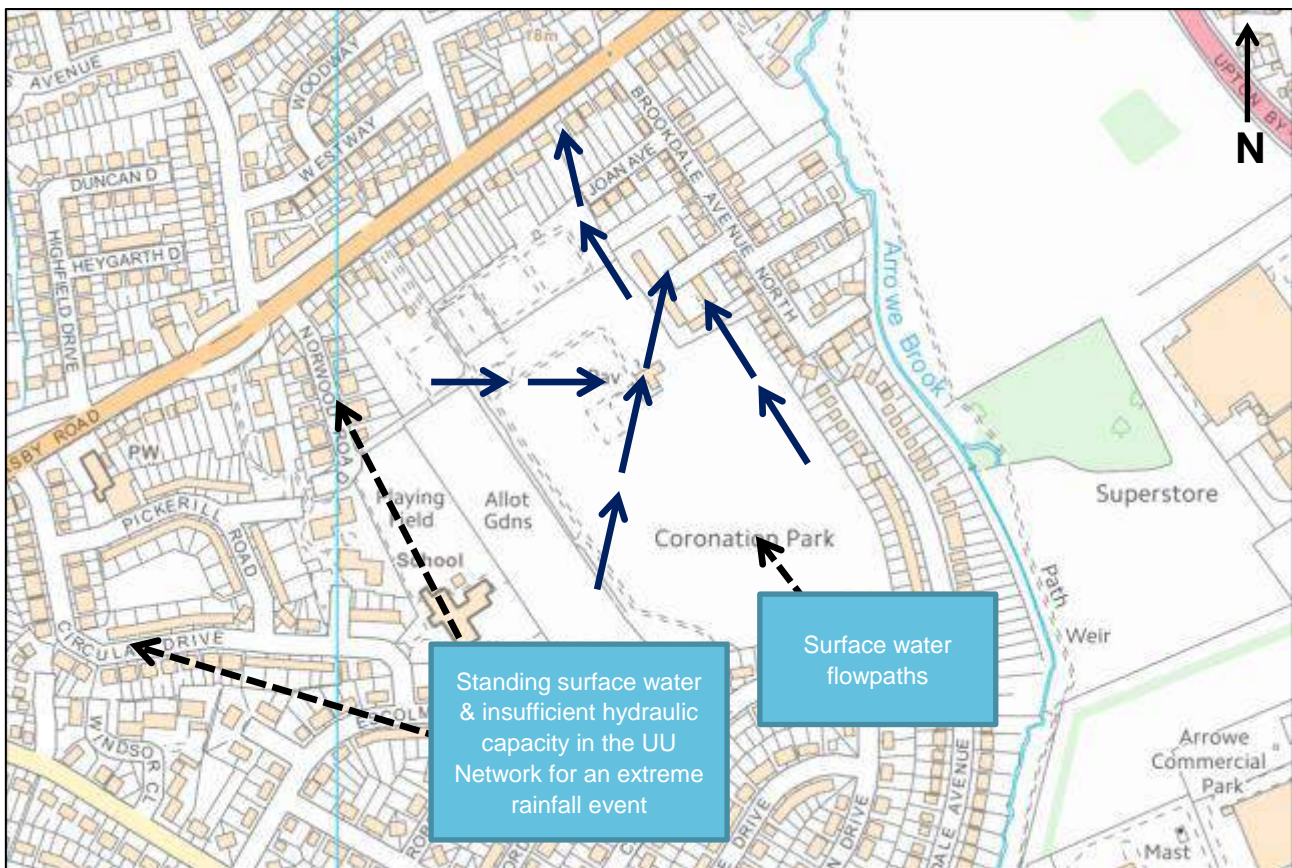
- The hydraulic capacity of the UU drainage network beneath Norwood Road and Circular Drive being exceeded due to the significant intensity of rainfall (with an estimated return period of 84 years for the 48 hour storm). UU's sewerage systems are not designed to accommodate flows from severe weather events (i.e. those greater than a 1 in 20 year rainfall event) (as detailed in Section 2.3.3).

**Figure 5-3 East Greasby Flooding Mechanisms**

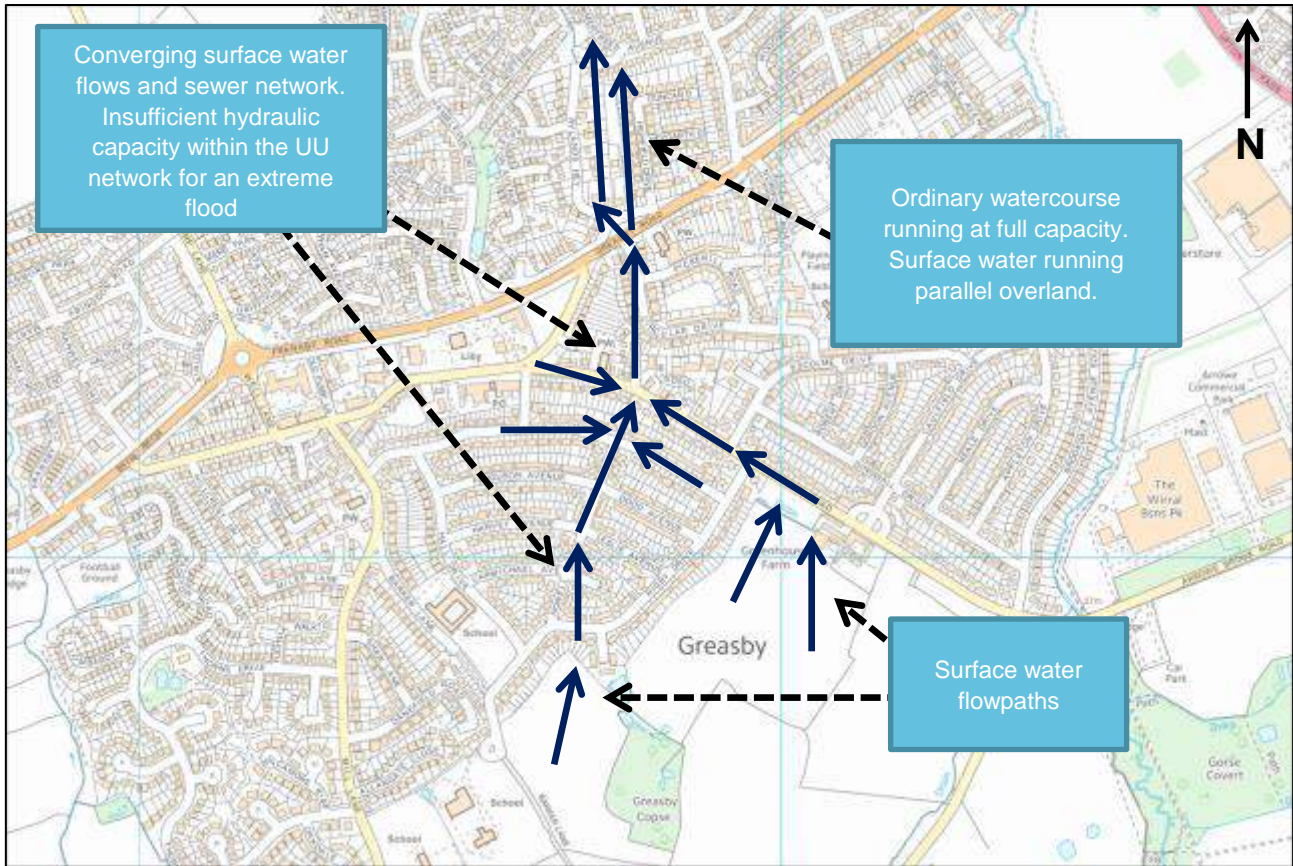
- Surface water flows were routed down Tudor Grange onto Circular Drive and subsequently onto Rylands Hey. This was compounded by UU sewers running at capacity due to the severe weather (being greater than a 1 in 20 year return period) and resulted in overland flow running through the gardens and properties on Rylands Hey.

**Figure 5-5 Central Greasby Flooding Mechanisms**

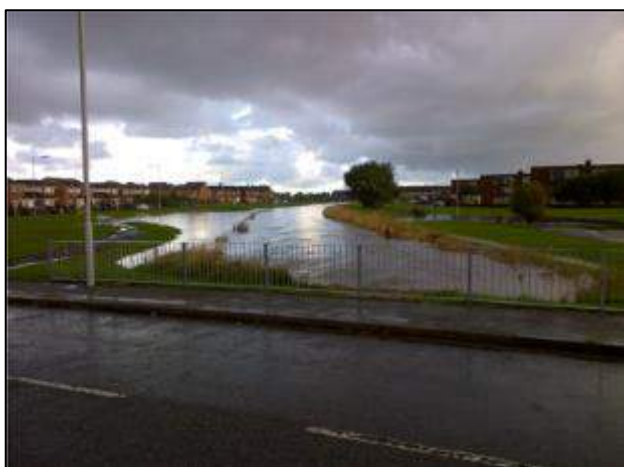
Photograph 5-16 Arrowe Brook Looking to Tern Way (2/9/15)

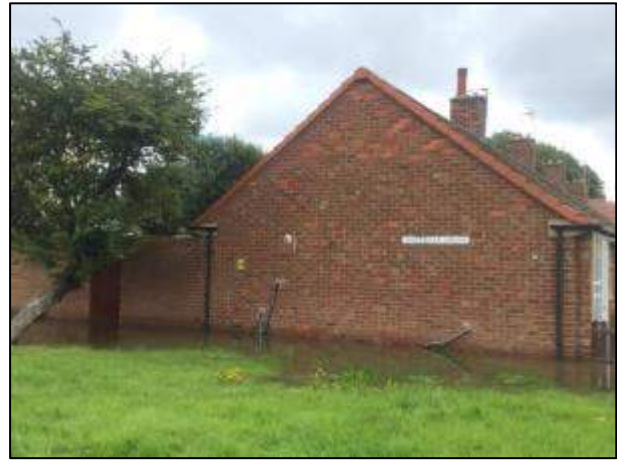
**Photograph 5-19 Wastdale Drive (2/9/15)**

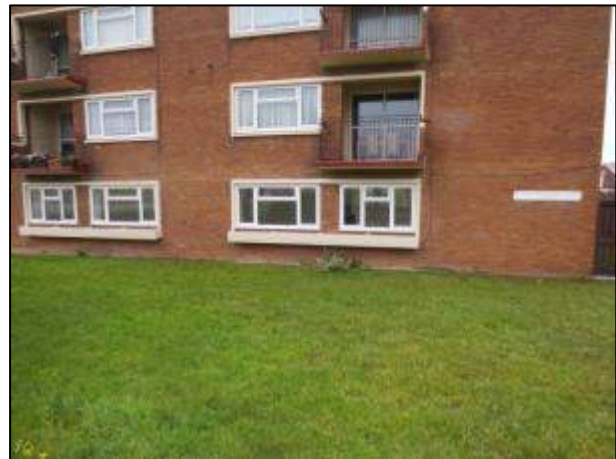
**Photograph 5-24 Vacant & Refurbished Flats at Moreton (2/3/16)**

A significant number of the ground-floor flats on Tern Way were observed as being vacant or having being recently refurbished. It was not evident from the site walkover if this refurbishment process also included retrofitting flood resilience measures. Given the significant number of vacant properties there was a limited opportunity to engage in dialogue with local residents about the flooding. However, the survey team were able to attend a previously arranged visit with a resident to discuss the flooding that occurred, RMA response and to provide bespoke advice on property resilience measures.

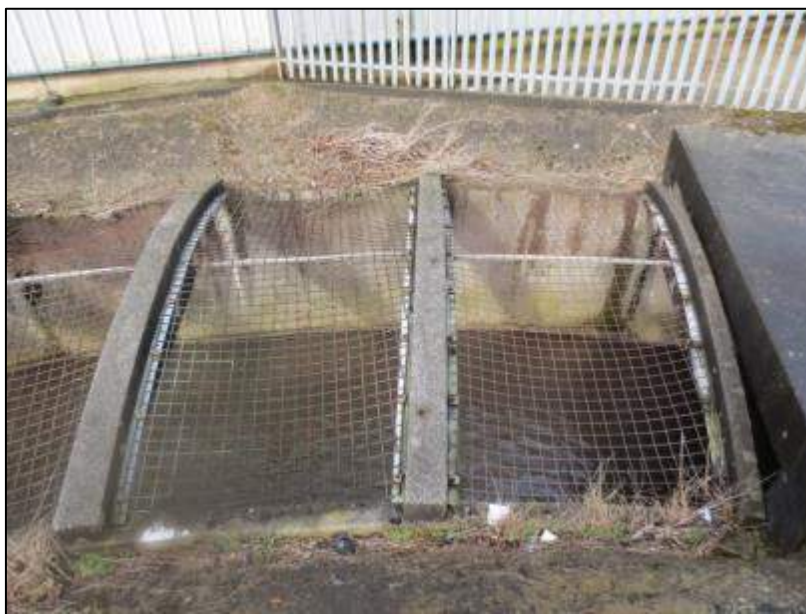
**Photograph 5-32 The Prenton Brook**

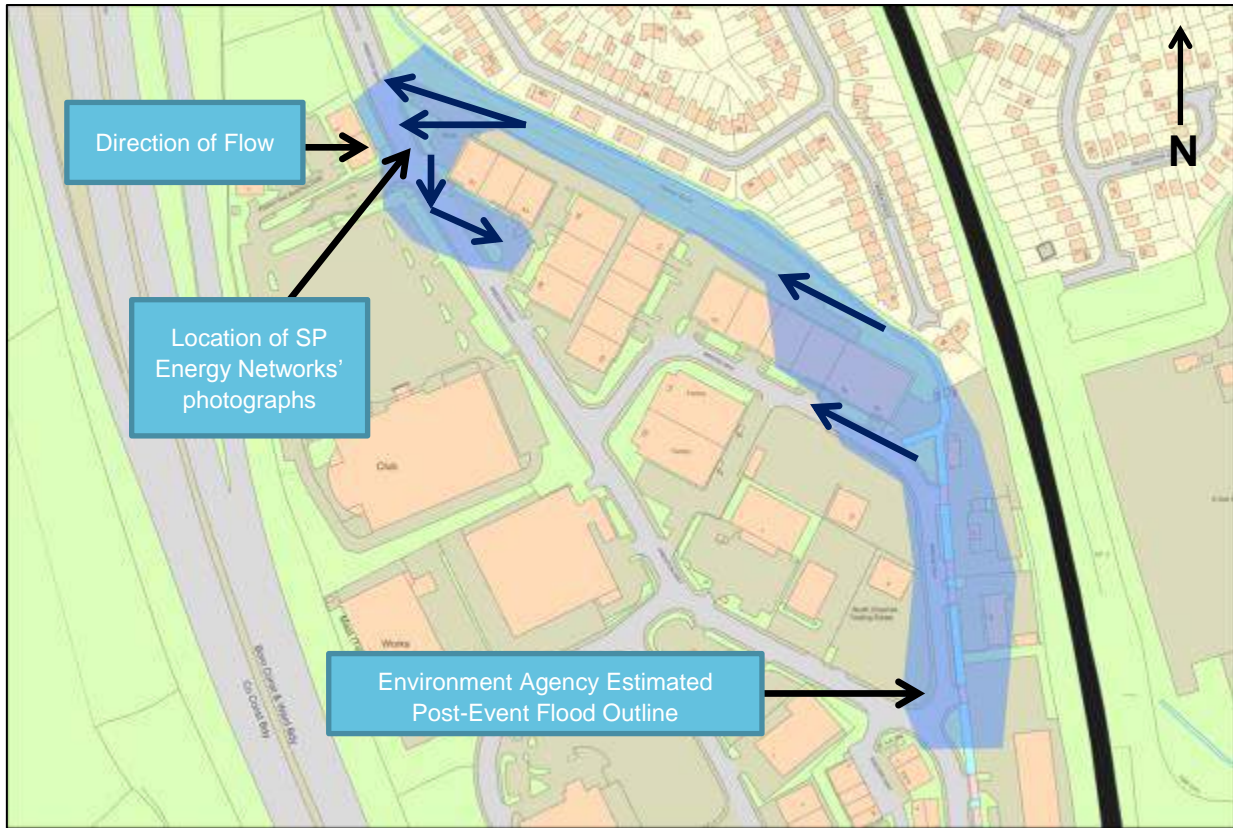
- A significant volume of fluvial floodwater being routed through the Prenton Brook.
- River level exceeding the capacity of the open sections of the Prenton Brook, particularly around the northern aspect of the North Cheshire Trading Estate where the gradient of the channel reduces.
- A low spot in the topography of the Prenton Way acting to retain fluvial floodwater until the flood peak had passed
- Potentially a backwater effect from the Access Bridge to Durley Drive, though this would need to be confirmed via a river modelling study.
- Surface water compounding the fluvial flooding, particularly if the UU surface water sewer outfalls to the Prenton Brook were unable to drain due to elevated water levels within the watercourse.

**Figure 5-11 Flooding Mechanisms at the North Cheshire Trading Estate**

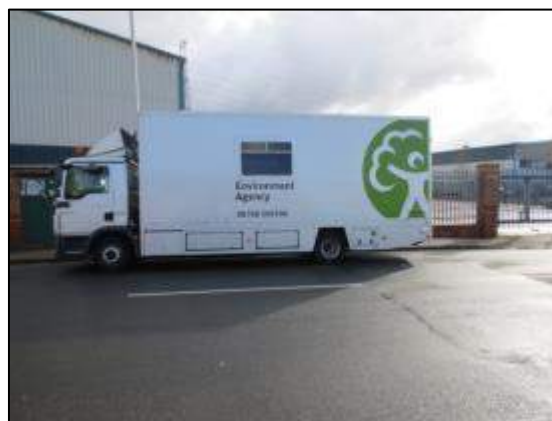
**Photograph 5-33 Environment Agency Operations Team**

- Merseyside Police were called out shortly after the overtopping and preventing cars from entering the estate and later prevented all access/ egress after being advised by the Environment Agency. The M53 was closed for approximately 30 minutes.
- An Environment Agency operations team was dispatched to inspect the watercourse for blockages following notification of the flooding
- The Environment Agency organised a Multi-Agency Meeting on the 12<sup>th</sup> November with business from the North Cheshire Trading Estate. This was also attended by representatives from WBC and UU.
- Environment Agency operatives have since been on site undertaking maintenance works (Photograph 5-33)

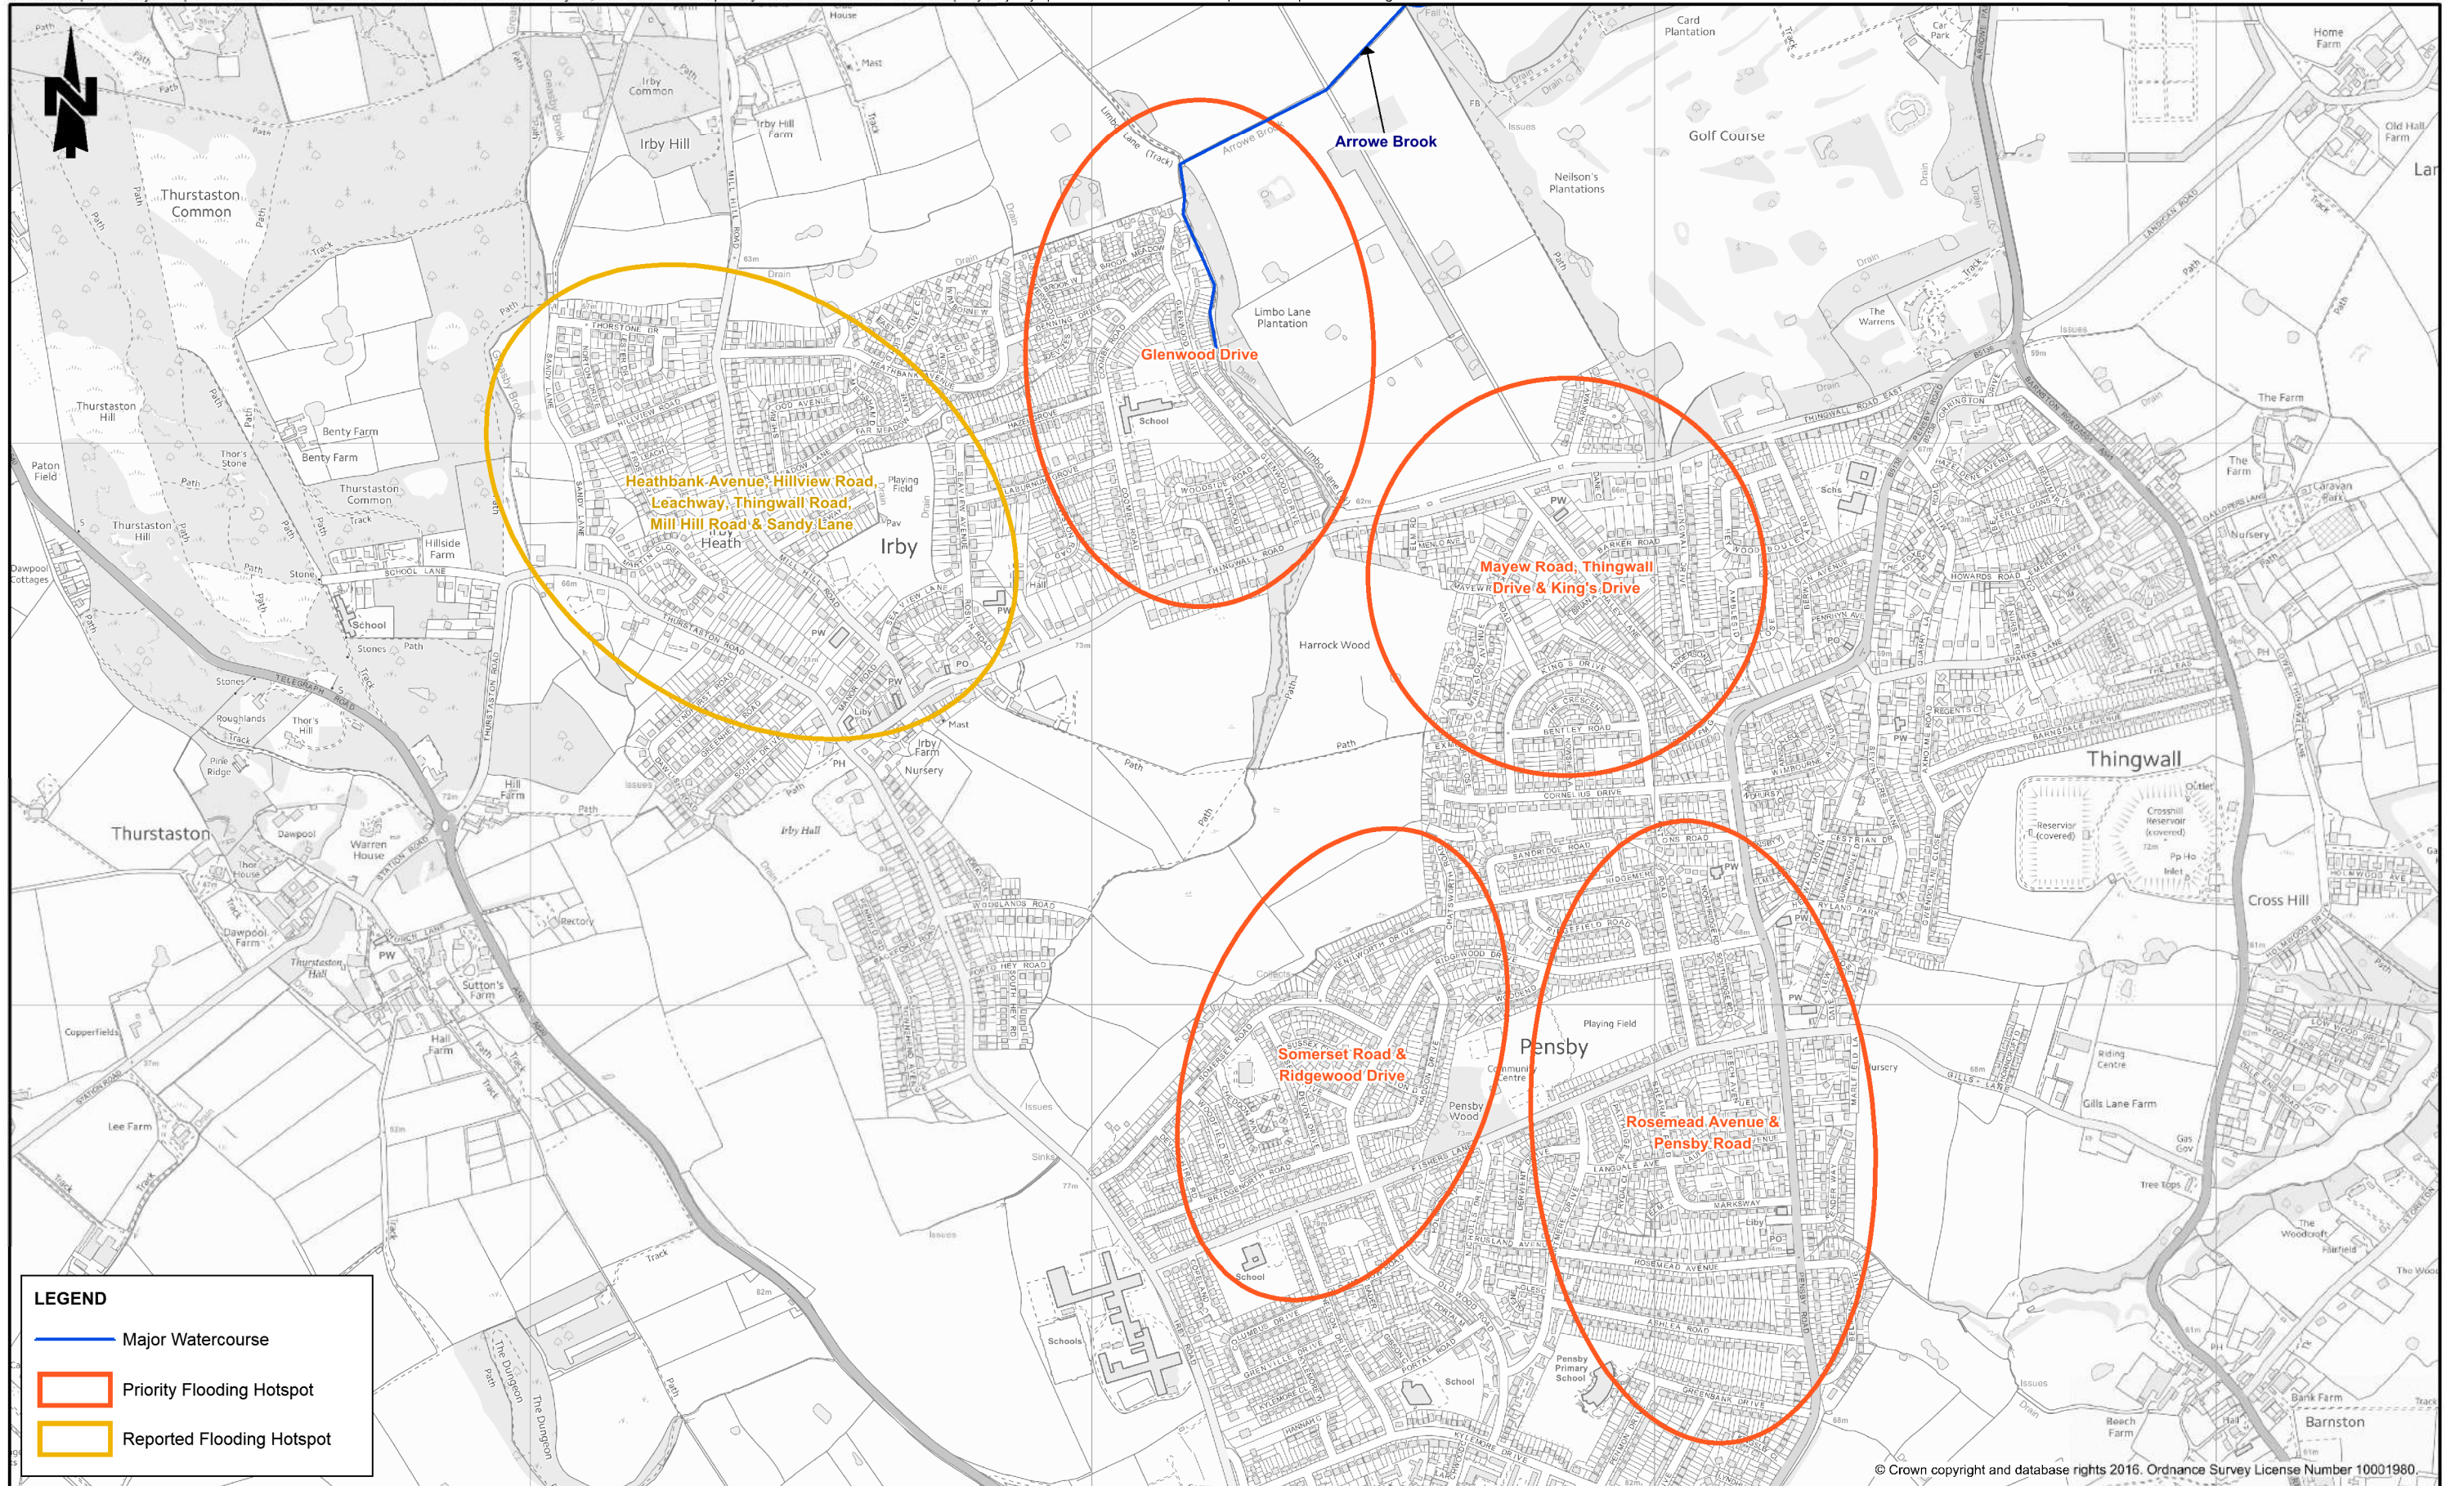
Title:	<b>IRBY, PENSBY &amp; THINGWALL FLOODING HOTSPOTS</b>
--------	---

The data review has been used to delineate flooding hotspots, as shown in Figure 5-12.

The most likely cause of flooding in this area is related to the 1 in 20 year design standard of the UU sewerage network being exceeded by the severity of the weather. WBC Highways and UU should review the road drainage infrastructure in this area to ensure it is adequate to cope with expected volumes of surface water runoff.

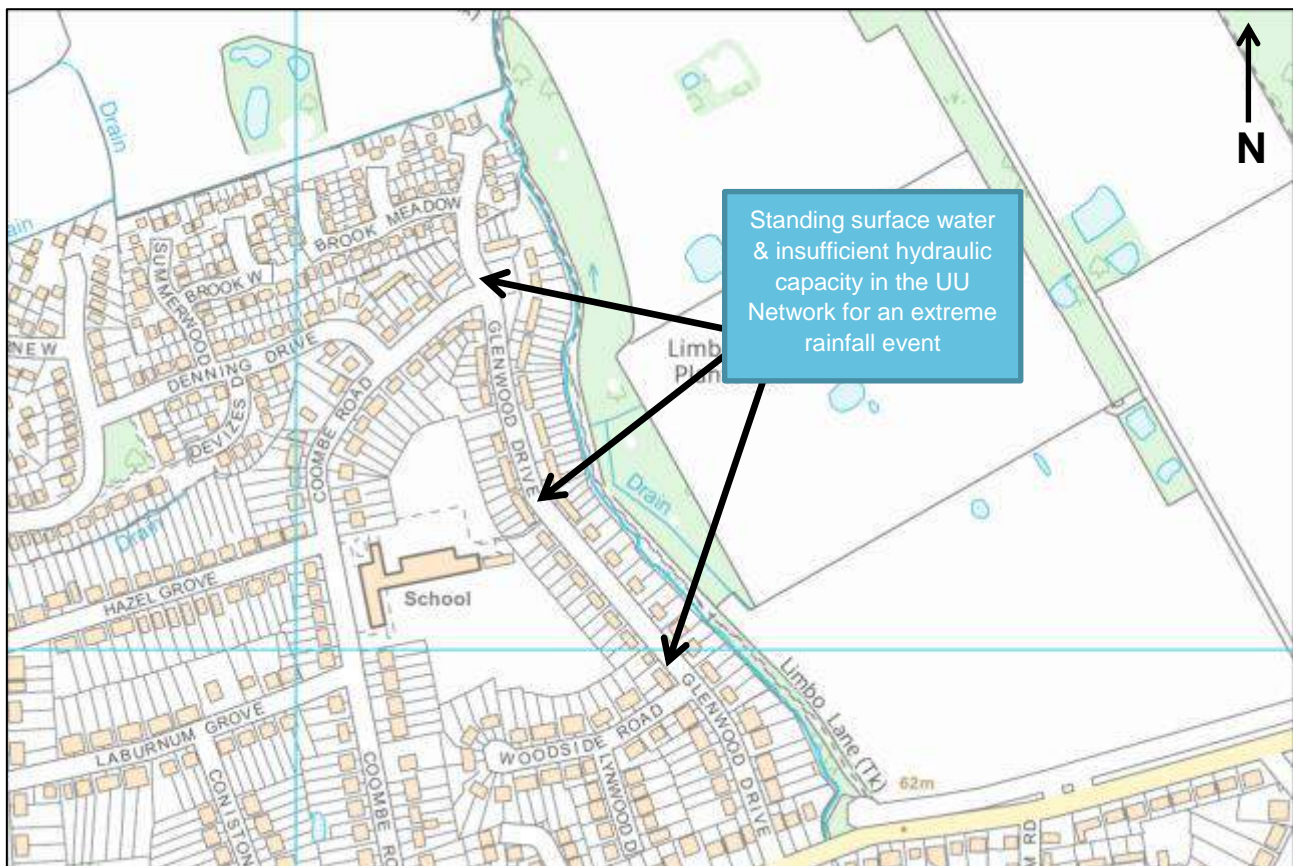
Figure 5-13 Irby Flooding Mechanisms

There was some evidence of localised waterlogging at the third grouping at the north of the estate which may be attributable to surface water shedding from the main highway onto the adjacent common land. One resident indicated that minor external flooding had occurred historically but otherwise declined to comment further.

UU has stated that their investigations into the area have confirmed that the flooding was a result of the 1 in 20 year design standard of the sewers being exceeded due to the exceptional severity of the weather, resulting in the external flooding of the highways shown in Figure 5-13.

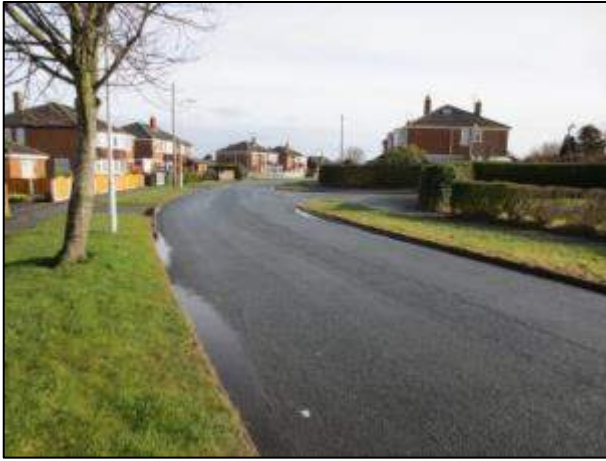
UU has stated that their investigations into the area have confirmed that the flooding was a result of the 1 in 20 year design standard of the sewers being exceeded due to the exceptional severity of the weather, resulting in the external flooding of highway.

Photograph 5-37 Somerset Road (3/3/16)

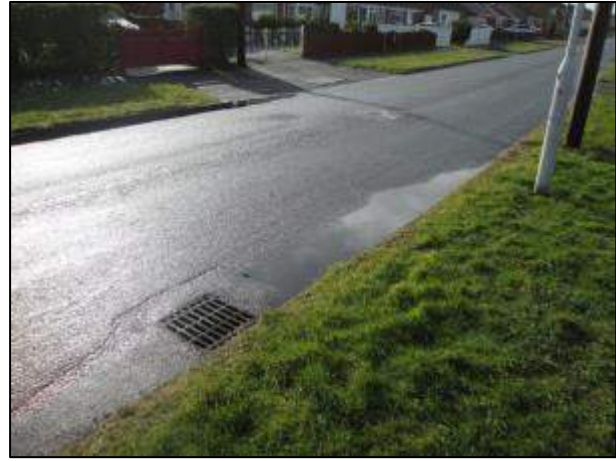
Photograph 5-38 Ridgewood Drive (3/3/16)

The survey team attended another pre-arranged visit with a resident on Ridgewood Drive who confirmed that the historic flooding issues were very similar to those that occurred on Somerset Road (the adjoining road). Following heavy rainfall water exceeds the capacity of the local drainage network and results in external flooding around a number of properties in this area. The resident stated that the flooding had not resulted in any internal property damage.

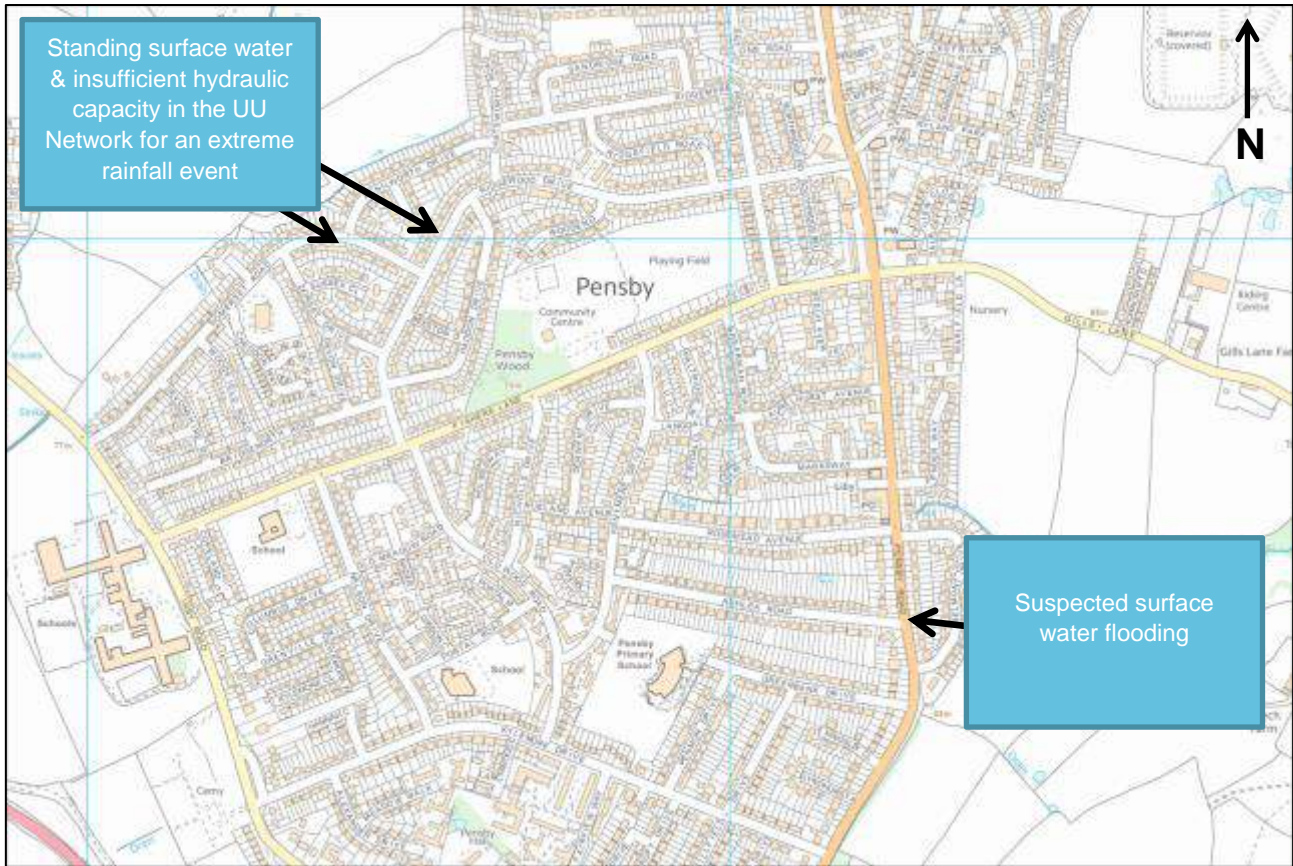
**Figure 5-15 Pensby Flooding Mechanisms**

- The 1 in 20 year hydraulic capacity of the surface water sewers being exceeded due to the intensity of the 2<sup>nd</sup> September rainfall.
- Localised variations in highways topography (i.e. at Thingwall Drive and Somerset Road) routing floodwater towards properties.

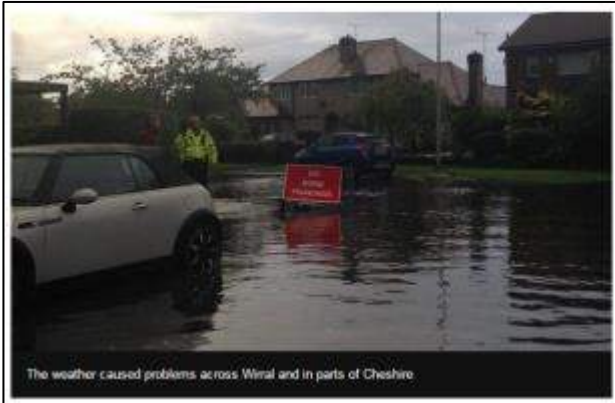
Based upon the verified flood investigation provided by UU the majority of these isolated instances relate to the severity of the weather exceeding of the 1 in 20 year design standard of the UU sewer network. Relevant photographs from news outlets are shown below. This was also compounded by localised ordinary watercourse and Main River flooding at discrete locations (i.e. the Clatter Brook in Dibbinsdale).

Photograph 5-39 Road Closures (2/9/15)
