# Wirral Borough Council:

## Section 19 Flood Investigation: 22<sup>nd</sup> August and 2<sup>nd</sup> September 2015

May 2016

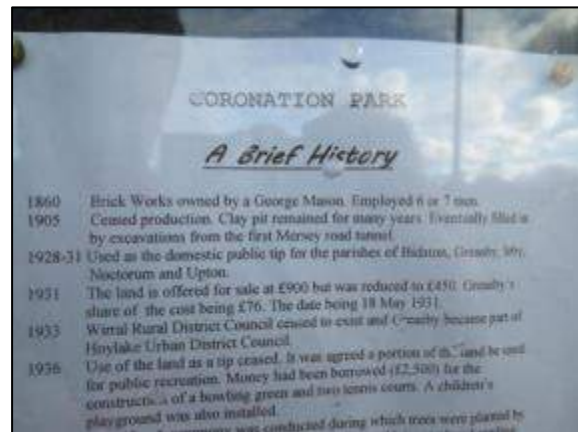
The grassed areas of the park were waterlogged (Photograph 5-4), with multiple instances of standing water observed. The park itself covers an area of approximately 8 hectares. A notice in the park’s information board suggests that the park was previously a clay excavation pit which was later capped with excavation material from the Mersey tunnel (Photograph 5-5).

Significant clay deposits and low permeability soils may prevent the infiltration of surface water into the ground and result in the generation of overland flow which residents indicated has happened historically (including on both the 22<sup>nd</sup> August and the 2<sup>nd</sup> September 2015). A drainage ditch is present on the park’s western boundary (adjacent to the allotments) and was observed to be conveying a small volume of water at the time of the visits. This feature may afford a low level of protection to the playing fields and the adjacent residential properties.

**Photograph 5-5 A Brief History of Coronation Park (1/3/16)**

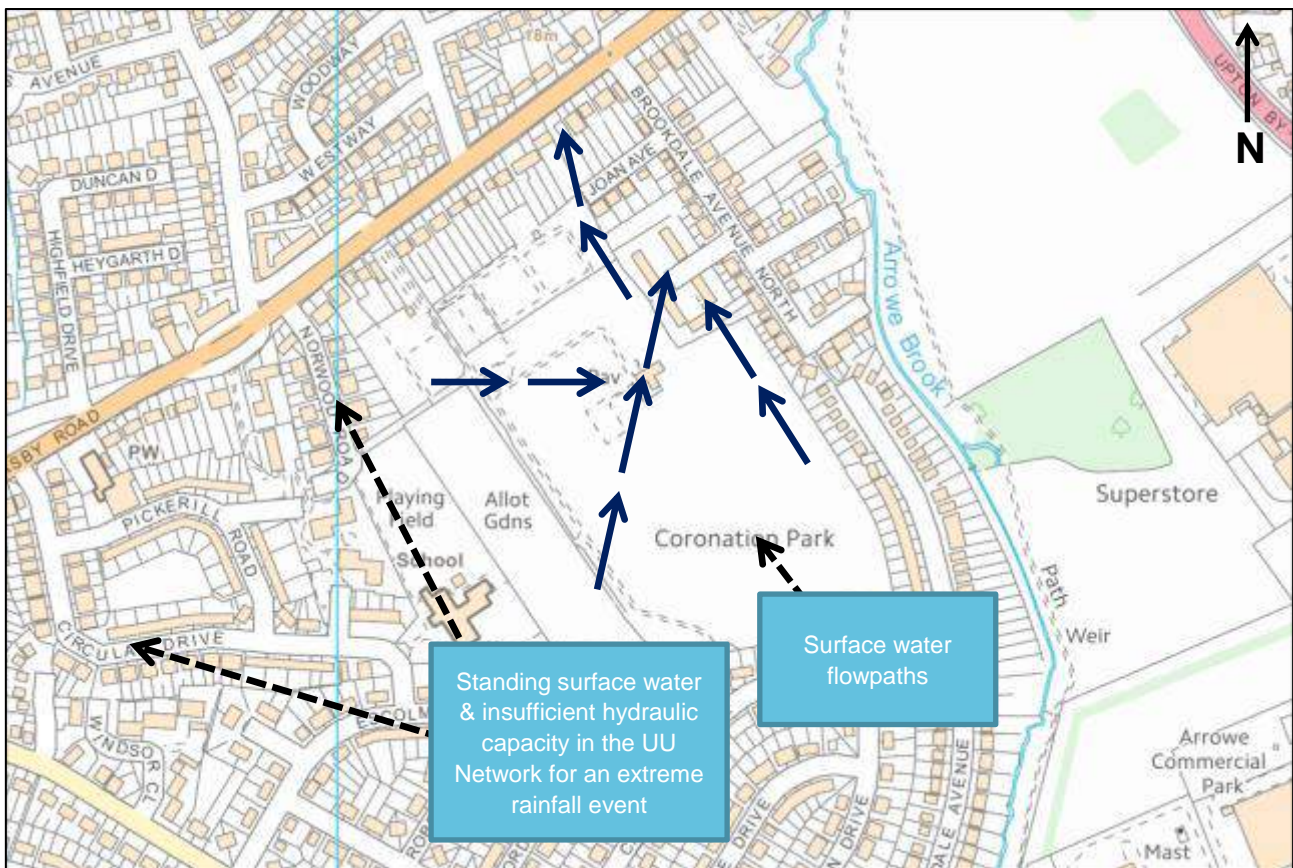
- Limited infiltration capacity within the grassed areas of Coronation Park resulting in the generation of a large volume of surface water. If there are significant clay deposits beneath the park this may create an impermeable lining which would exacerbate this issue.

- Wet antecedent conditions arising from the rainfall on the 1<sup>st</sup> of September may have further reduced the infiltration capacity of the grassed areas of the park prior to the second pulse of rainfall on the 2<sup>nd</sup> September.

- The topography of the grassed area of Coronation Park slopes towards the north. Water unable to infiltrate into the ground would be routed overland in this direction towards Brookdale Close and Joan Avenue.

- The hydraulic capacity of the UU drainage network beneath Norwood Road and Circular Drive being exceeded due to the significant intensity of rainfall (with an estimated return period of 84 years for the 48 hour storm). UU's sewerage systems are not designed to accommodate flows from severe weather events (i.e. those greater than a 1 in 20 year rainfall event) (as detailed in Section 2.3.3).

**Figure 5-3 East Greasby Flooding Mechanisms**

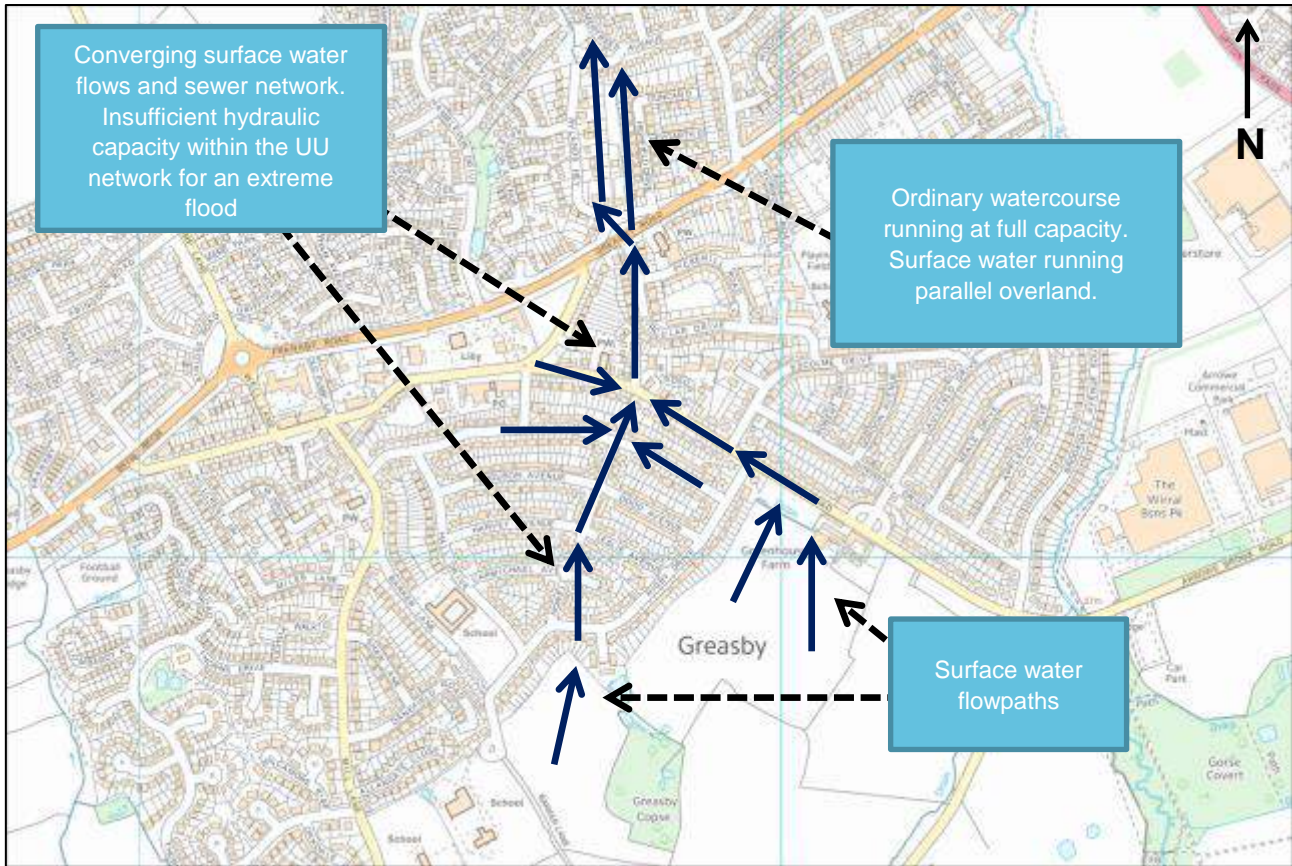
- Surface water flows were routed down Tudor Grange onto Circular Drive and subsequently onto Rylands Hey. This was compounded by UU sewers running at capacity due to the severe weather (being greater than a 1 in 20 year return period) and resulted in overland flow running through the gardens and properties on Rylands Hey.

**Figure 5-5 Central Greasby Flooding Mechanisms**

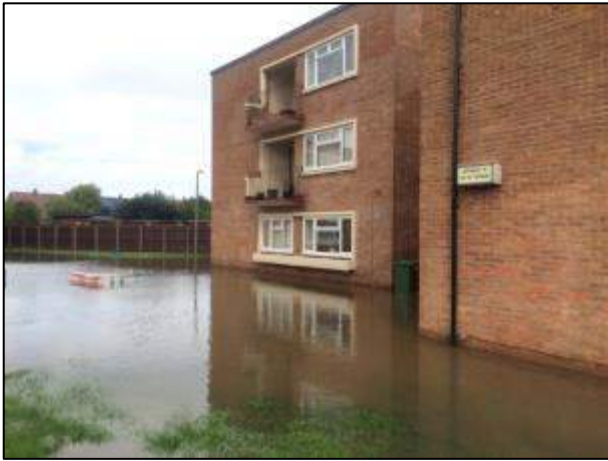
**Photograph 5-18 Tern Way Flats (2/9/15)**

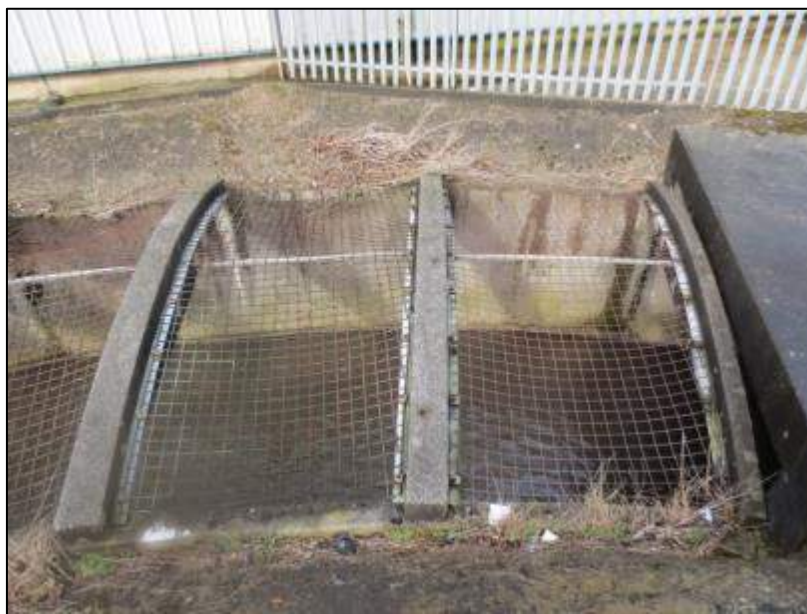
**Photograph 5-32** The Prenton Brook

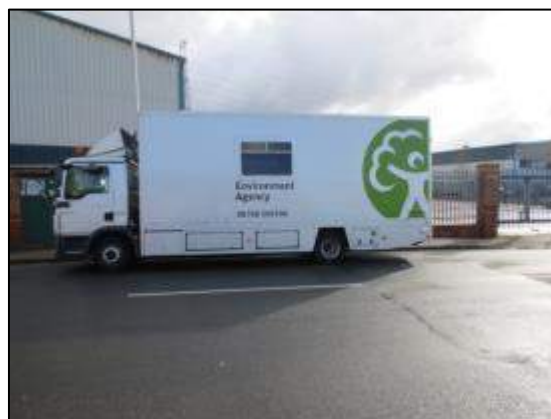
**Photograph 5-33 Environment Agency Operations Team**

- Merseyside Police were called out shortly after the overtopping and preventing cars from entering the estate and later prevented all access/ egress after being advised by the Environment Agency. The M53 was closed for approximately 30 minutes.
- An Environment Agency operations team was dispatched to inspect the watercourse for blockages following notification of the flooding
- The Environment Agency organised a Multi-Agency Meeting on the 12<sup>th</sup> November with business from the North Cheshire Trading Estate. This was also attended by representatives from WBC and UU.
- Environment Agency operatives have since been on site undertaking maintenance works (Photograph 5-33)

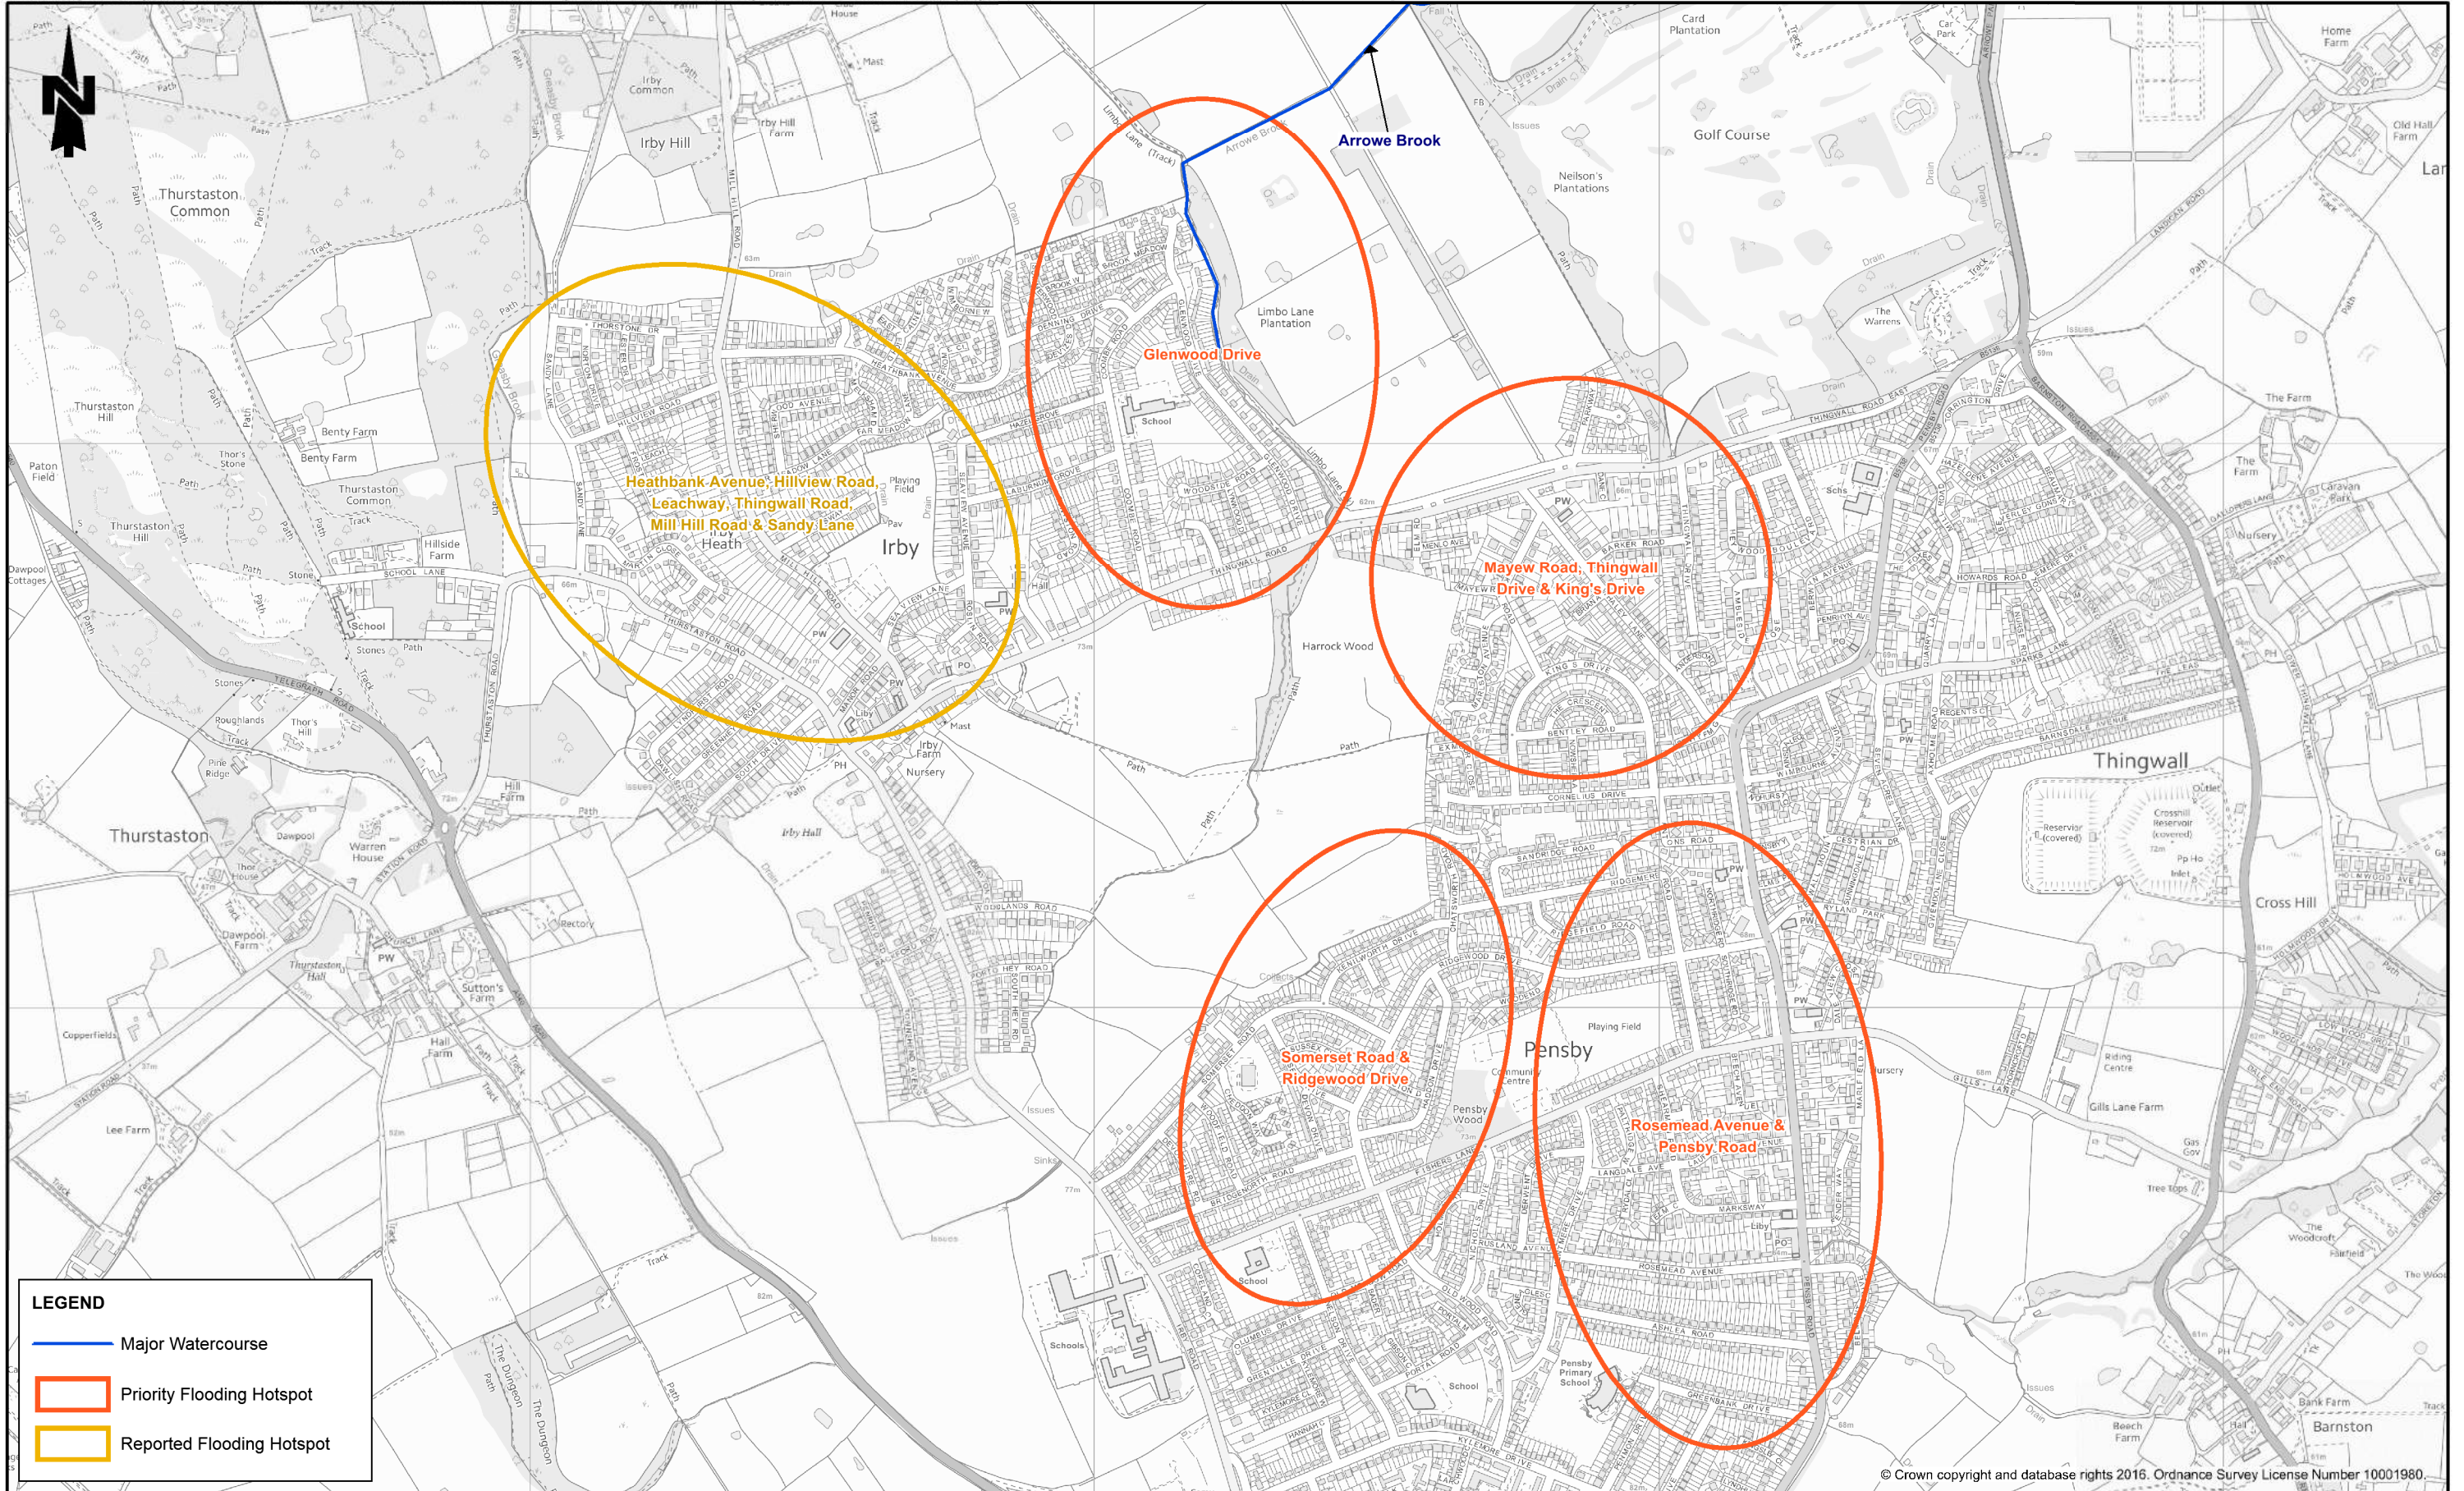
Design:	AB	GIS:	AB
Chk'd:	RJ	App'd:	RJ
Date:	22-03-2016	Scale:	1:11,000@A3
No. FIGURE 5-12			Rev: 0

The stakeholder consultation and data review described in Section 4 identified multiple reports of property and highway flooding during the 2<sup>nd</sup> September 2015 event. The majority of these issues relate to surface water, sewers and ordinary watercourses. The main rivers were not reported as having caused any flooding issues within this location.

The data review has been used to delineate flooding hotspots, as shown in Figure 5-12.

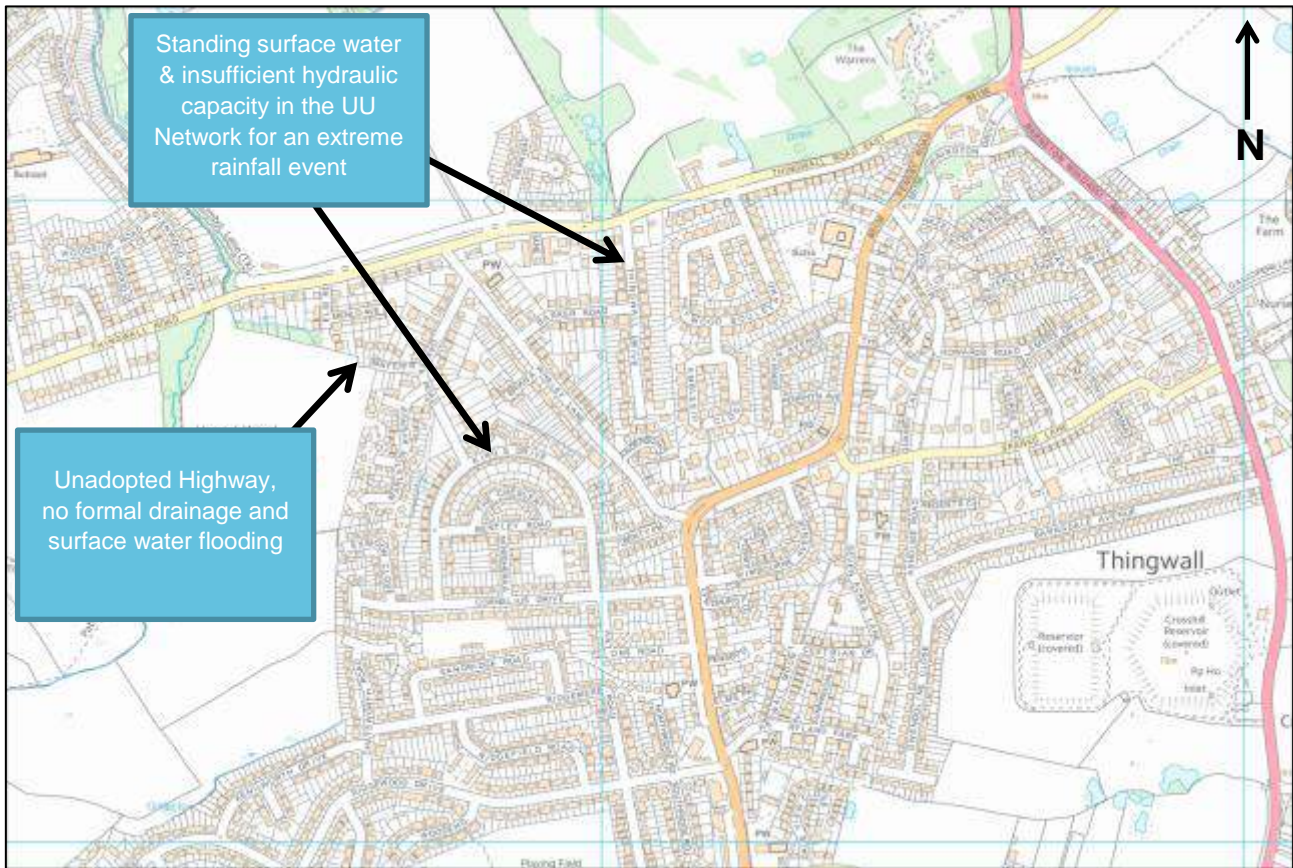
**Figure 5-14 Thingwall Flooding Mechanisms**

The survey team spoke to two residents on King’s Drive. The first resident indicated that there had been no flooding, however, the second stated that the fire service had been called out following major rainfall (though they could not remember the date that this occurred). The resident advised that the fire service had been in attendance to pump water out of the road, though they had not had any flooding issues since then.

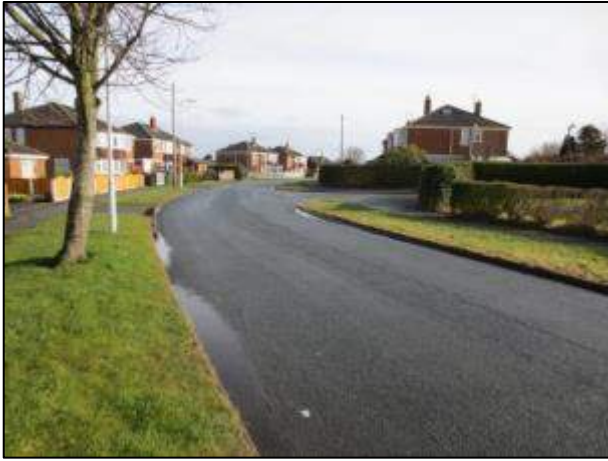
**Photograph 5-37 Somerset Road (3/3/16)**

Dialogue with additional residents confirmed UU has been particularly active along the road following the flooding, implementing additional resilience measures and undertaking further maintenance and clearance along Somerset Road.

UU has stated that their investigations into the area have confirmed that the flooding was a result of the 1 in 20 year design standard of the sewers being exceeded due to the exceptional severity of the weather, resulting in the external flooding of highway.
