OXTON CONSERVATION AREA APPRAISAL

Prepared for Wirral Council and The Oxton Society
by Donald Insall Associates Ltd

January 2010

VOLUME 1 – CONSERVATION AREA APPRAISAL

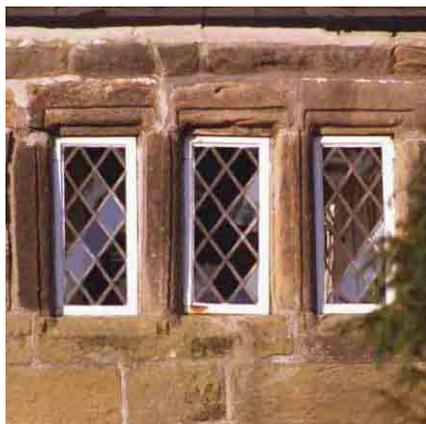
C17th sandstone 3-light ovolo moulded mullioned window, fitted with metal frames and leaded lights

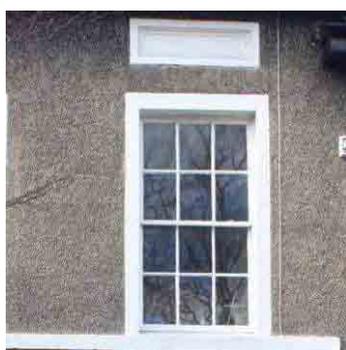
Conventional 12-pane double-hung sliding sash window with fine glazing bars in rectangular opening, given additional character by recessed panel above and projecting cill band below

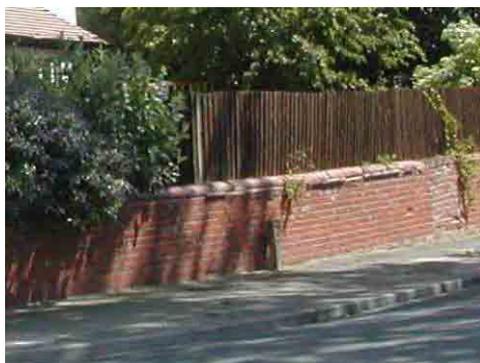
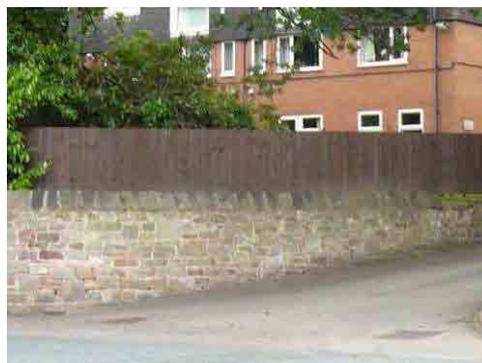
Inappropriate panel fencing atop a brick wall and sandstone wall

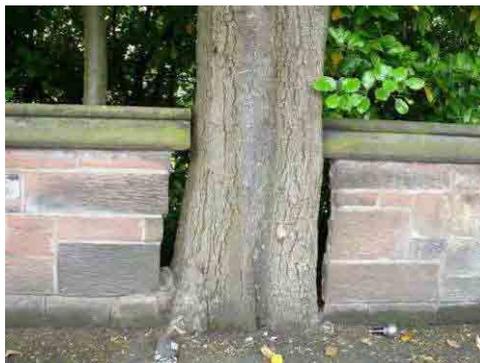
Low squared sandstone wall with copings demonstrating one method of retaining trees

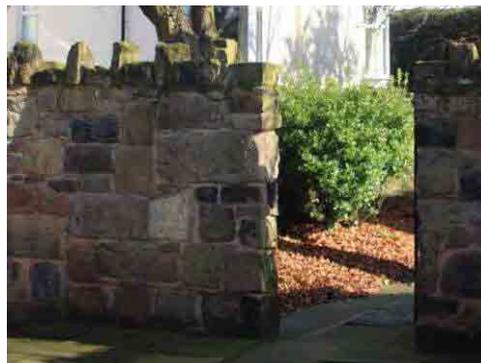
Example of 'cock and hen' coping, which adds variety to the streetscape

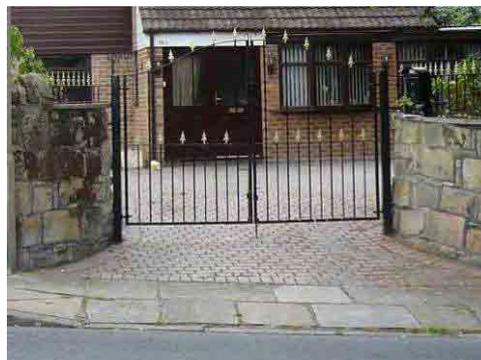
A well-intentioned attempt at introducing iron railings and gates, sadly out of character with both the character of the conservation area and the style of the house.

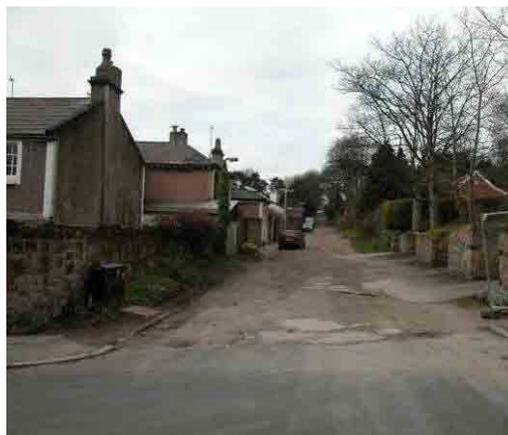
Arno Road West of Fairview Road is unmade, but heavy use has led to the creation of potholes and some uncoordinated patch repairs

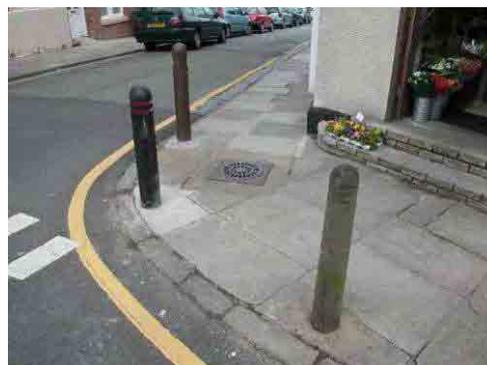
The requirements of road users and the need for frequent repairs impact on the visual quality of the roads and pavements

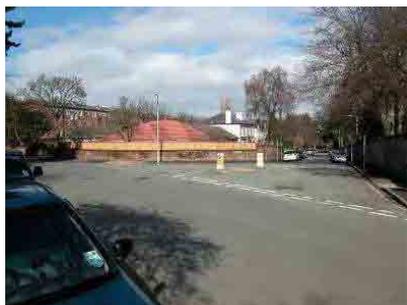
At the junction of Village Road and Alton Road all that can be seen of this bungalow is its bright red roof. It fails to add positively to the townscape of this important junction and detracts from the prevalent characteristics of the area.

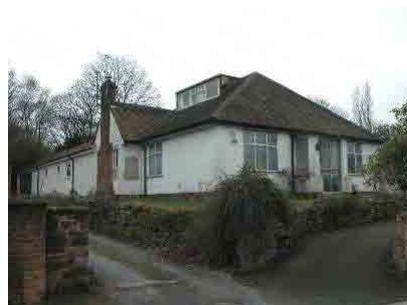
This bungalow on the site of a former villa on Victoria Mount is highly visible due to its elevated position and weak boundary treatment to the adjacent track.

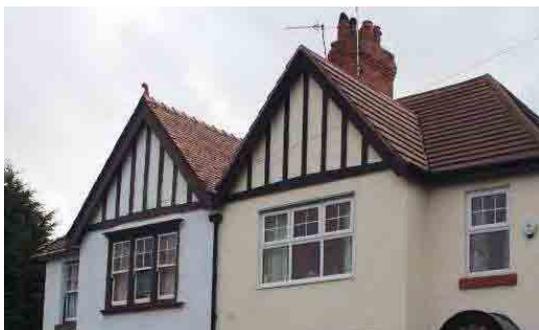
This pair of houses on Glenmore Road illustrate the impact of replacement windows and roof covering (right) as compared with the originals (left). Concrete tiles have a harsh stepped appearance. The decorative finial and subtle pattern of lapped ridge tiles have been lost. The replacement uPVC windows are flat and lacking in the attractive modelling of sashes with horns, cill and cornice detail and vertical rhythm of sash boxes.

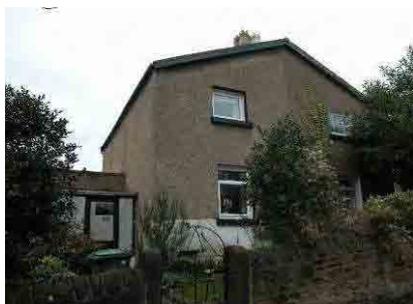
Sandstone house on Parr's Road with rendered façade and modern replacement windows

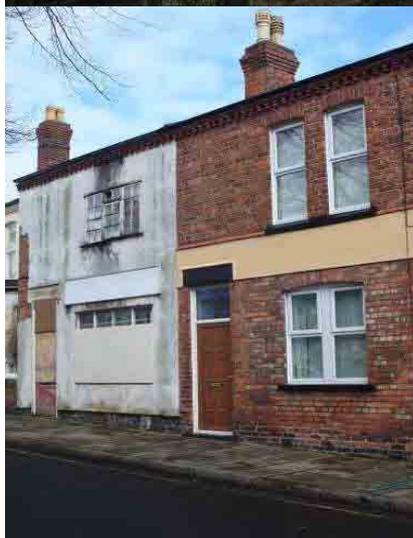
(left) Brick terrace on Claughton Firs where the application of painted render and insertion of horizontally proportioned small paned windows, along with vacancy and neglect has had a disastrous effect on the building.

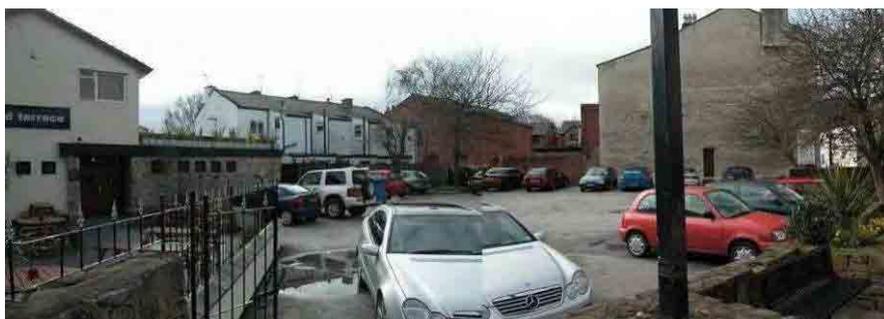
Loss of enclosure around car park at village centre

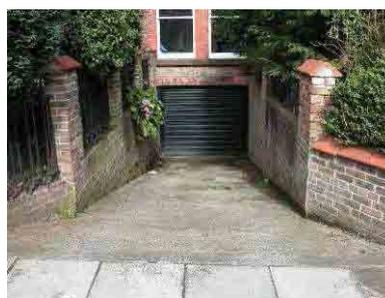
Basement converted to garage on Village Road
